# Preliminary Report on the Performance of the New Orleans Levee Systems in Hurricane Katrina on August 29, 2005

Preliminary findings from field investigations and associated studies performed by teams from the University of California at Berkeley and the American Society of Civil Engineers, as well as a number of cooperating engineers and scientists, shortly after the hurricane.

Report No. UCB/CITRIS – 05/01  
November 17, 2005

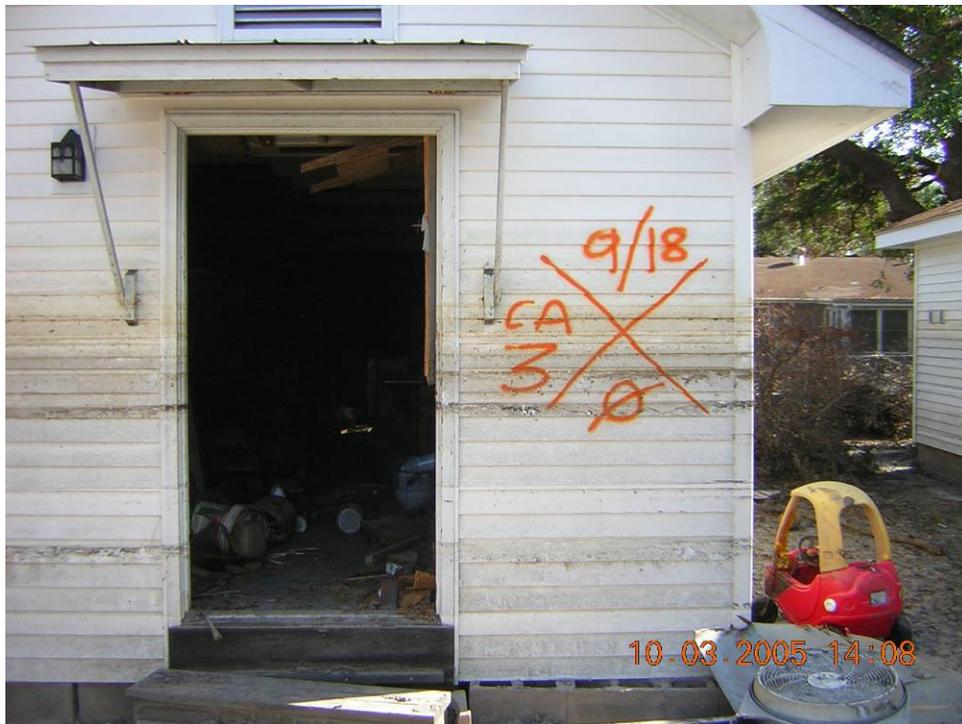
Figure 1.8: High water marks remain on structures after temporary levee repairs have been completed and flood waters have been pumped out.

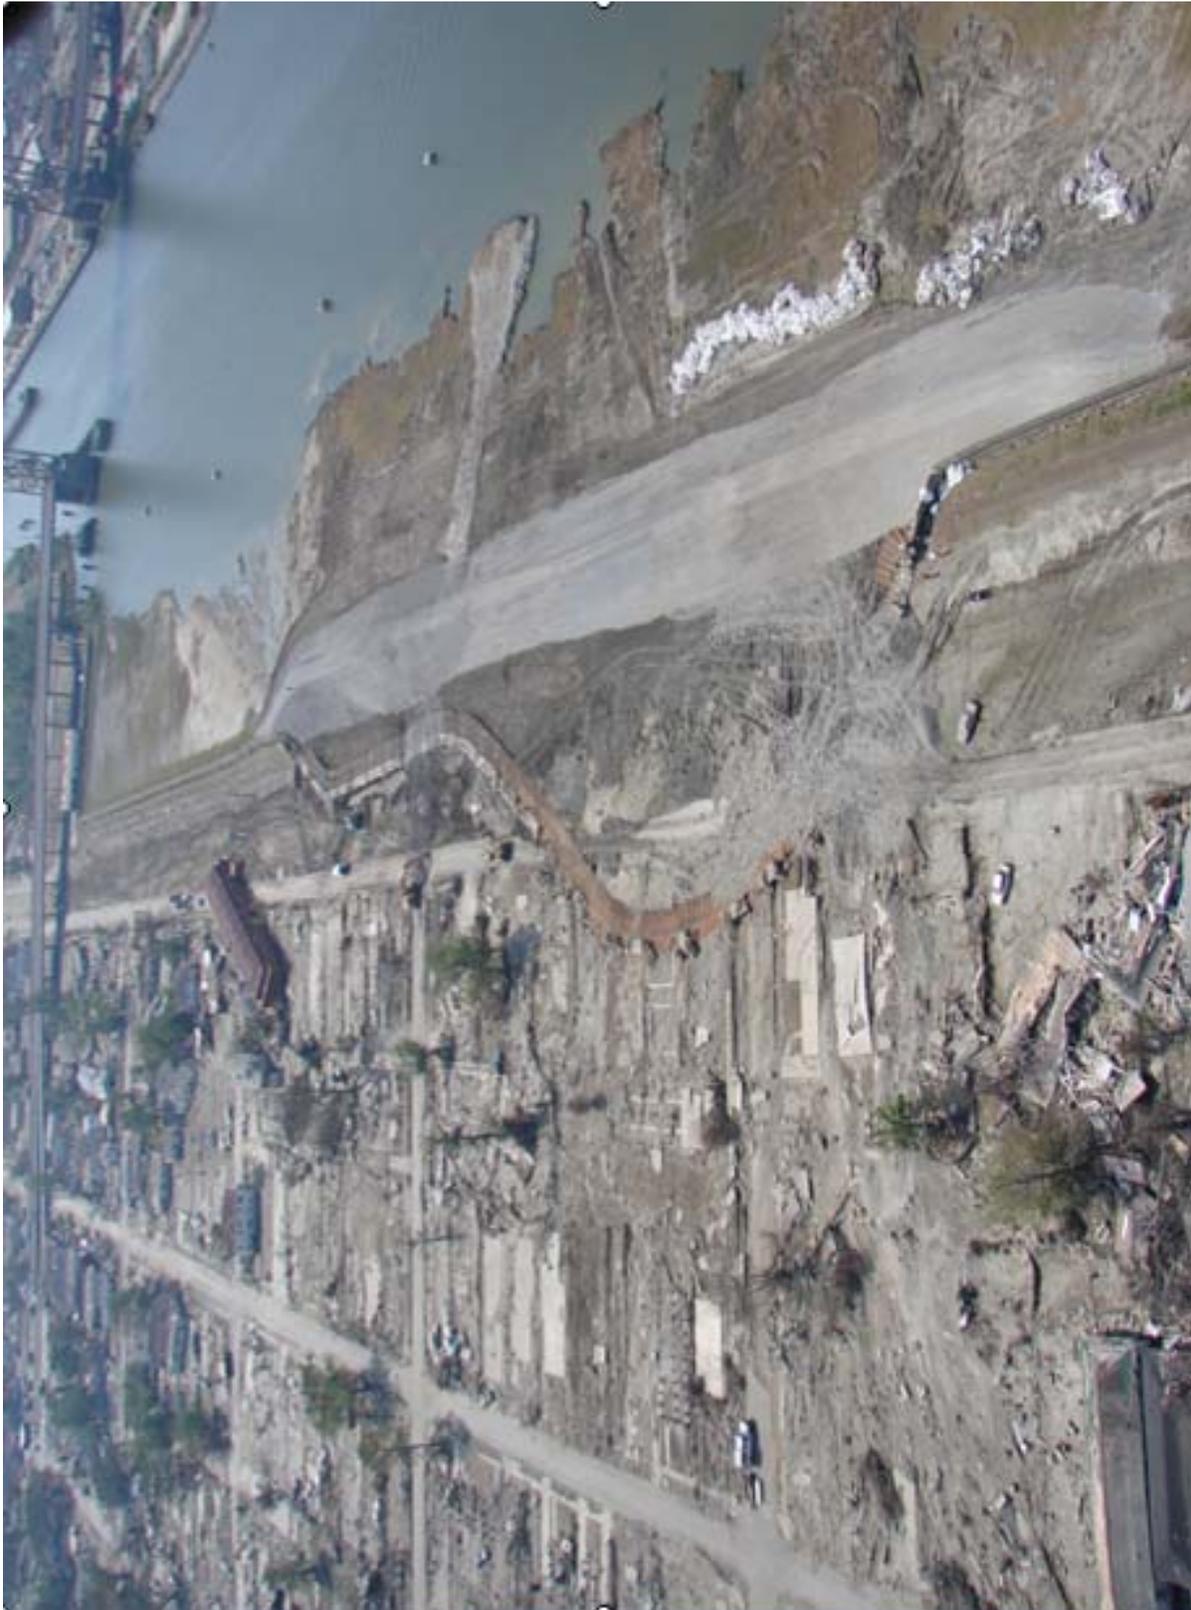
Figure 1.9: Oblique view of the (south) levee break at the Inner Harbor Navigation Canal into the lower Ninth Ward.

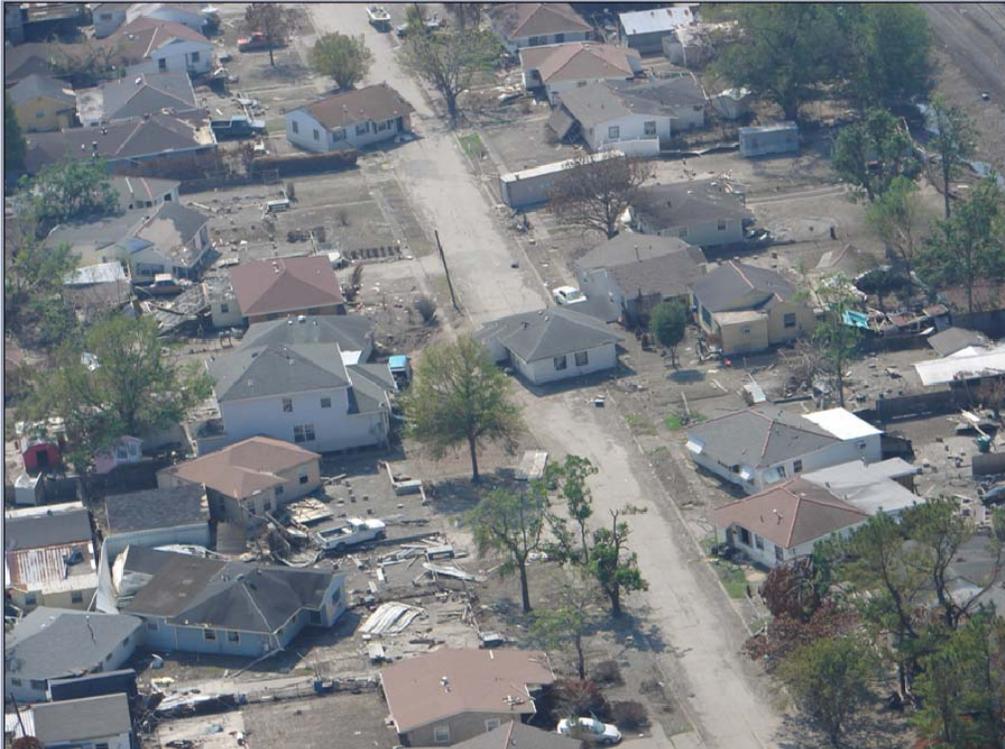
Figure 1.10: Flooded neighborhood in St. Bernard Parish, showing homes floated off their foundations and transported by floodwaters.

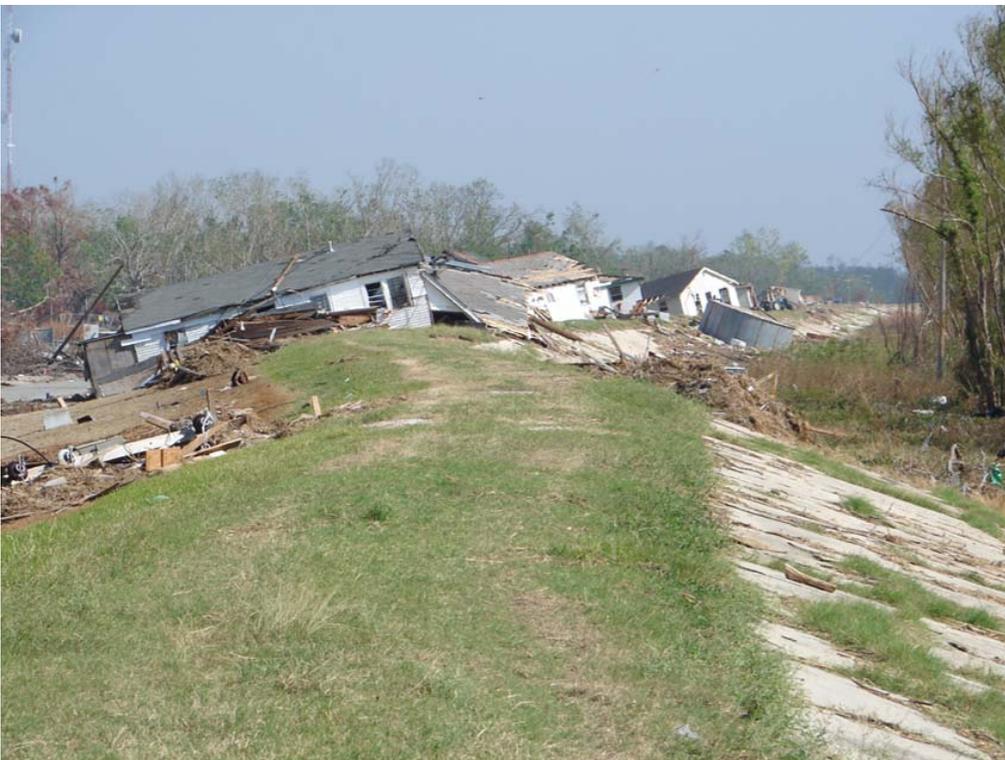
Figure 1.11: Homes in Plaquemines Parish carried from left to right in photo and strewn across the crown of the Mississippi Riverfront levee.

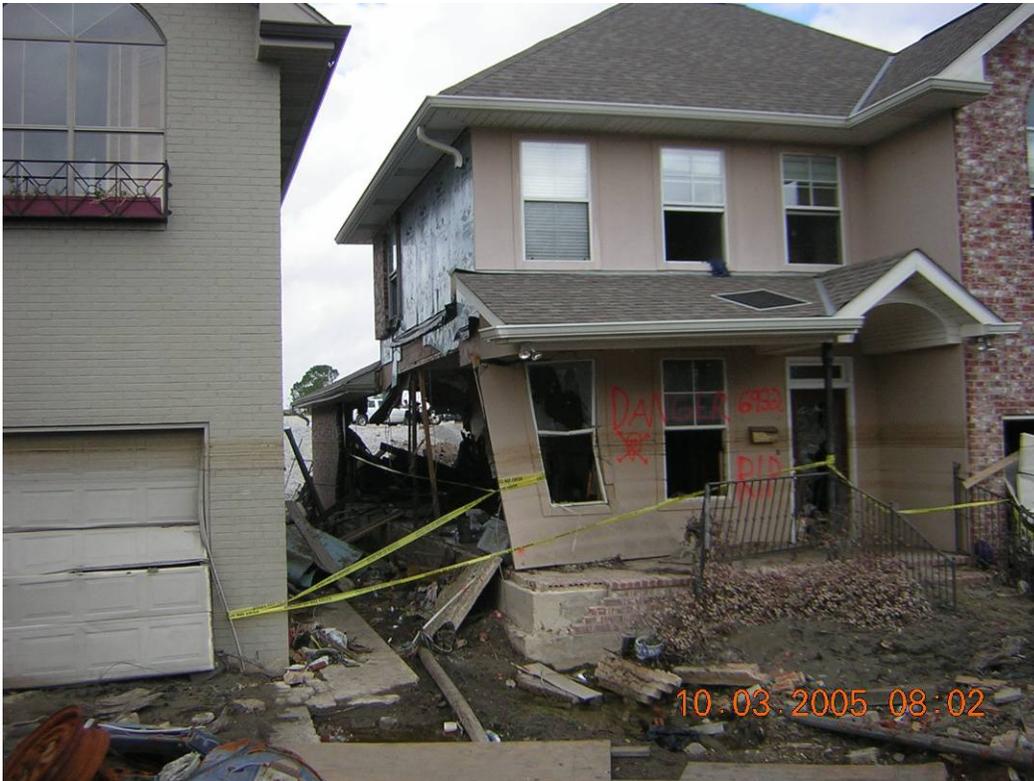
Figure 1.12: Damage to a residential neighborhood in the 17<sup>th</sup> Street Canal area due to flooding.

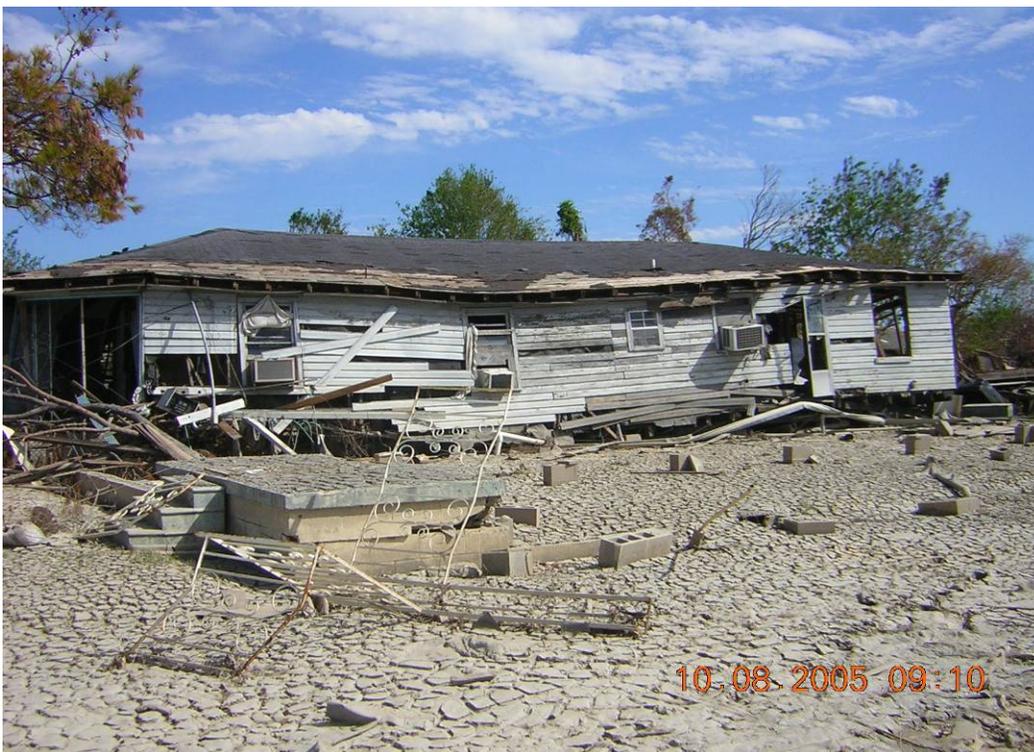
Figure 1.13: Another view of flooding damage, this time in the lower Ninth Ward.

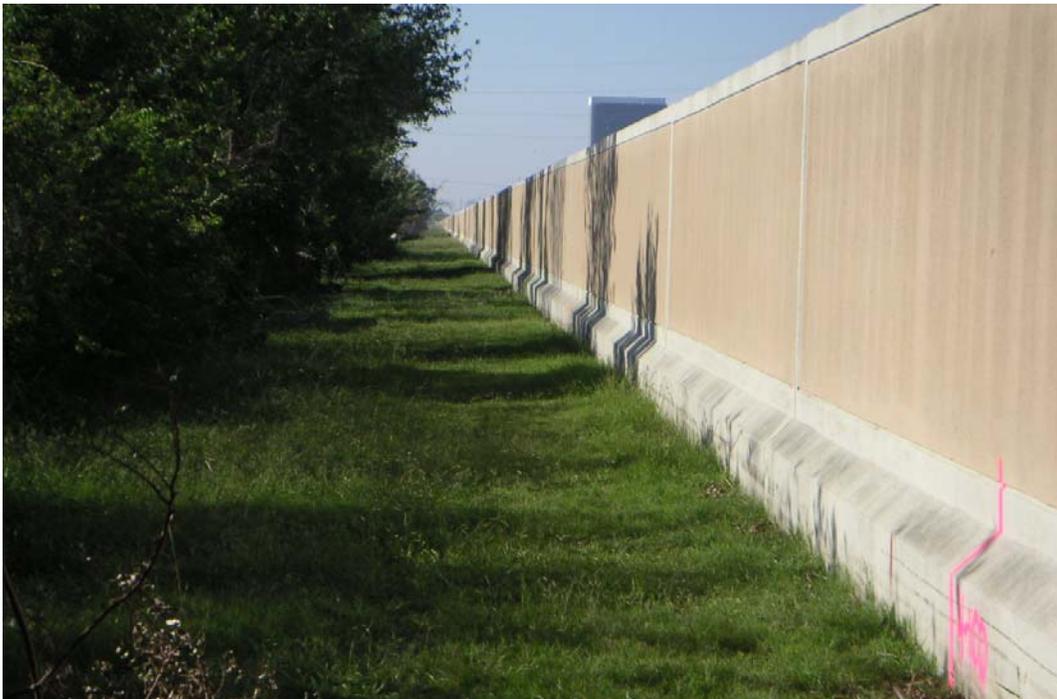
Figure 2.11: Typical conditions at the inboard side of floodwalls along the 17<sup>th</sup> Street Canal showing no scour of soil at the toe of the wall.

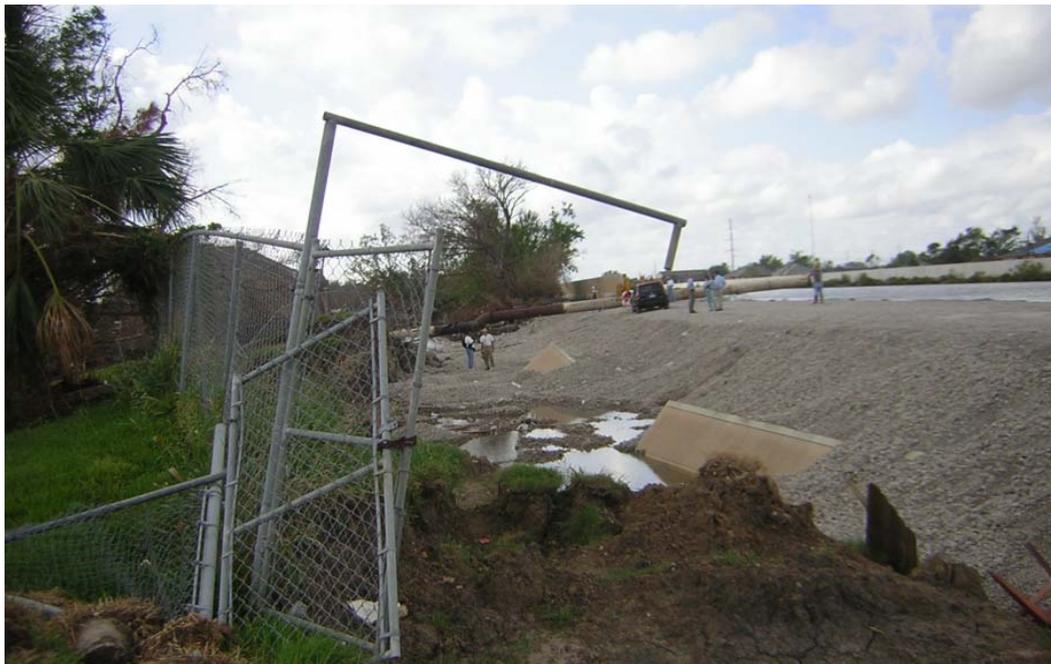
At the time of our field teams' initial visit (October 3, 2005) an embankment fill had been placed over the core of large sandbags and large stone used to effect the initial closure. Additional gravelly fill had been placed at the inboard toe to provide a working mat. The conditions at this time are shown in Figure 2.12. The fill used as a covering veneer was a gap graded sandy gravel known locally to be internally unstable with regard to erosion, and our site team noted four sinkholes at the outboard lip of the crest of the temporary levee section, as shown in Figure 2.13. Three of these could be observed to be curving inward toward the center of the embankment section, and running water could be clearly heard in one of these.

Figure 2.12: Temporary closure section embankment on October 3rd, 2005.

The USACE was notified of the apparently unstable condition, with evidence of ongoing internal erosion of the fill, and the section was covered the next day, initially with a three foot thick layer of open graded stone (6-inch to 24-inch stone), which was then covered at the crest by a five to seven foot (uncompacted) lift of better graded silty sand, as shown in Figure 2.14. Both the open-graded stone, and the covering veneer silty sand fill can be clearly seen in this photo. The silty sand was also pushed down the inboard and outboard faces of the embankment providing a covering veneer of several feet on both sides of the emergency embankment section. The USACE was again notified that this did not appear to represent a hydraulically stable (or well filtered) embankment configuration; and the rapid placement of additional competent fill as an inboard berm, to be quickly followed by installation of a sheetpile cut-off wall, was recommended.

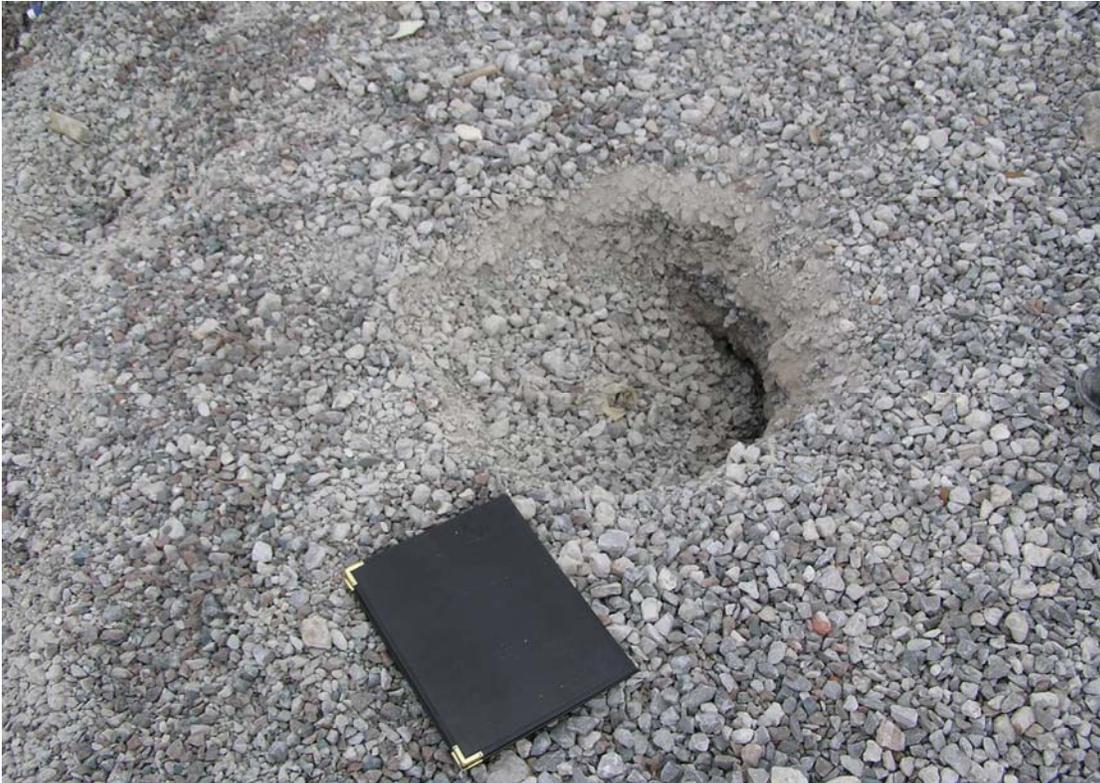
Figure 2.13: One of four sinkholes noted at the front lip of the crest of the temporary closure section embankment.

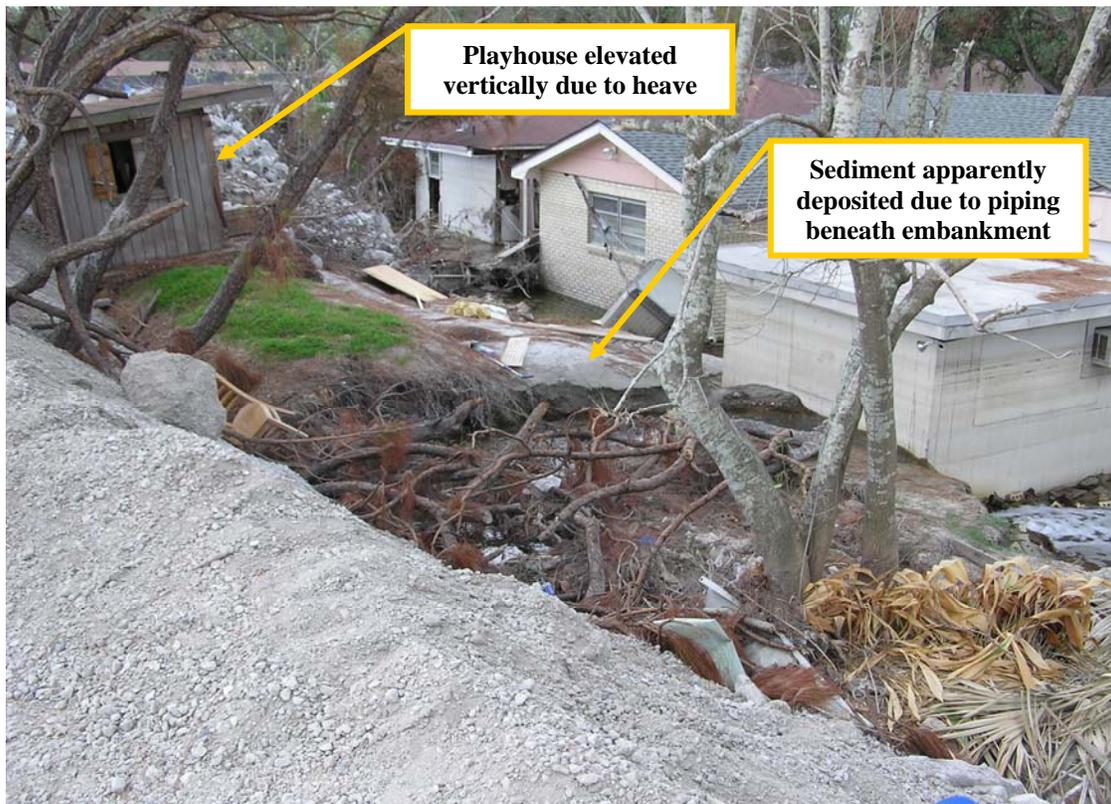
Figure 2.16: Conditions at the inboard toe of the London Avenue Canal (North) breach section.

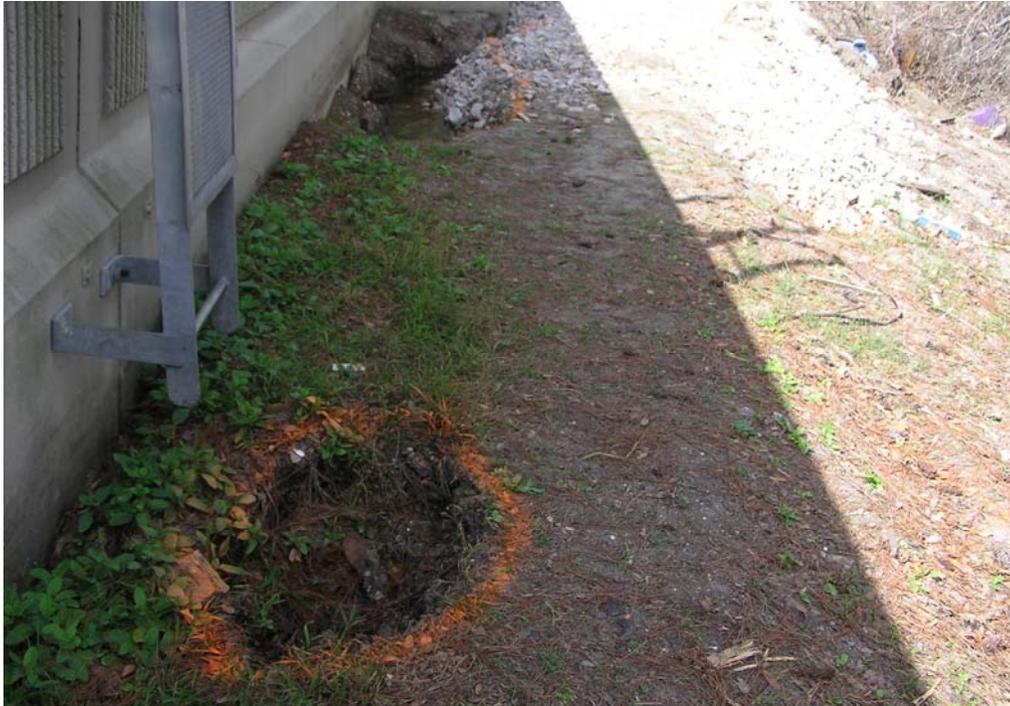
Figure 2.21: Closeup view of sinkholes at the inboard toe of the floodwall, at the location of the engineer wearing a red shirt in Figure 2.20.

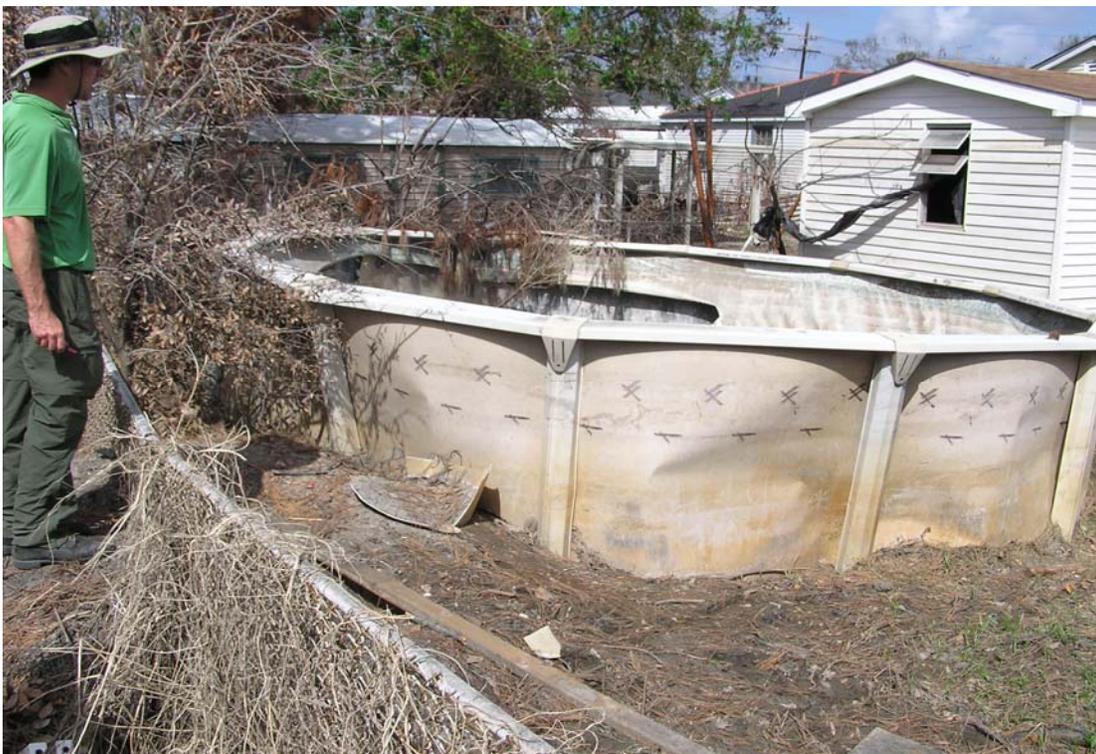
Figure 2.22: View of conditions at the inboard toe, immediately inboard of the locations shown previously in Figures 2.21 and 2.22. Note the bulged and hummocky ground, the laterally displaced chain link fence, and the piping boil ejecta.

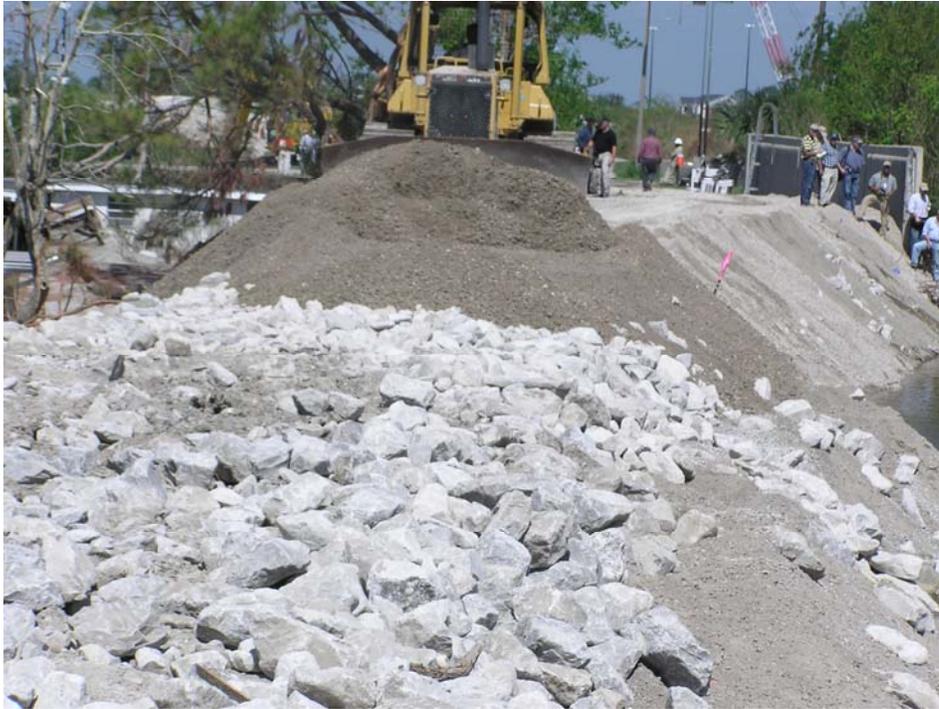
Figure 2.23: Photo during construction of the emergency breach repair embankment at the London Avenue Canal (North) breach site.

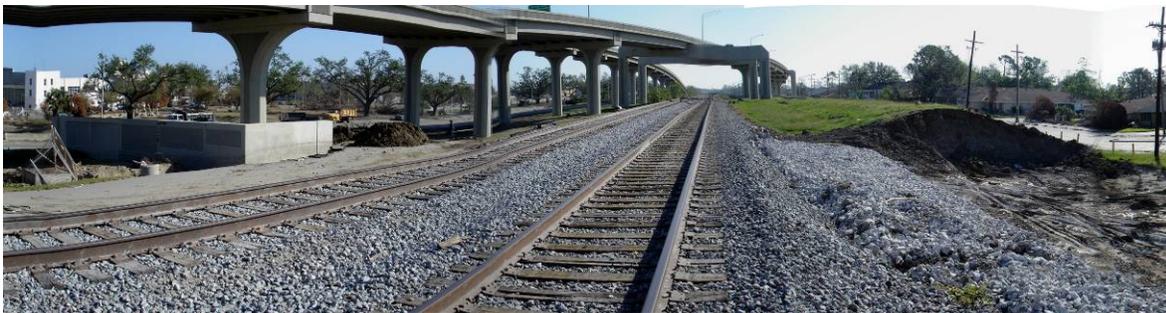
Figure 3.2: Complex transition near Lakefront Airport consisting of various flood protection heights, differing materials and junctures between various jurisdictional organizations. These types of complex transitions were found to be associated with several of the levee flood protection problems.

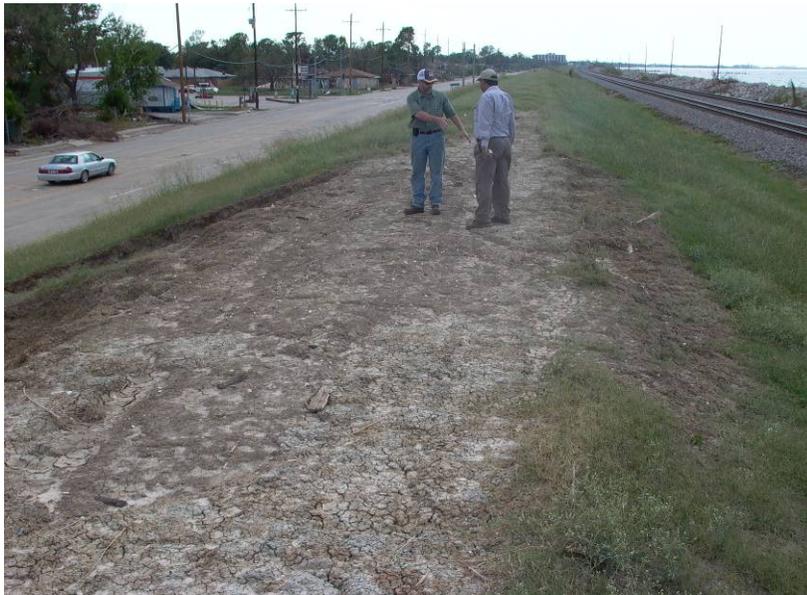
Figure 3.6: Wave overtopping of lakefront earthen levee at low spot in structure did not cause serious damage (N 30° 03' 47.8", W 89° 58' 13.1)

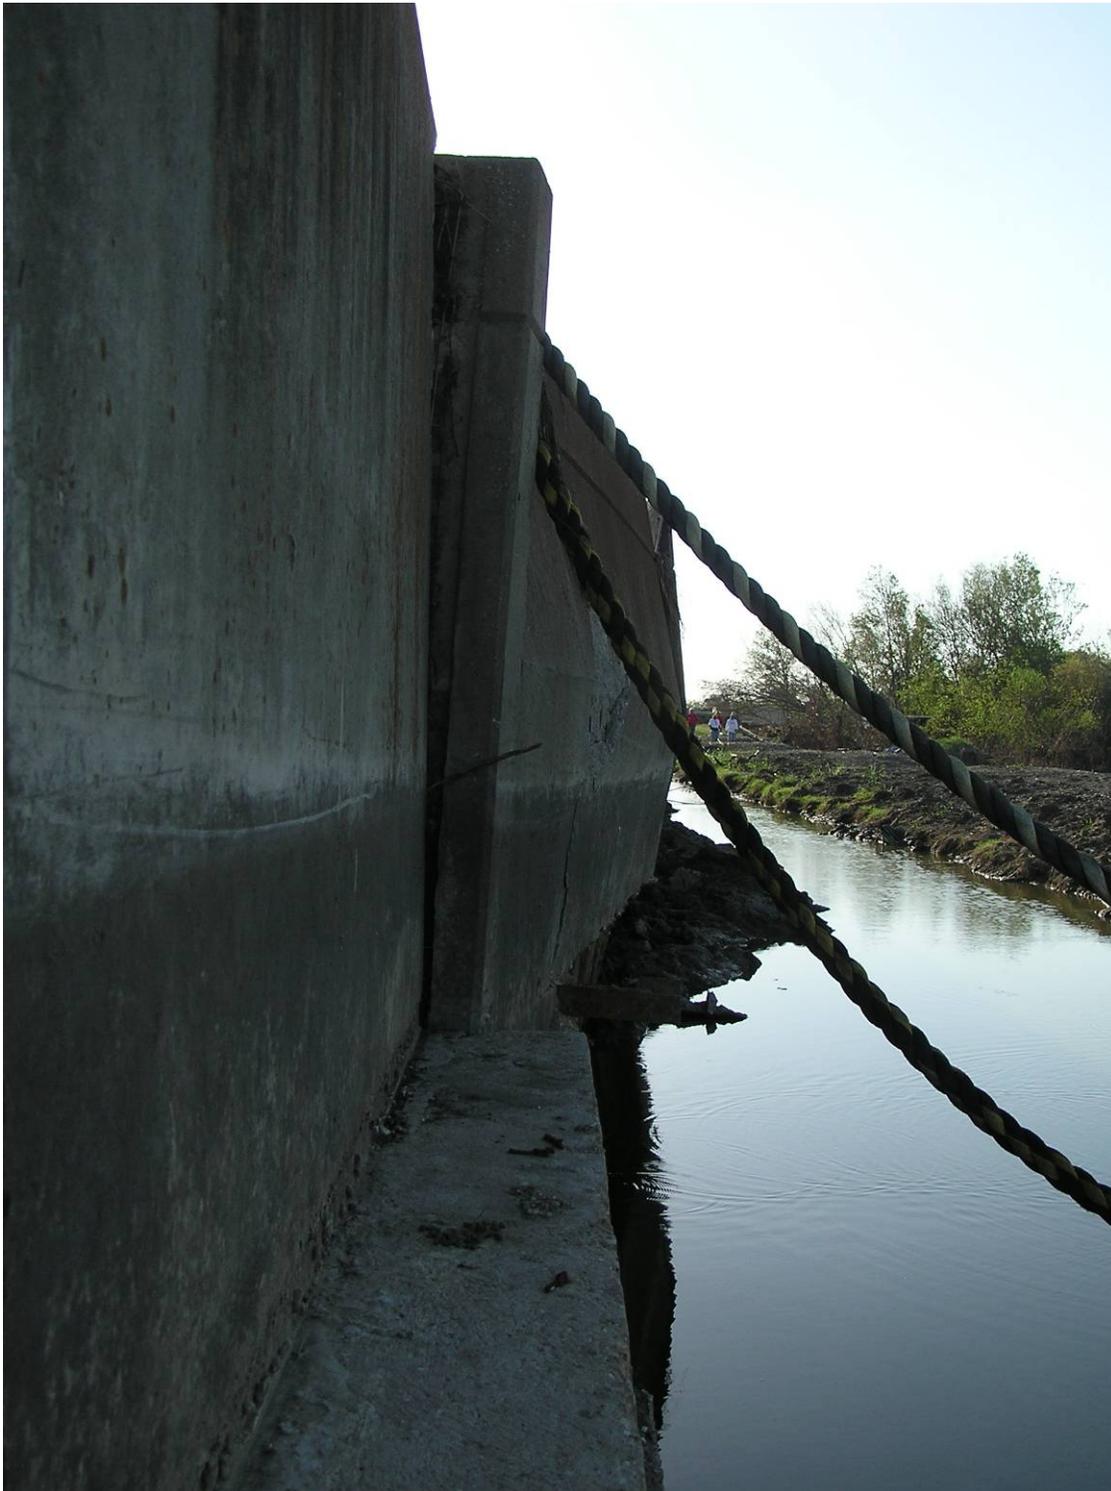
Figure 3.10: Undamaged T-wall in foreground and damaged I-wall in background along the IWW/MRGO. Severe scour on the landside and distress of the I-wall (N30.00030 W89.99459).

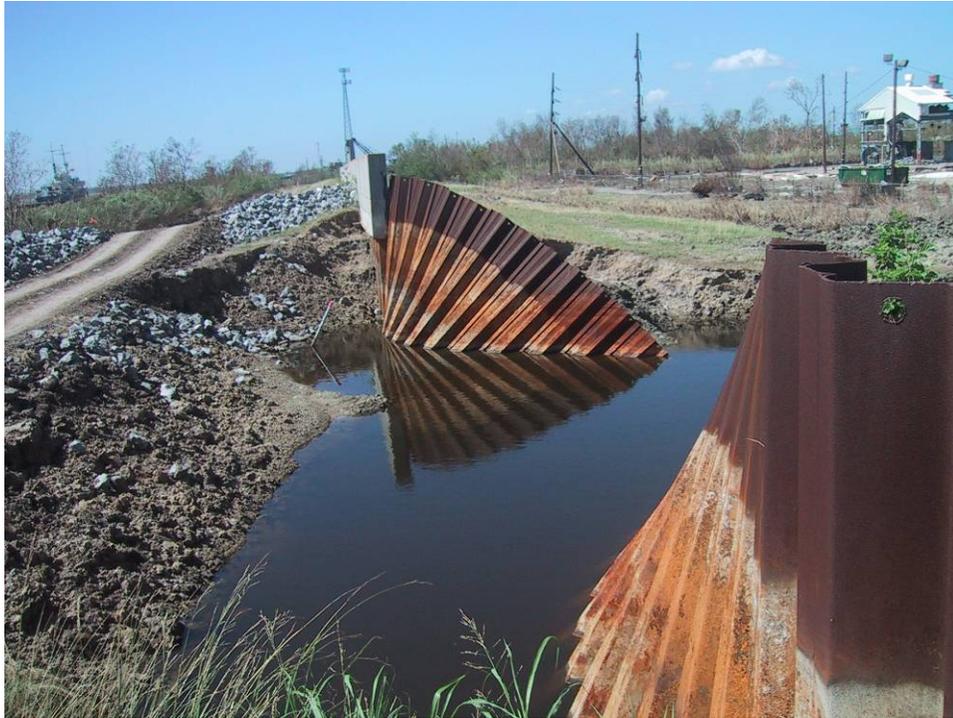
Figure 3.13 Failure of sheetpile wall adjacent to higher and stronger concrete topped I-wall on the north side of the IWW.

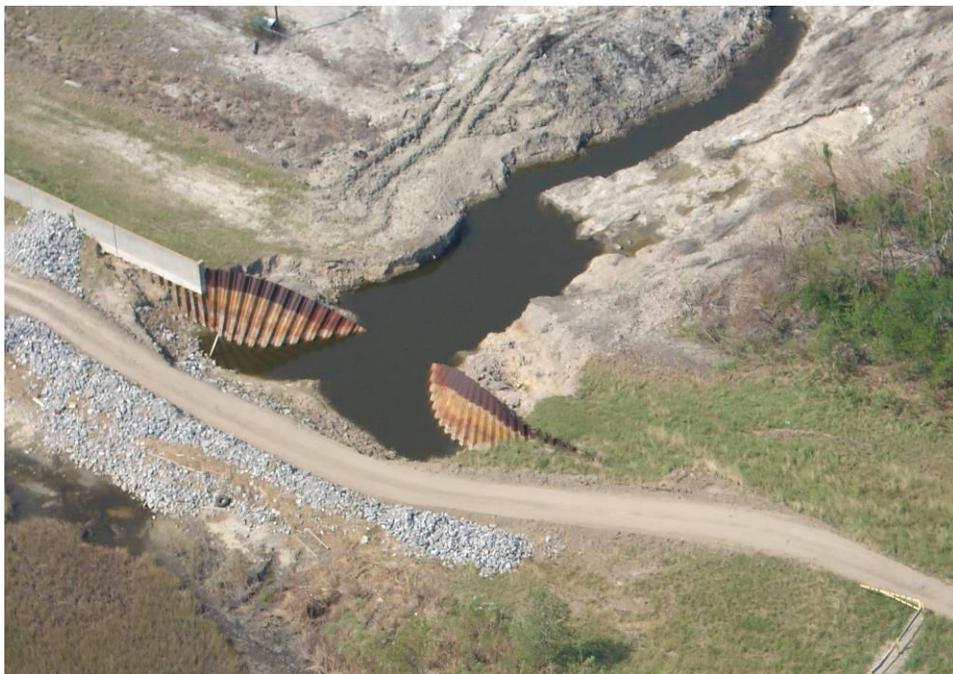
Figure 3.14: Aerial view of the failed wall section shown in Figure 3.14

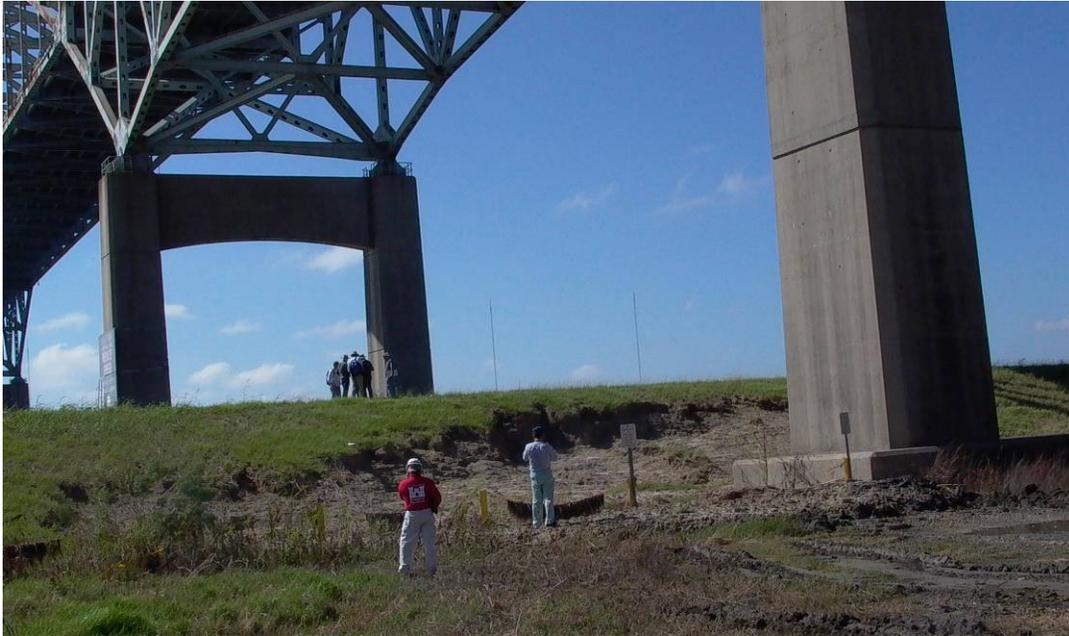
Figure 3.17: Earth levee beneath the north abutment of the Route 47 Bridge over the IWW/MRGO, next to the Entergy Michoud Generating Plant, looking south. Despite considerable damage, the levee performed satisfactorily during and after overtopping.

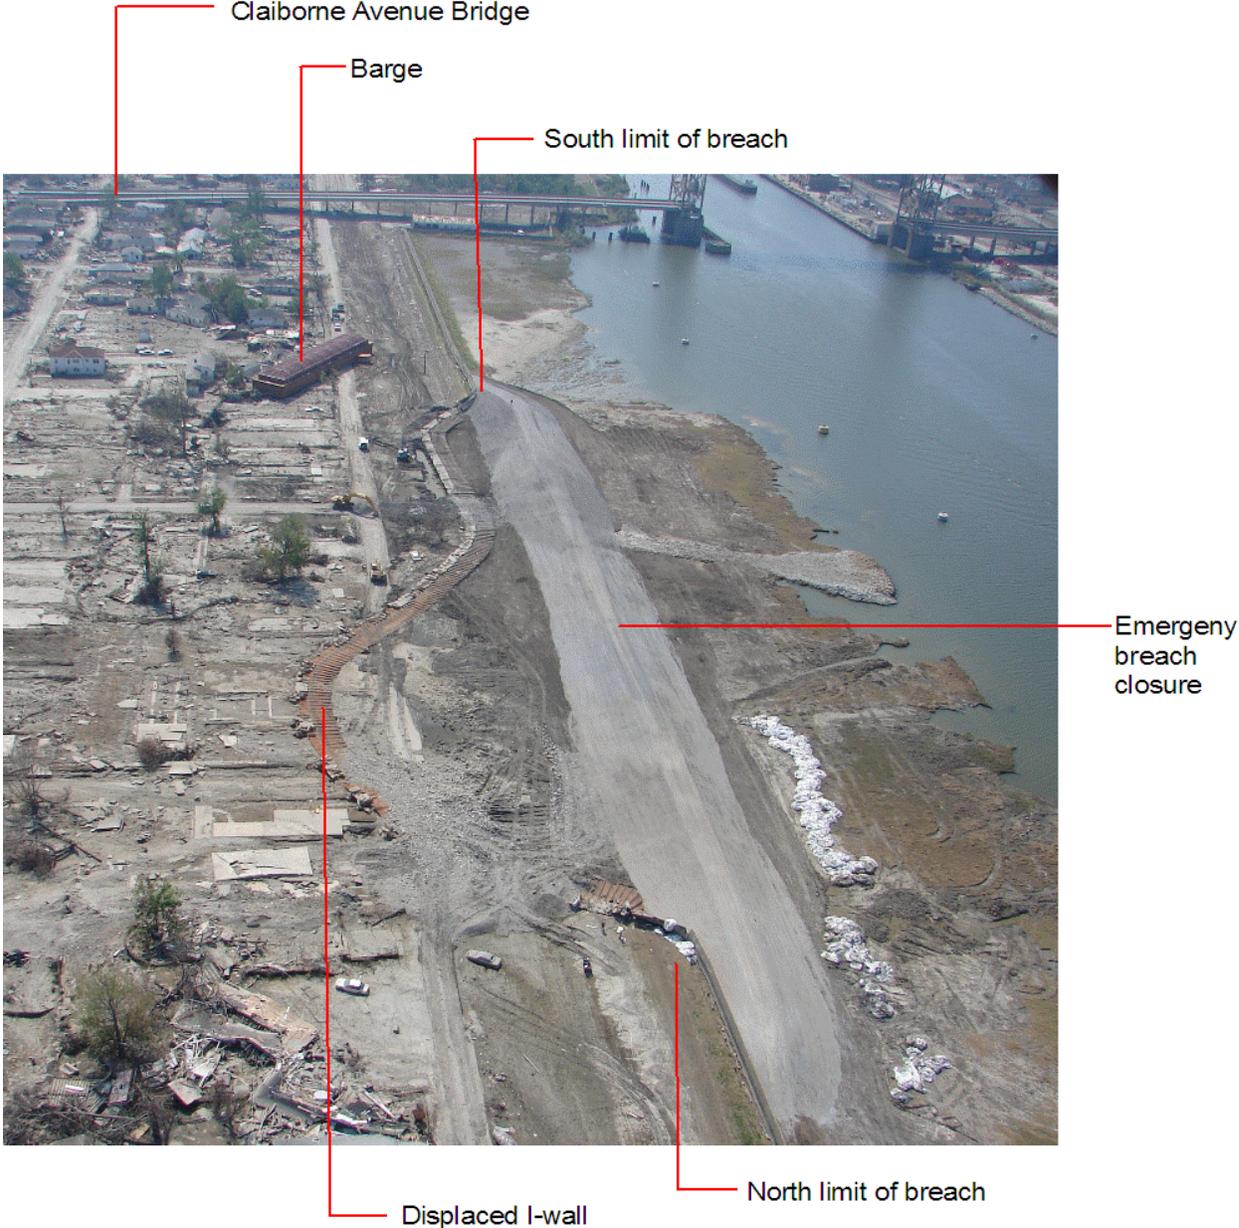
Figure 4.2: Aerial view of the south breach at the Lower Ninth Ward (L. Harder, October 14, 2005).

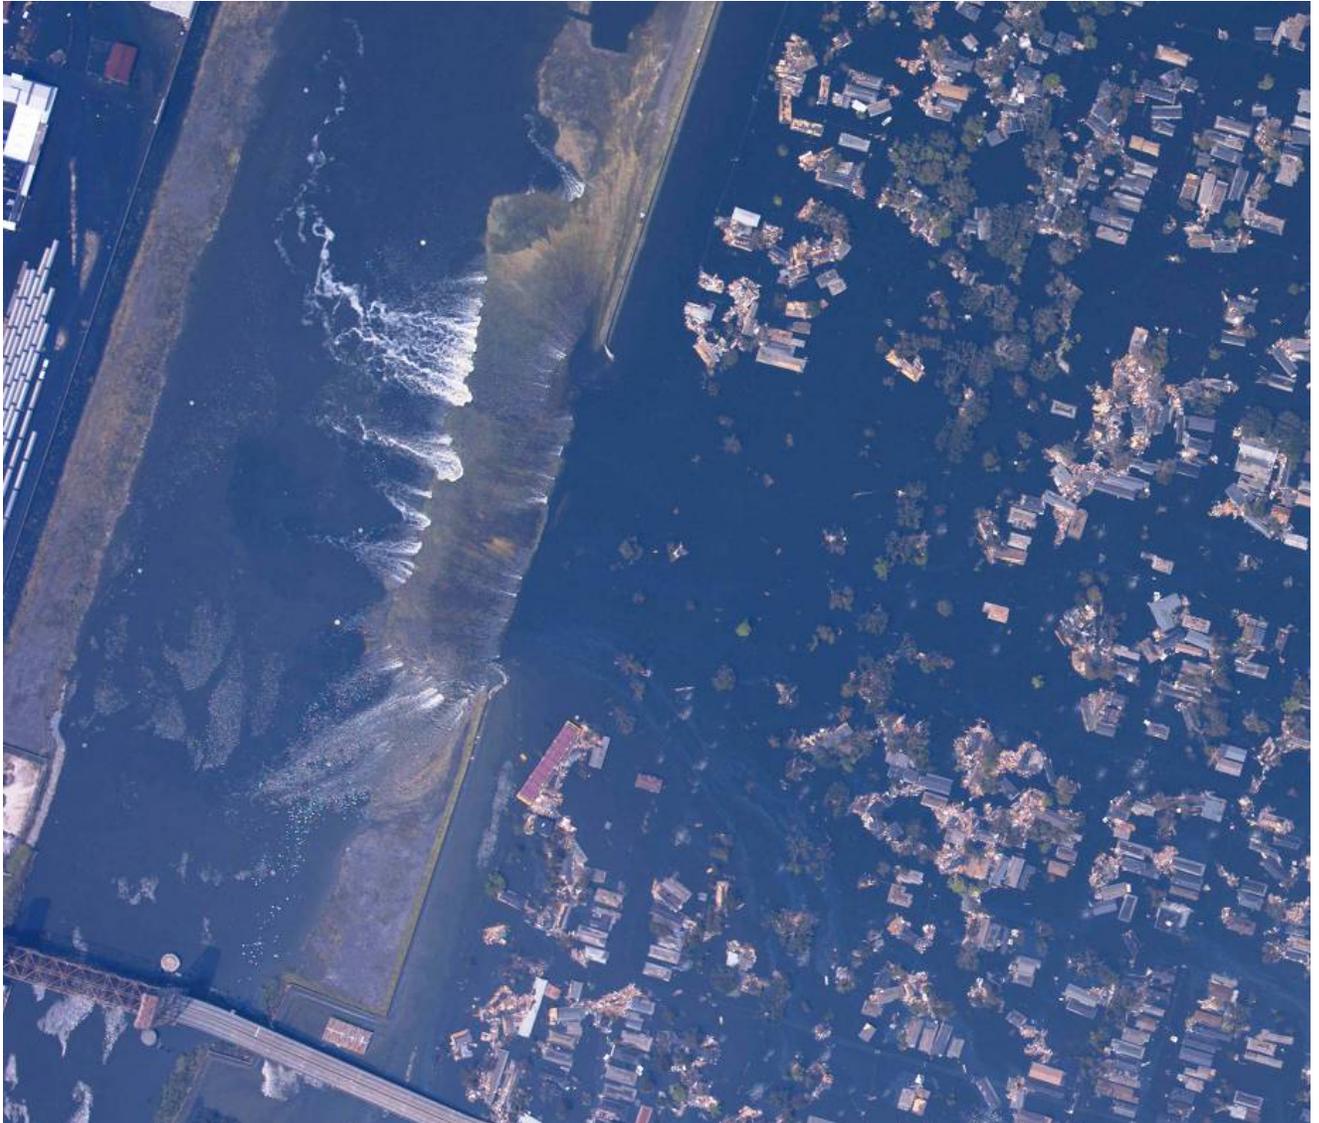
Figure 4.3: Airborne digital imagery of the south breach at the Lower Ninth Ward. Water is shown flowing back into the IHNC (courtesy NOAA, August 31, 2005).

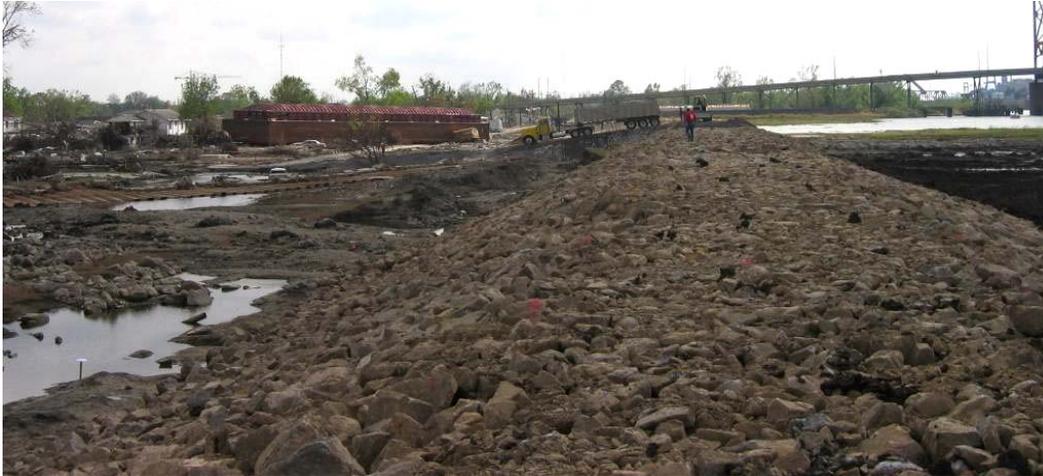
Figure 4.6: South view of the south breach repair at the Lower Ninth Ward (J. Wartman, October 4, 2005).

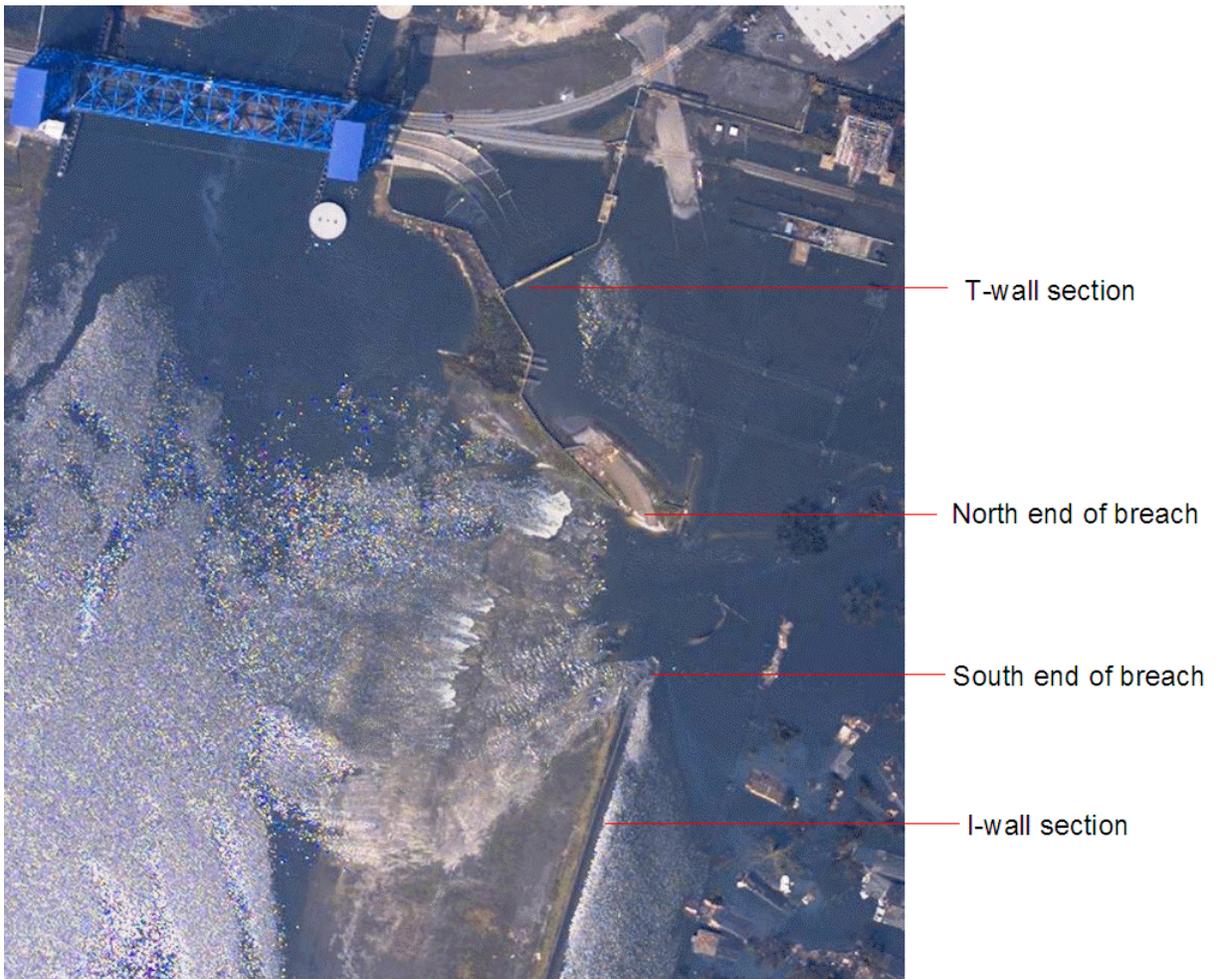
Figure 4.7: Airborne digital imagery of the north breach at the Lower Ninth Ward. Water is shown flowing back into the IHNC (courtesy NOAA, August 31, 2005).

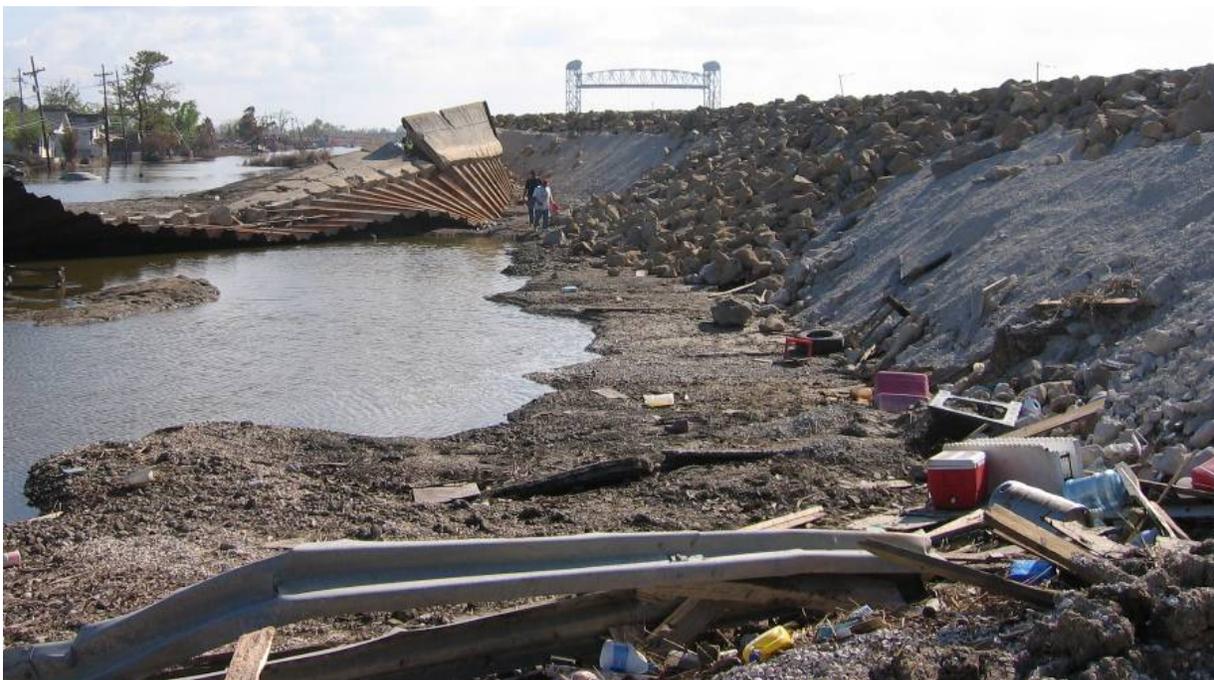
Figure 4.11: Looking south along the north breach repair at the Lower Ninth Ward (J. Wartman, October 4, 2005).
