# Preliminary Report on the Performance of the New Orleans Levee Systems in Hurricane Katrina on August 29, 2005

Preliminary findings from field investigations and associated studies performed by teams from the University of California at Berkeley and the American Society of Civil Engineers, as well as a number of cooperating engineers and scientists, shortly after the hurricane.

Report No. UCB/CITRIS – 05/01  
November 17, 2005

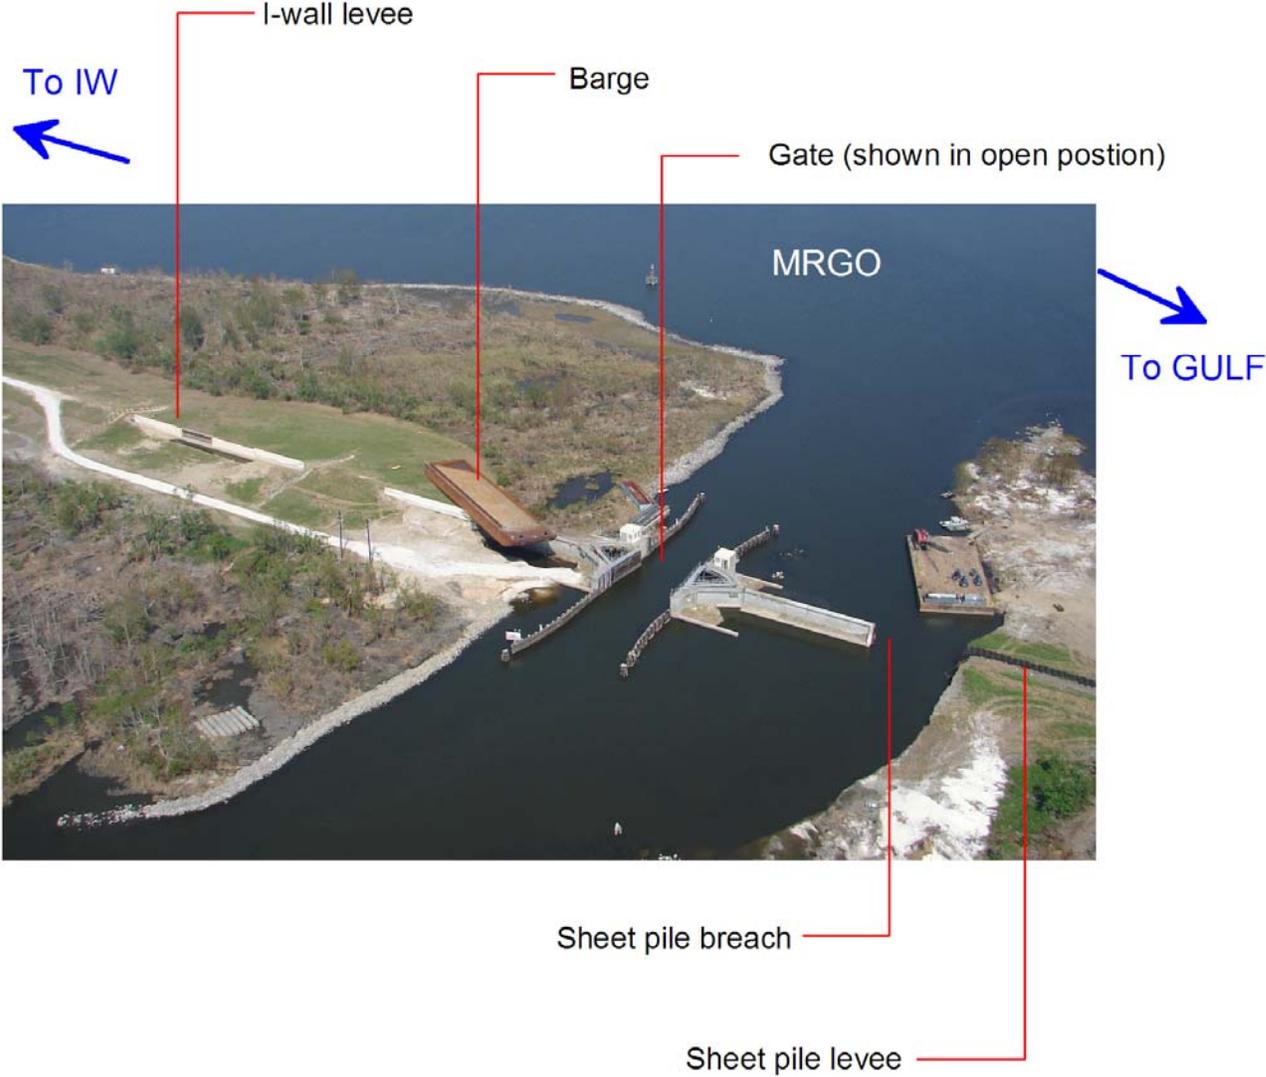
Figure 4.12: Northwest facing aerial view of the Bayou Bienvenue Gate structure (L. Harder, October 14, 2005).

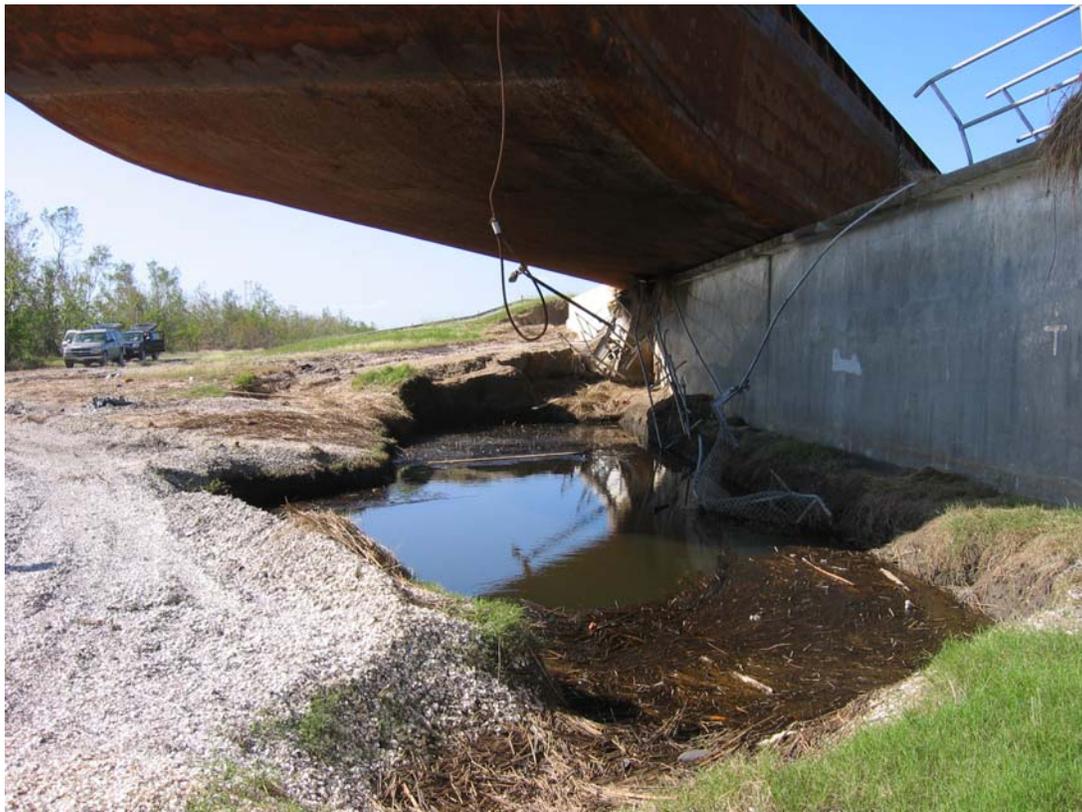
Figure 4.14: Scour near barge damage at the Bayou Bienvenue Gate site (J. Wartman, October 5, 2005).

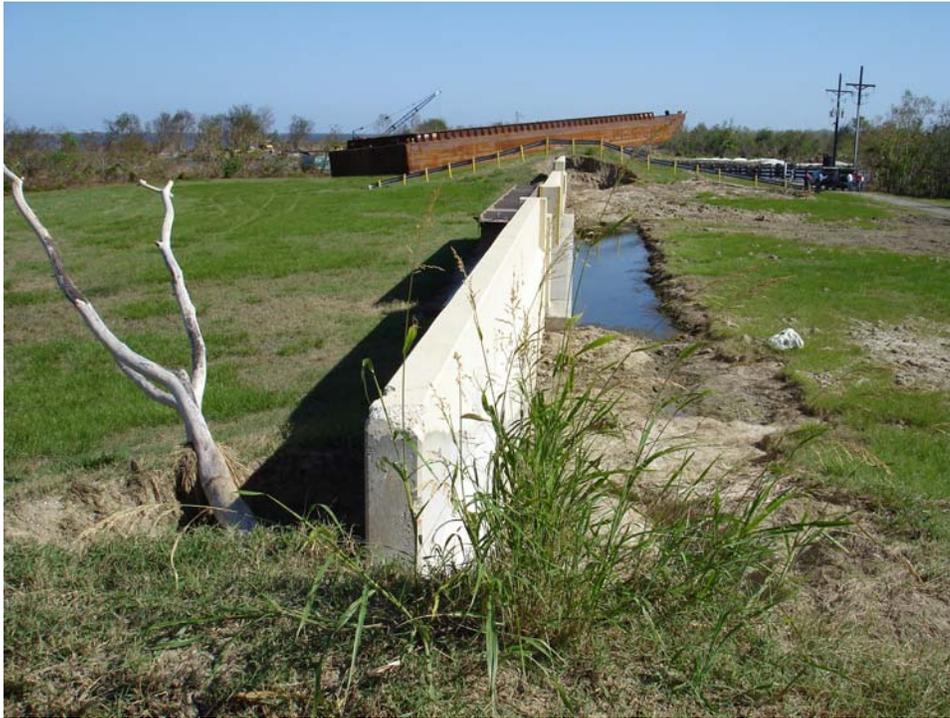
Figure 4.15: Scour near Bayou Bienvenue Gate site (L. Wooten, October 5, 2005).

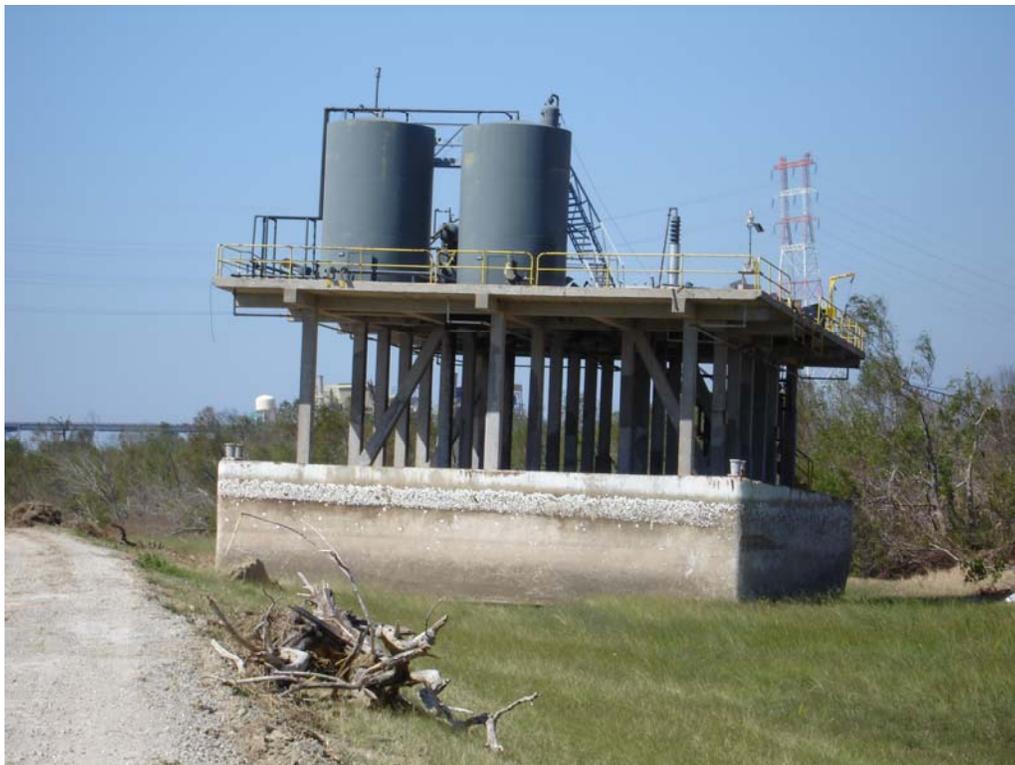
Figure 4.18: Various barges and other floating structures made contact with the earth levees without causing significant damage. Photo shows a gas processing barge (F. Silva, October 1, 2005).

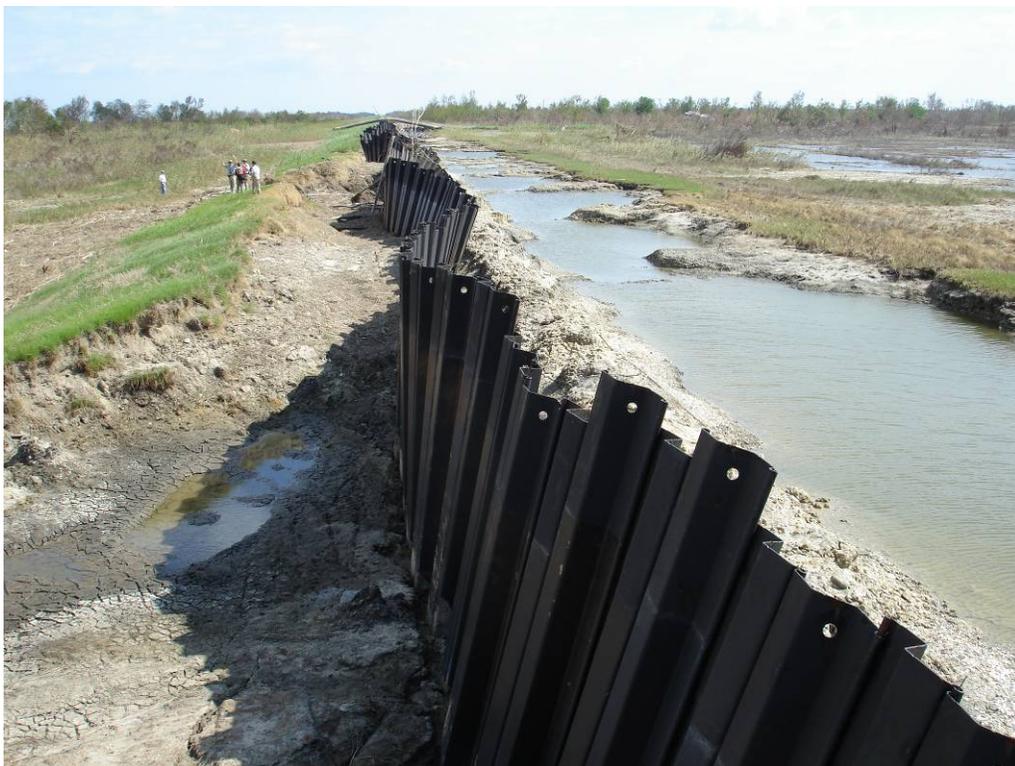
Figure 4.20: Failure of earth levee with steel sheetpile barrier on the southeast bank of the MRGO. Note severe erosion and scour (L. Wooten, October 6, 2005).

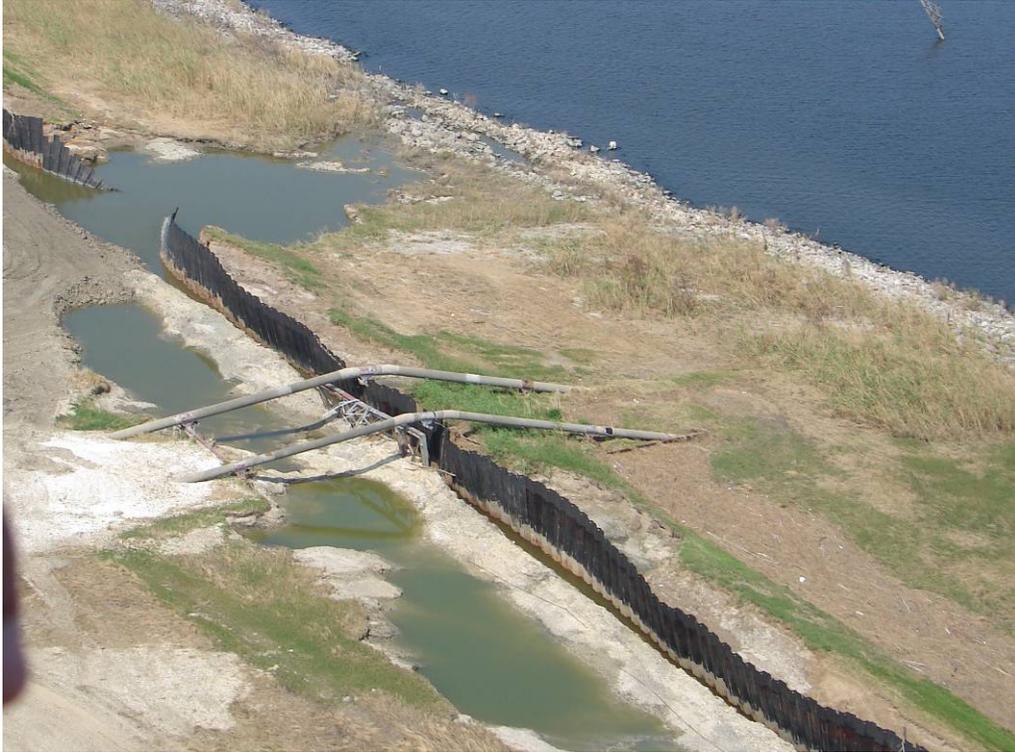
Figure 4.21: Levee failure on southwestern bank of MRGO between Bayou Bienvenue (where barge is aground on I-wall) and Bayou Dupree. Note severe erosion and scouring (L. Harder, October 14, 2005).

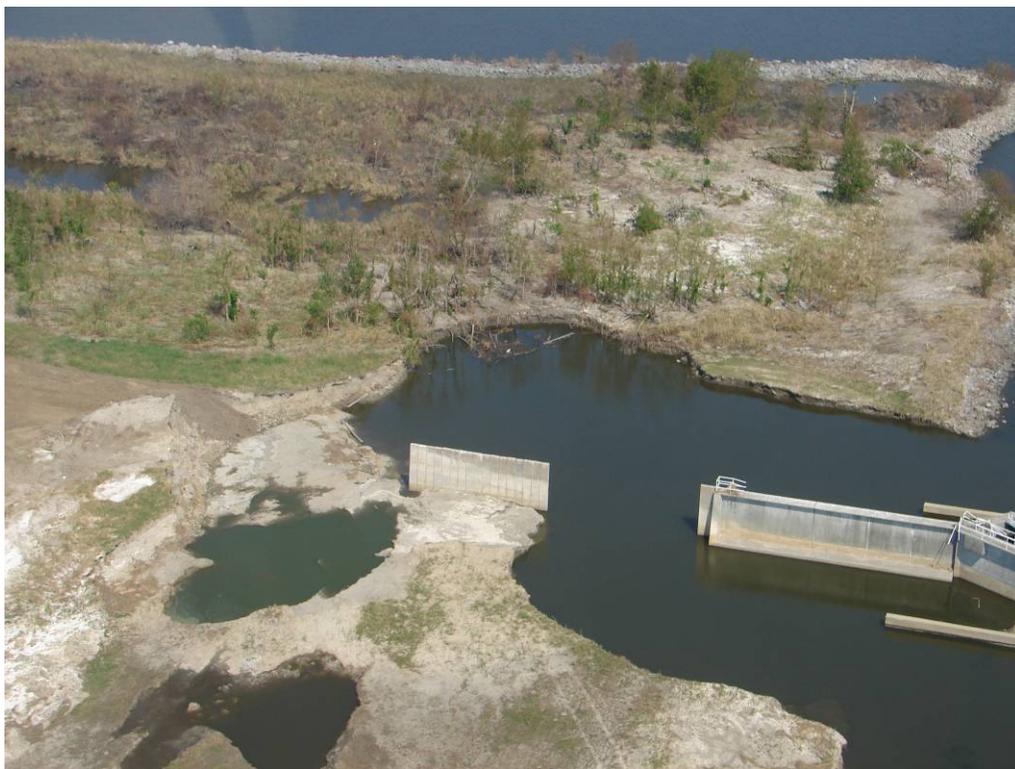
Figure 4.22: Levee failure on southwestern bank of MRGO at Bayou Dupree. Note concrete sheetpile and levee transition washouts (L. Harder, October 14, 2005).

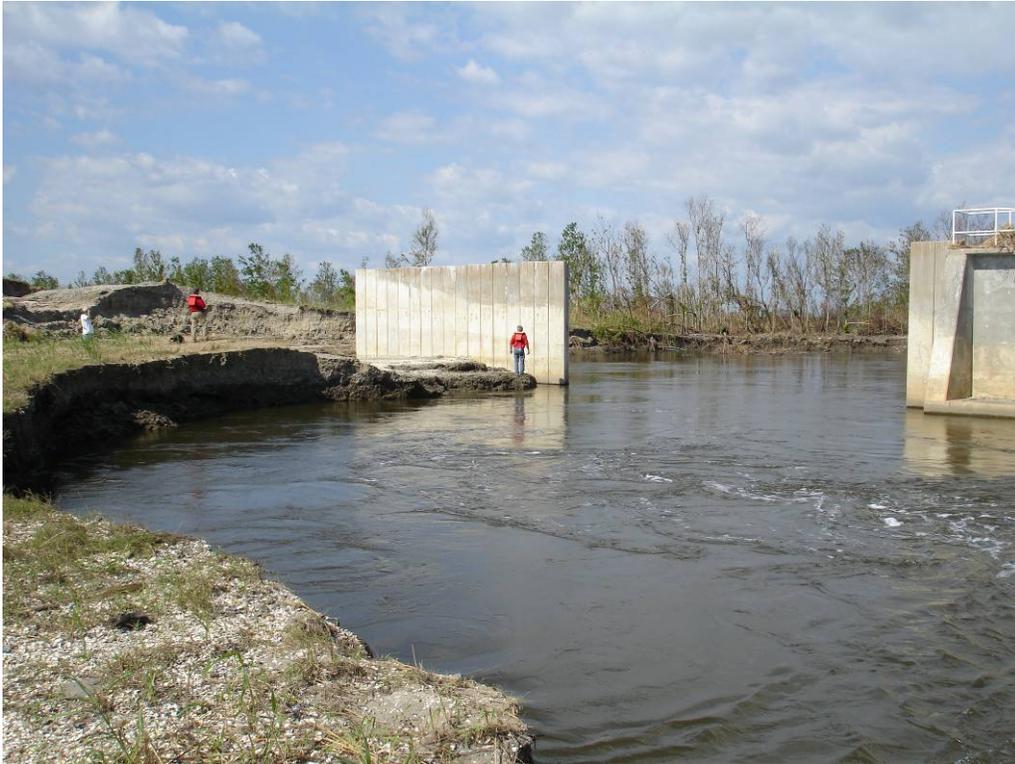
Figure 4.23: Ground perspective of Bayou Dupree gate abutment failure (L. Wooten, October 6, 2005).

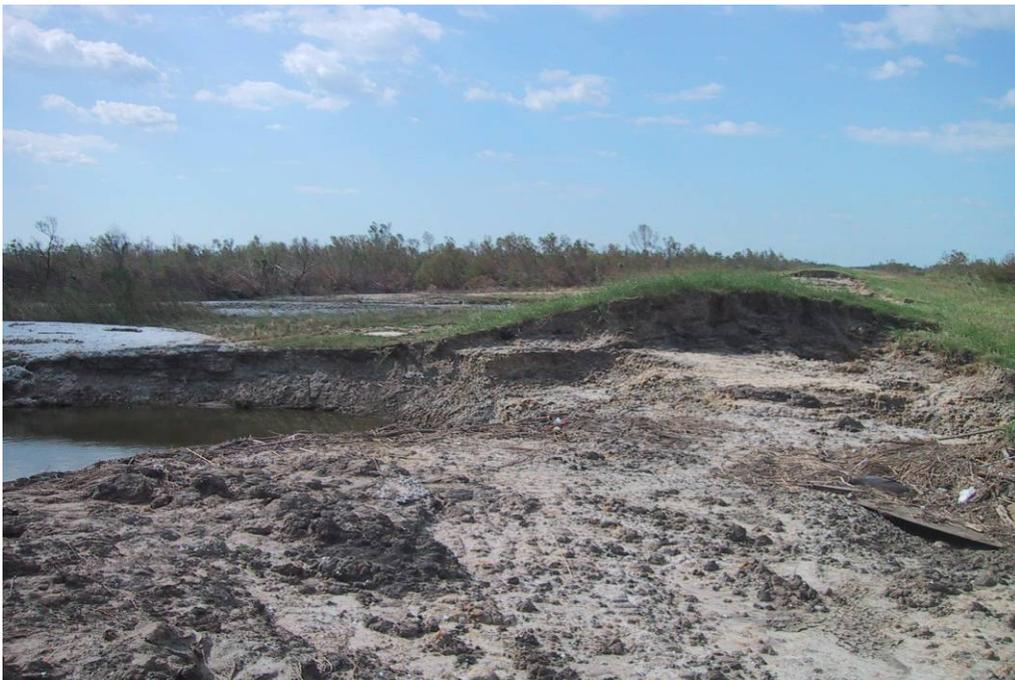
Figure 4.24: Failure of earth levee on southwest bank of MRGO adjacent to the Bayou Dupree gate (L. Wooten, October 6, 2005).

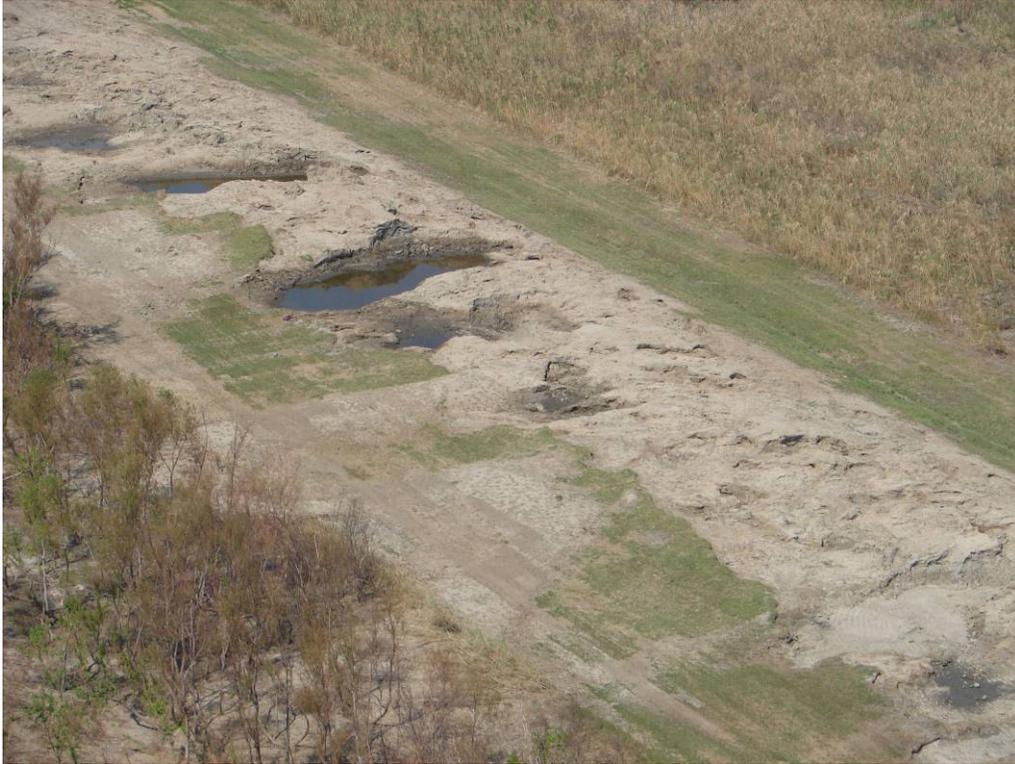
Figure 4.25: Overtopping obliterated earth levee along southwestern bank of MRGO, within two miles southeast of Bayou Dupree. Note deep scour at the levee foundation level (L. Harder, October 14, 2005).

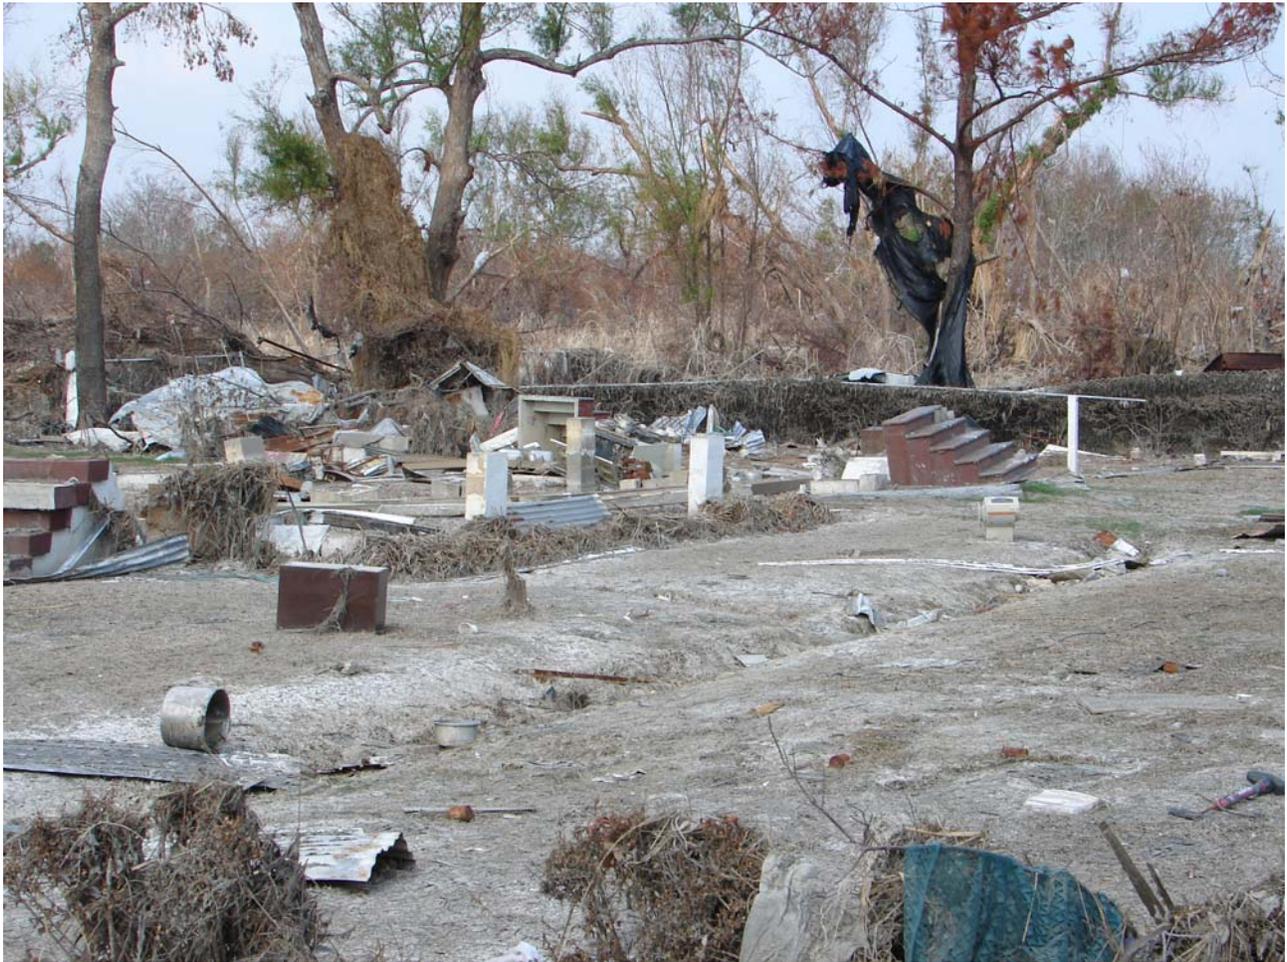
Figure 5.8: Photograph of Pointe a la Hache homes deposited on Mississippi River levee after storm surges overtopped the levee from the east (left) towards the river (right) (October 12, 2005)
