## **Test Report on Cold-Formed Steel Shear Walls**

CFS-NEES – RR03  
June 2012

The objective of report is to detail recent cyclic tests on cold-formed steel (CFS) framed shear walls sheathed with Oriented Strand Board (OSB). The tests details are motivated from shear walls designed for a two-story ledger-framed building that will undergo full-scale shake table testing as part of the National Science Foundation funded Network for Earthquake Engineering Simulation (NEES) project: CFS-NEES ([www.ce.jhu.edu/bschafer/cfsnees](http://www.ce.jhu.edu/bschafer/cfsnees)). Monotonic and cyclic (CUREE protocol) tests are conducted on 4 ft × 9 ft (1.22m × 2.74 m) and 8 ft × 9 ft (2.44m × 2.74 m) shear walls utilizing 54 mil (1.37mm) back-to-back chord studs and 7/16 in. (11.1 mm) OSB sheathing on the exterior. Practical building details studied in the shear wall tests include the impact of (a) ledger track, which is attached to the top of the interior face of the wall, (b) gypsum, which is attached to the interior face of the wall below the ledger track, (c) locations of panel seams, both horizontal and vertical in the OSB, and (d) the impact of differing stud thickness and grade for the fie

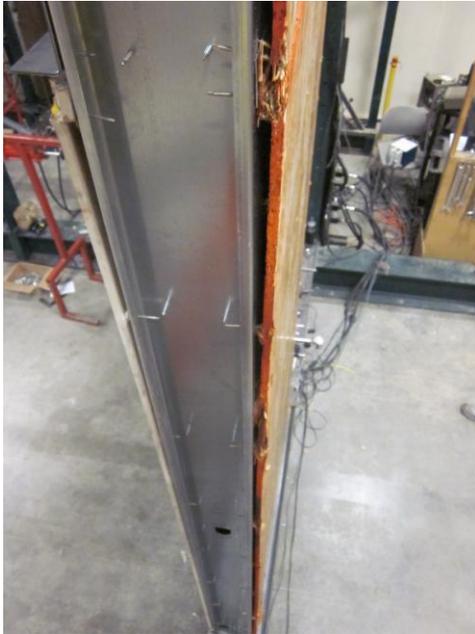
OSB failure

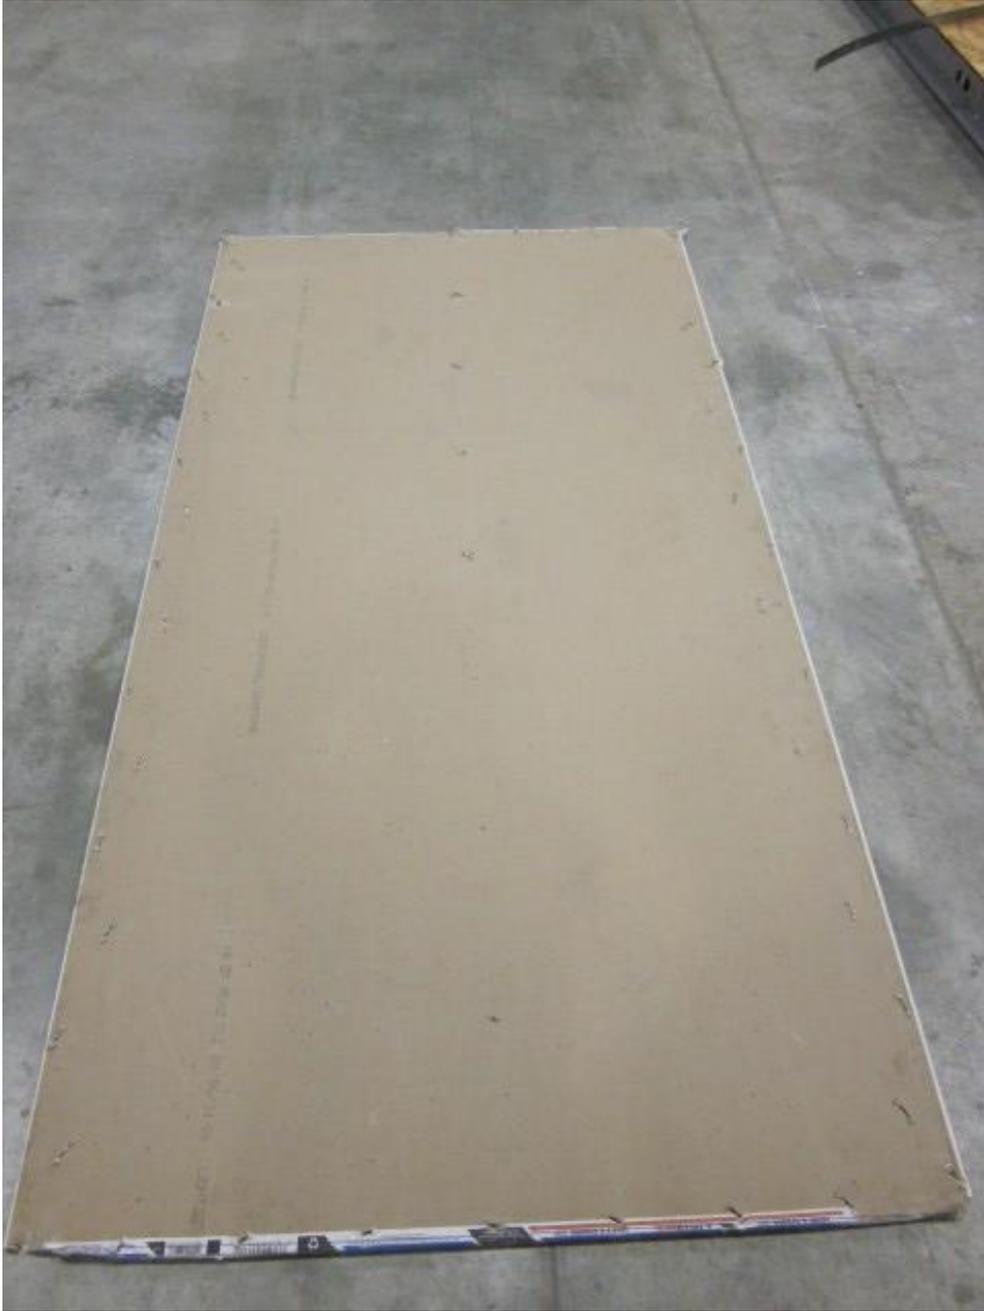
Gypsum board after test

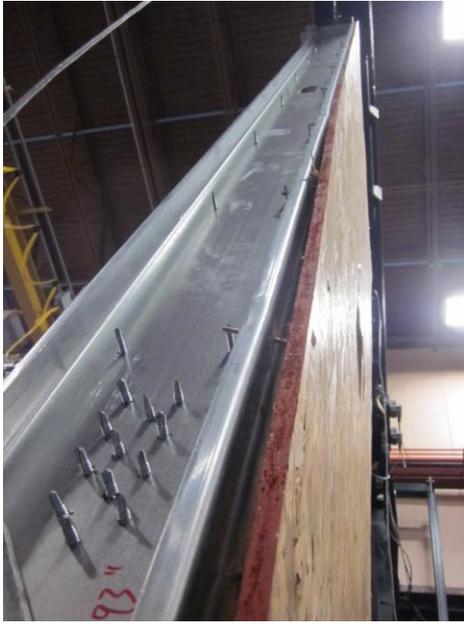
OSB failure (North)

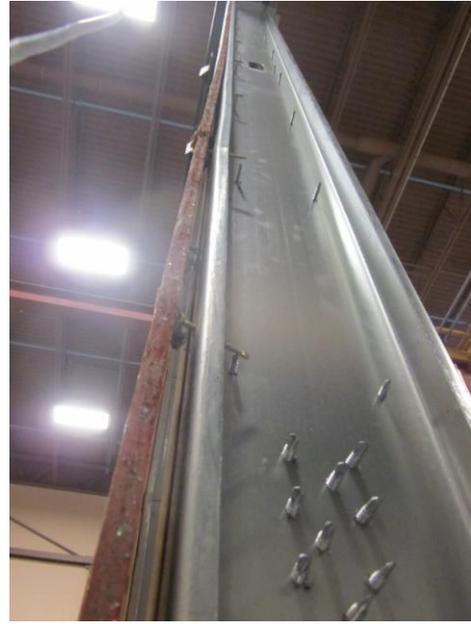
OSB failure (South)

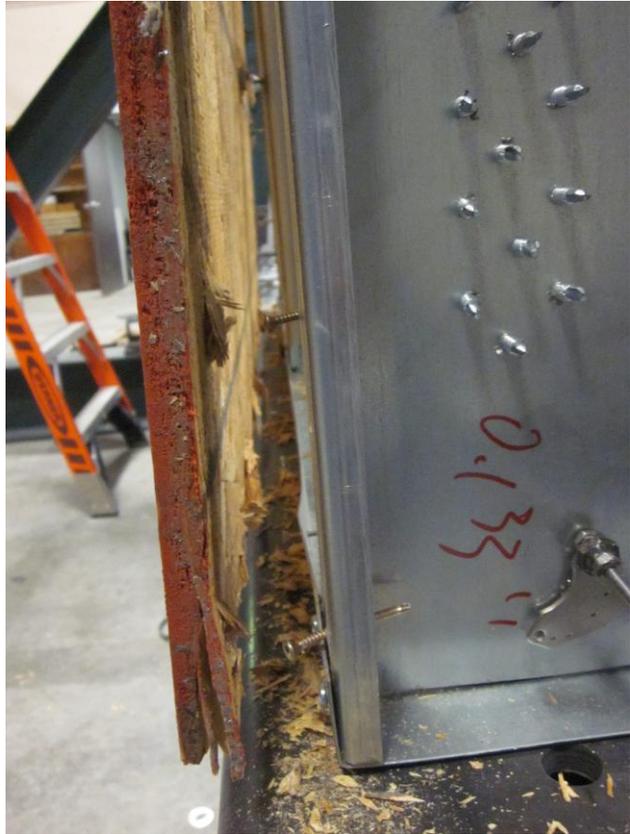
Bottom failure

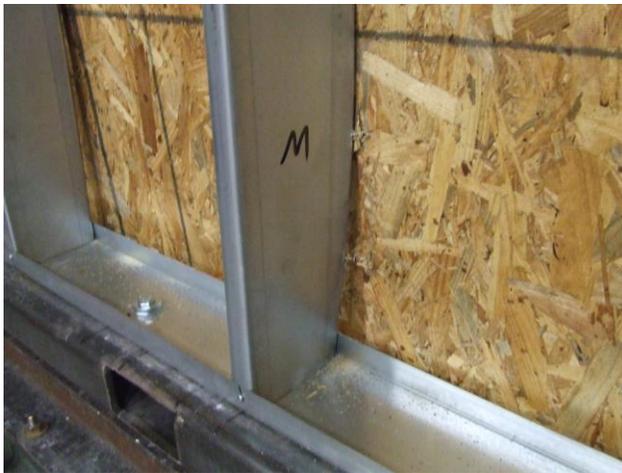
Missing fasteners at the bottom
