Built Like Bridges: Iron, Steel, and Rivets in the Nineteenth-century Skyscraper

Source: *Journal of the Society of Architectural Historians*, Vol. 69, No. 2 (June 2010), pp. 234-261

THOMAS LESLIE  
Iowa State University

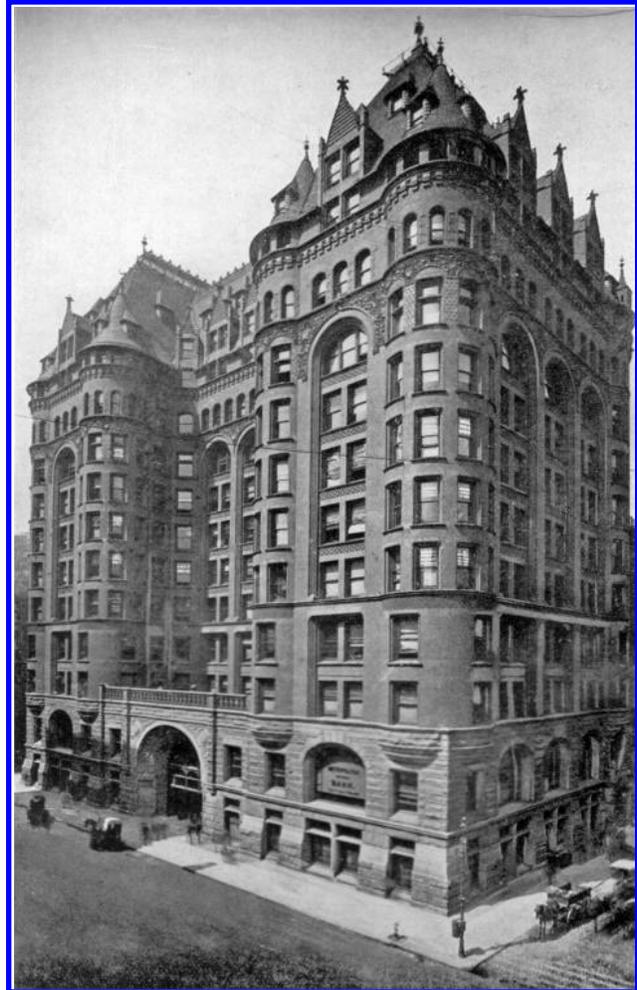
**Figure 5** Burnham & Root, Woman's Christian Temperance Union ("Women's Temple"), Chicago, 1892 (demolished 1926). View from northwest (*One Hundred and Twenty-Five Photographic Views of Chicago* [Chicago: Rand-McNally, 1902], plate 9)

Lest they be constrained by these primitive rules of thumb, engineers and architects sought ways to channel and resist lateral forces in the new lightweight frames. Masonry walls, which had been used in buildings such as the Tacoma to absorb loads from wind, reached their peak efficiency in relatively short buildings. In the late 1880s buildings had grown "so high that it does not appear possible that the masonry walls, after considering their own crushing weight, can have much efficiency left for the purposes of bracing the frame."<sup>12</sup> The thick masonry walls of the Monadnock (Burnham and Root, 1891) and the Woman's Temple (Burnham and Root, 1892) touched the limits of masonry bracing, with walls of cyclopean thickness at their bases that discouraged shop owners and that settled with alarming unevenness (Figure 5).

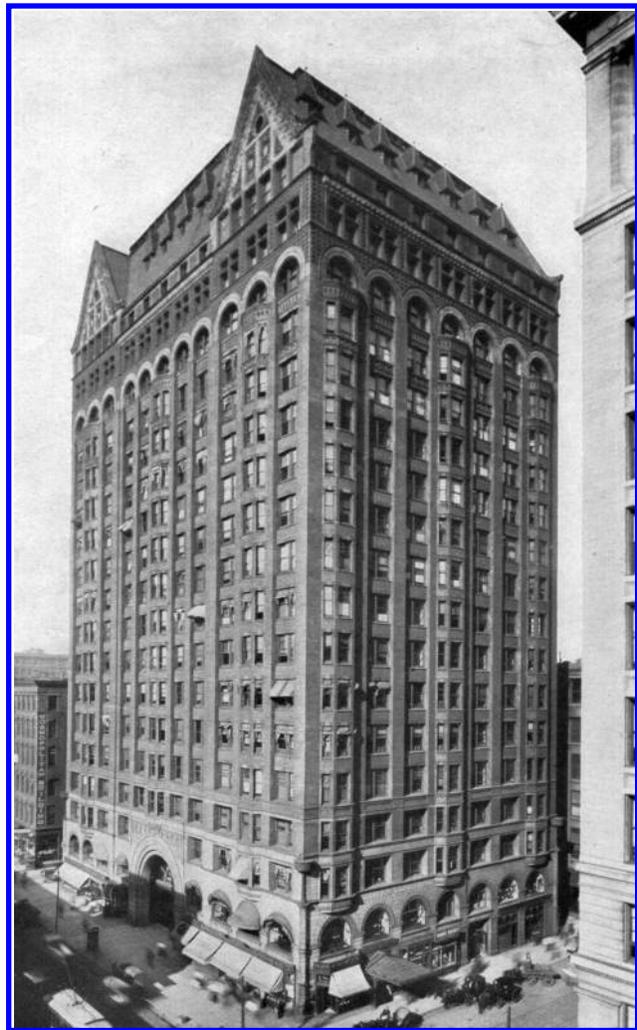
**Figure 7** Burnham & Root, Masonic Temple (later Capitol Building), Chicago, 1892 (demolished 1939). View from southwest. (from *One Hundred and Twenty-Five Photographic Views of Chicago* [Chicago: Rand-McNally, 1913], plate 79)

Sway-rod wind bracing was adopted for two well-known Chicago buildings of 1891–92: the thirteen-story Venetian, designed by Holabird & Roche, and the more widely recognized twenty-one-story Masonic Temple by Burnham and Root (Figures 7, 8). Both buildings had narrow, rectangular floor plans whose proportions offered enough footprint to resist wind loading in one direction, but they required additional bracing parallel to their shorter axes. The Venetian employed a compromise system that relied primarily on diagonal bracing concealed within four continuous partition walls. These were staggered through the floor plan to allow greater flexibility in planning, and the connections

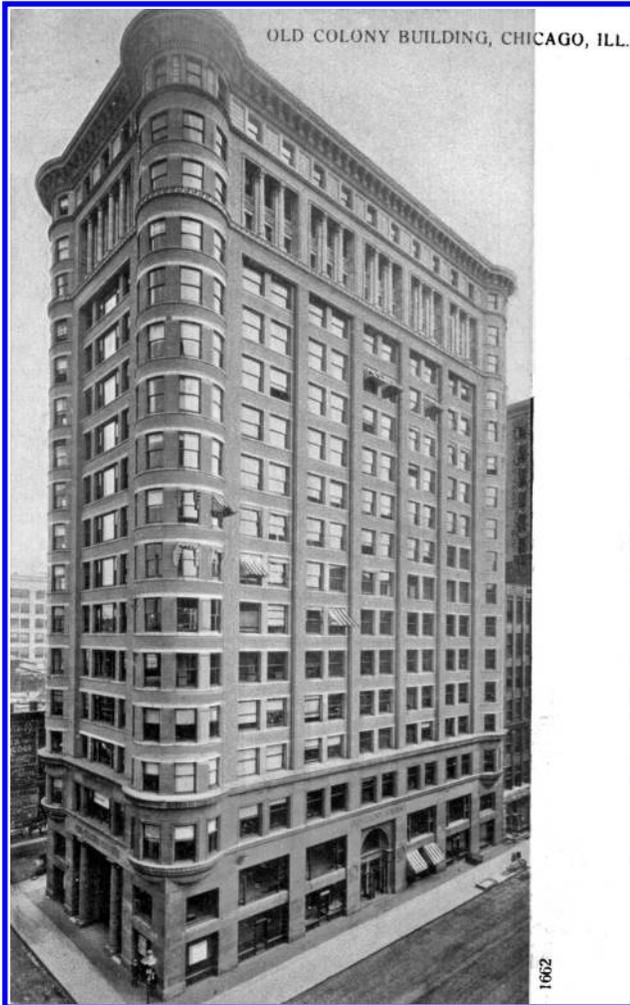
**Figure 9** Holabird and Roche, Old Colony Building, Chicago, 1894. Commercial postcard, ca. 1895, view from northwest (A. C. Bosselman & Co., New York)

The best-known example of portal framing was Holabird & Roche's Old Colony Building (1893), constructed on a narrow block between Dearborn and Plymouth Place in Chicago (Figures 9, 10). Like the Venetian and the Masonic Temple, its floor plan was a narrow rectangle, offering a deep enough footprint in the north-south direction to overcome wind loading but requiring added strength in its shorter, east-west direction because of its height, 212 feet.<sup>26</sup> While the building's engineer, Corydon Purdy, originally specified a system of offset tie rods, this was changed late in the design process due to a dispute with the steel supplier. Wrought-iron columns were substituted for steel, and Purdy was forced to change the Old Colony's structural design.<sup>27</sup> The result was a system of paired iron arches, elliptical in shape, that engaged beams and columns along their full lengths and that provided deep iron webs that reinforced the structural joints between framing members (Figure 11).<sup>28</sup> These arches

provided needed stiffness in the building's short direction, but they were heavy, and they reduced ceiling height considerably, especially in the corners. Holabird and Roche designed covered plaster ceilings in the affected offices, but the wasted volume, extra weight, and expense of the Old Colony's portal system reflected the drawbacks of this approach.<sup>29</sup> Jenny used shorter braces, which he described as being similar to those used in ship construction, in the Isabella Building in Chicago (1892), but even this revised system interfered with ceiling heights where the knee brace attached to the column.<sup>30</sup>

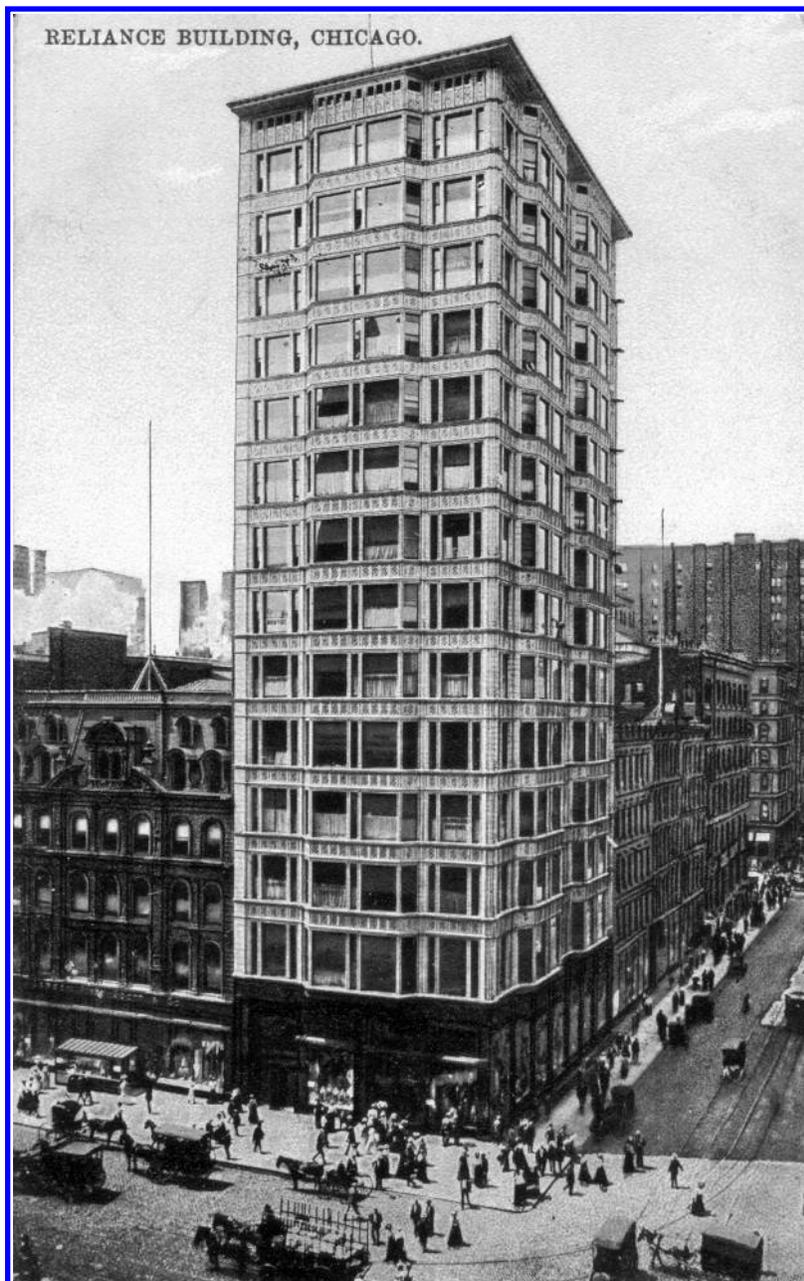
**Figure 17** D. H. Burnham and Co. (Charles Atwood, designer), Reliance Building, Chicago, 1895. Contemporary postcard (W. G. MacFarlane, Toronto)

building site of alarmingly narrow proportions—less than 60 feet of frontage on State Street and only 80 feet on Washington (Figure 17). Given the projected height of around 200 feet, such dimensions offered little inherent resistance to wind. While the building’s corner site required two perpendicular masonry firewalls, Shankland chose not to rely on these entirely, instead designing the Reliance’s frame using oversized girders and Gray columns (Figure 18). Each connection had no fewer than seven pairs of rivets, taking full advantage of the Gray columns’ generous flat surfaces.<sup>67</sup> Pre-drilled rivet holes were reamed on site, guaranteeing a secure fit.<sup>68</sup> The result, according to *Scientific American*, was

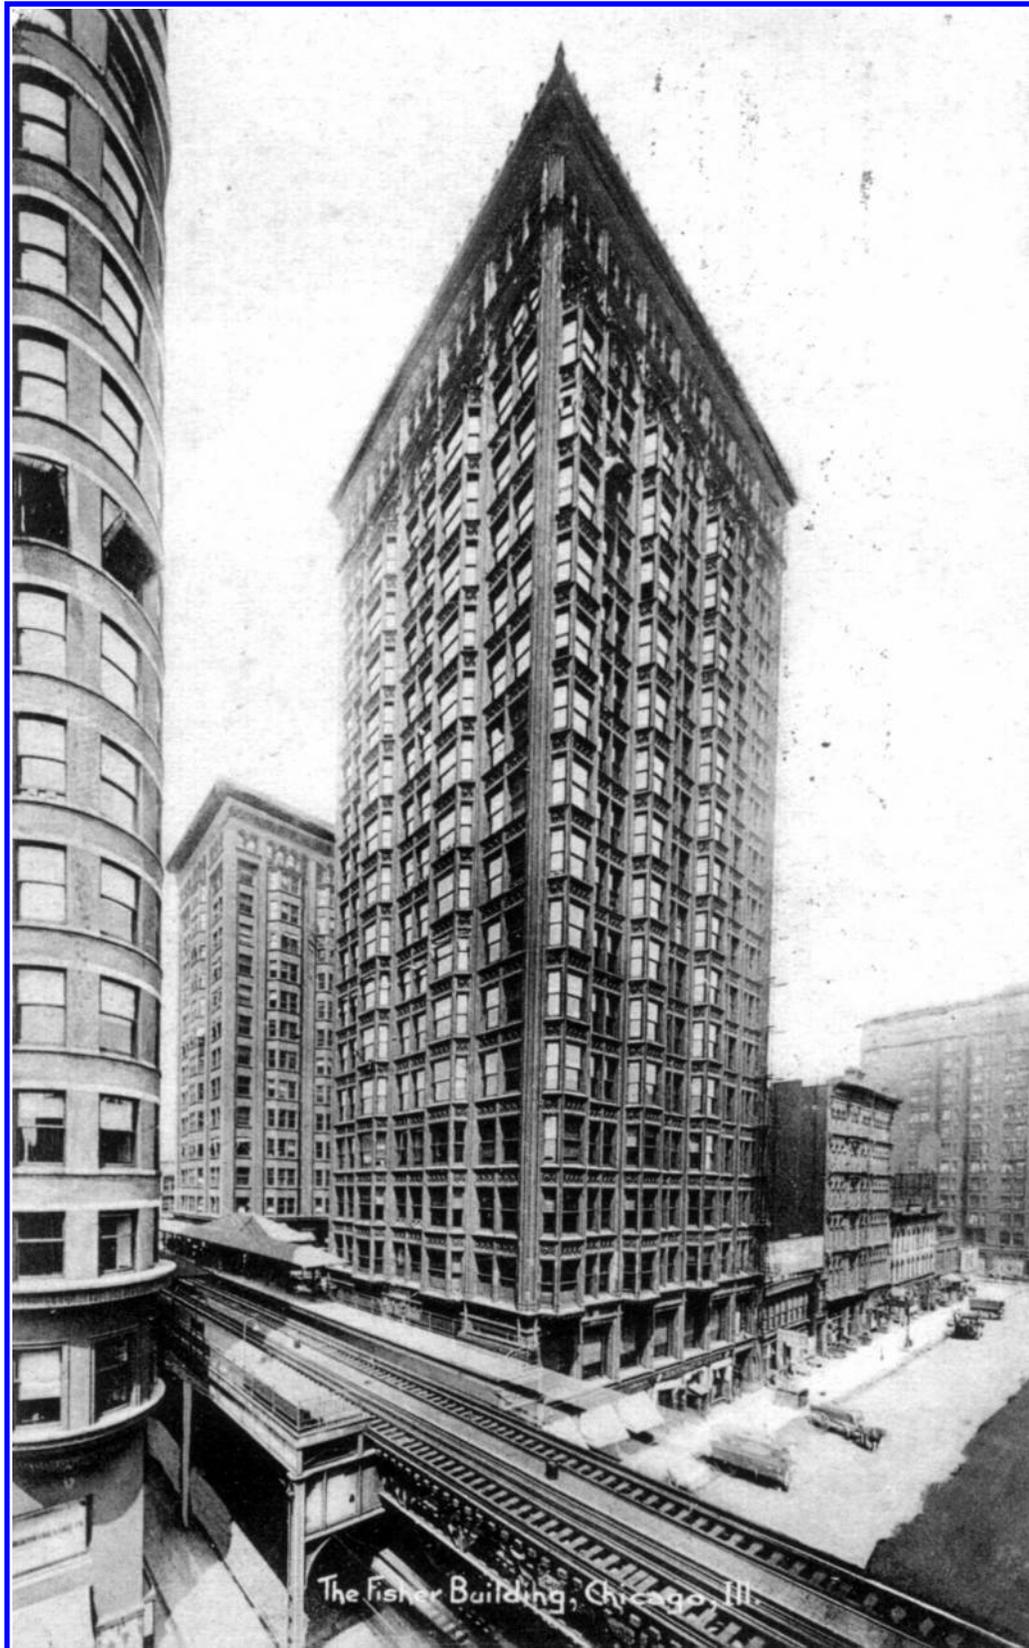
**Figure 21** Fisher Building. Commercial postcard (The Rotograph Co., New York, card no. D28034)

structure to the north. Shankland broke its footprint with nine lines of Gray columns that ran across the short, east-west dimensions of the site, positioned at the building edges and in two rows either side of the main, double-loaded corridors (Figure 20). The moment frame and a particularly wide span between girders contributed to an extraordinarily light building—Shankland estimated the dead load of the system at only 75 pounds per square foot, much lighter than buildings such as Old Colony, which had weighed over 90.<sup>70</sup> This was matched by a remarkably free floor plan, punctuated only by columns at the central corridor and devoid of the sectional intrusions that were inherent in cross-braced and portal-framed structures. Combined with a light, glassy terracotta and glass exterior, the Fisher's minimal structure prompted the *Inland Architect* to marvel that it seemed to be “a building without walls.”<sup>71</sup> (Figure 21)
