### PHOTOELASTIC MODELING

by Robert Mark

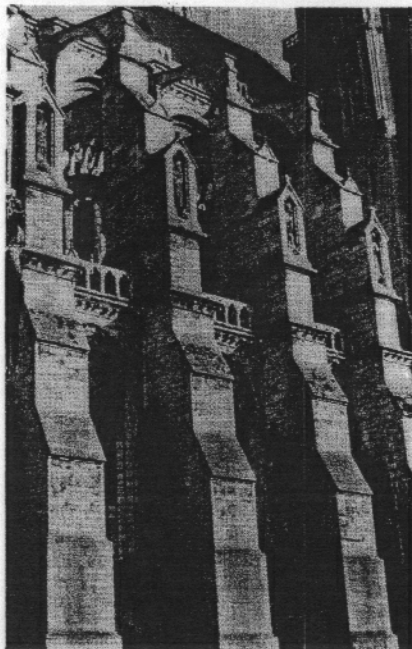
20 Chartres nave buttressing. Flying buttresses are almost hidden by the massive pier buttresses. Photo by J. Hart.

the entire system is massive except for the relatively light upper flyers (figure 20). Each of the tall pier buttresses, exclusive of its foundation, weighs about 1 million kg (2.2 million lbs). At Bourges, on the other hand, a series of fine, steeply sloped flyers is supported by low pier buttresses, each weighing but 400,000 kg (880,000 lbs) (figure 21).

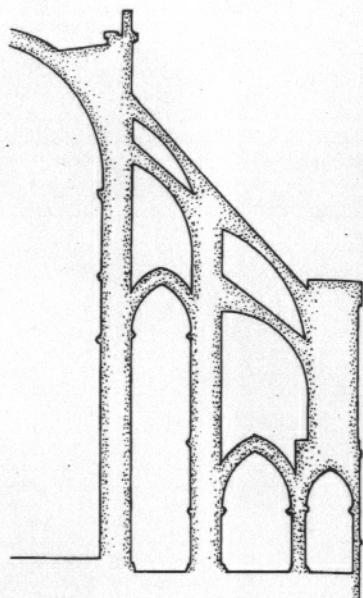
Chartres

25 Comparative sections of Chartres, Bourges, and Guadet's St. Ouen indicate a design progression to lighter buttressing.

Bourges

St. Ouen (modified)

Guadet's alternate design for St. Ouen can be considered a theoretically more advanced Gothic structural form that represents how the form might have evolved if some techniques of scientific analysis had been available to the builders. Hence it is particularly interesting to juxtapose the sections of the three buildings, which are all of similar size, to reveal an obvious hierarchy (figure 25). The great reduction in the amount of materials used for both Bourges and the hypothetical St. Ouen is achieved by carrying the vault and roof forces more directly to the foundations by raising the angle of the flying buttresses and consequently lowering the height of the pier buttresses. With only primitive machinery available for the quarrying, transportation, shaping, and lifting of the huge stones into place, the 60-percent reduction in weight of the pier buttresses at Bourges must have represented a tremendous economy in construction.
