# Preliminary Report on the Performance of the New Orleans Levee Systems in Hurricane Katrina on August 29, 2005

Preliminary findings from field investigations and associated studies performed by teams from the University of California at Berkeley and the American Society of Civil Engineers, as well as a number of cooperating engineers and scientists, shortly after the hurricane.

Report No. UCB/CITRIS – 05/01  
November 17, 2005

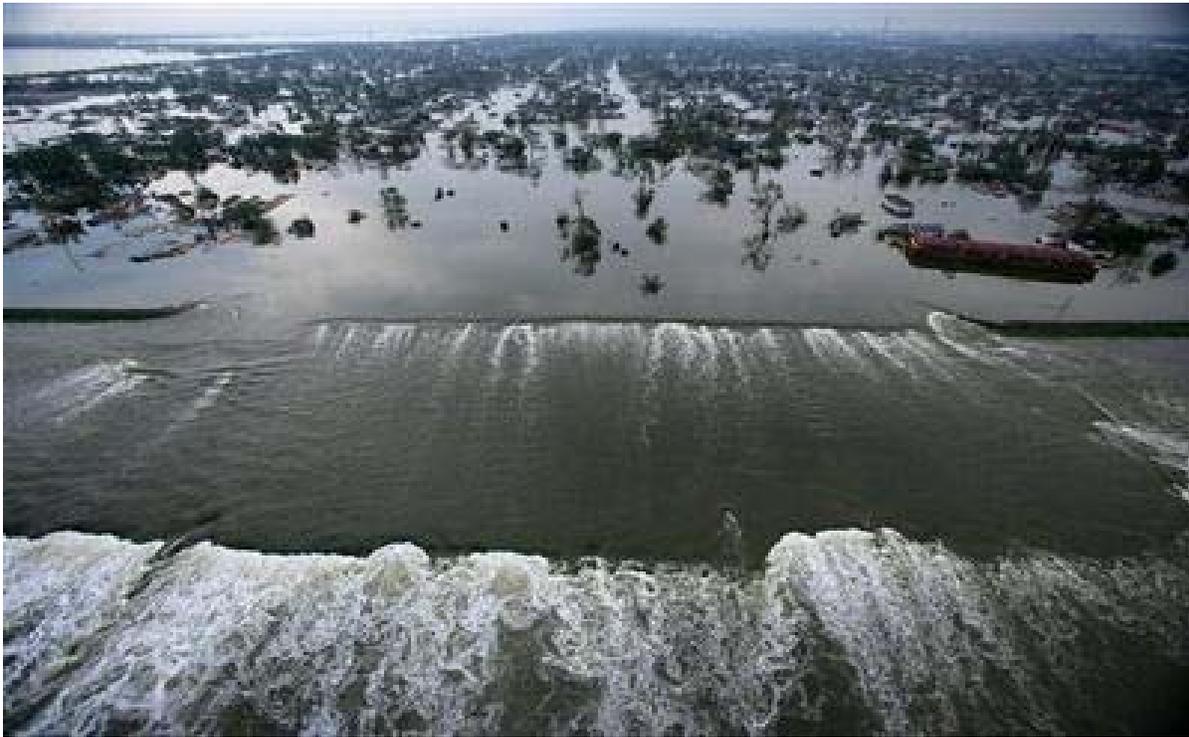
The consequences of the flooding of major portions of all four levee-protected polders were catastrophic. Figure 1.7 shows inundation of the Ninth Ward adjacent to one of the major breaches in the levee along the IHNC. Numerous areas of greater New Orleans were similarly flooded, as shown in Figures 1.4 and 1.5. Large developed areas within all of the main polders were flooded, and they remained inundated for several weeks before levee breaches could be repaired and the waters pumped out.

Figure 1.7: Flooding at the west end of the Ninth Ward, and outflow through levee breach as initial storm surge subsides.

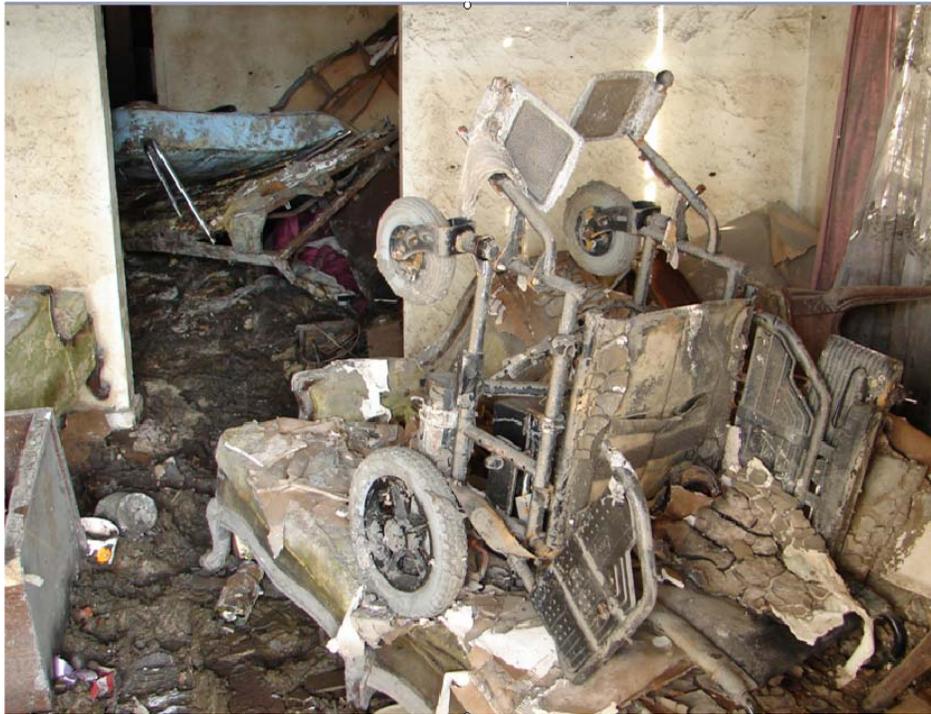
Figures 1.12 and 1.13 show typical devastation within the stricken flooded areas. The spray painted markings on the sides of the buildings in these areas are left by search and rescue teams, and they denote a number of important findings within each dwelling, including toxic contamination, etc. The most important numbers are those centered at the base of the large "X", as this denoted the number of dead bodies found within the building. In most cases, as shown previously in Figure 1.8, this number was "0", but this was not always the case. Figure 1.14 shows the outside of a dwelling in the Ninth Ward with a "3" beneath the X, indicating three deaths within. This was a housing unit, and the wheelchair ramp from the front door is askew at the bottom of the photograph. Figure 1.15 shows the muddy devastation, and a wheelchair, within this flooded structure.

Figure 1.15: View inside structure shown previously in Figure 1.14.

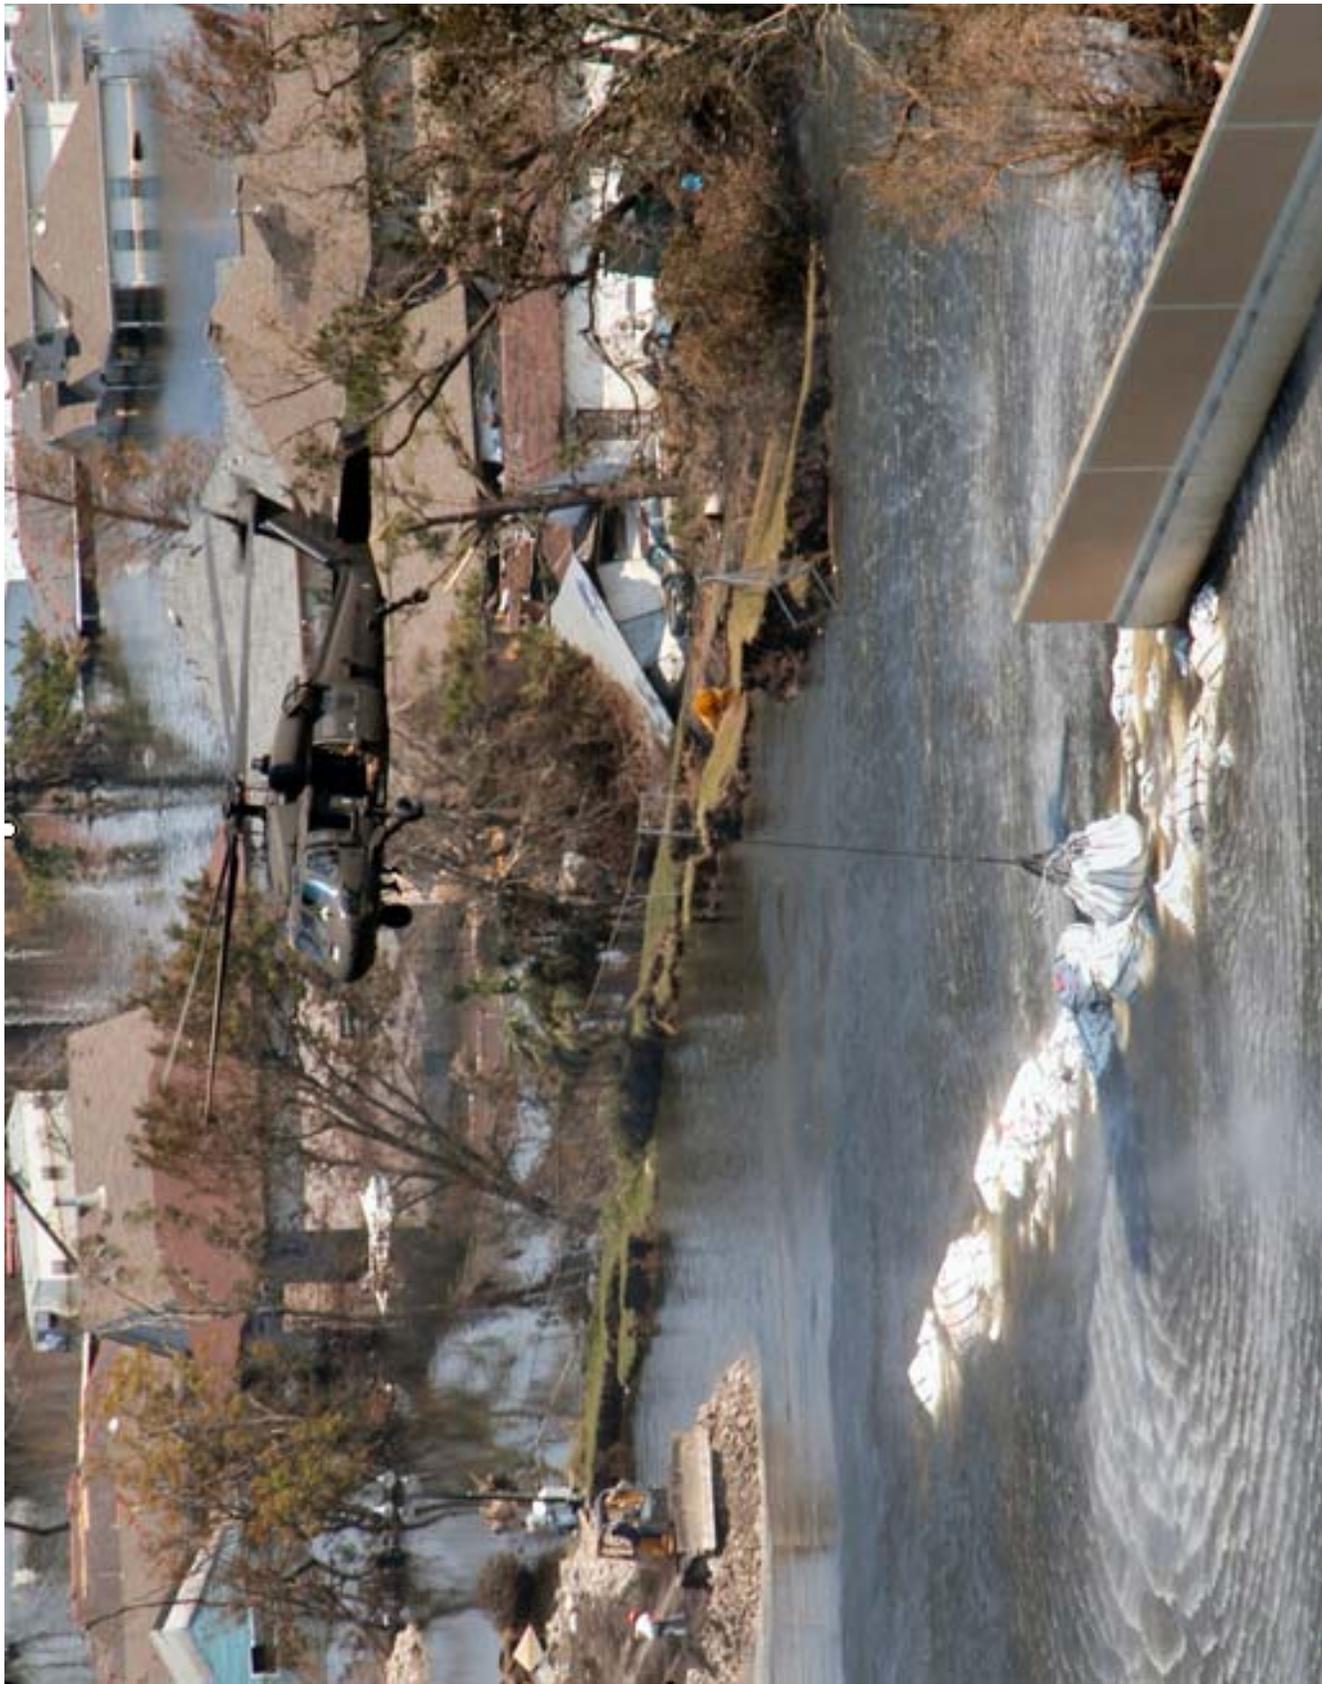
Figure 2.3(a): The 17<sup>th</sup> Street Canal breach during initial breach closure.

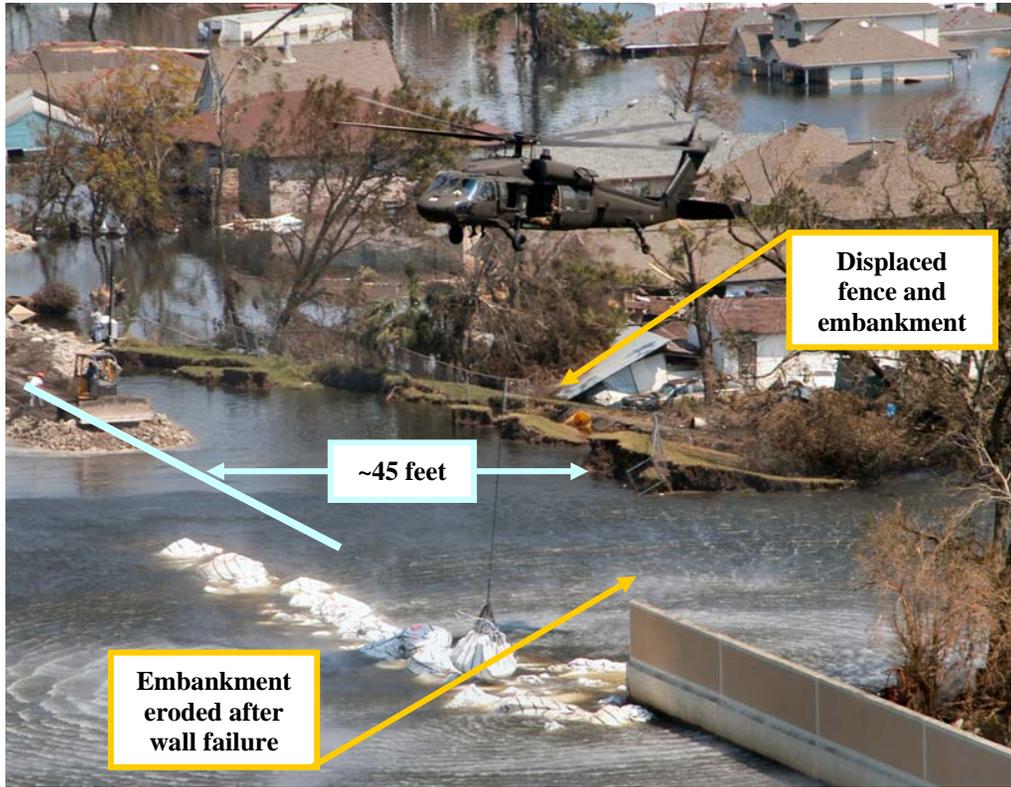
Figure 2.3(b): The 17<sup>th</sup> Street breach, highlighting key points for discussion

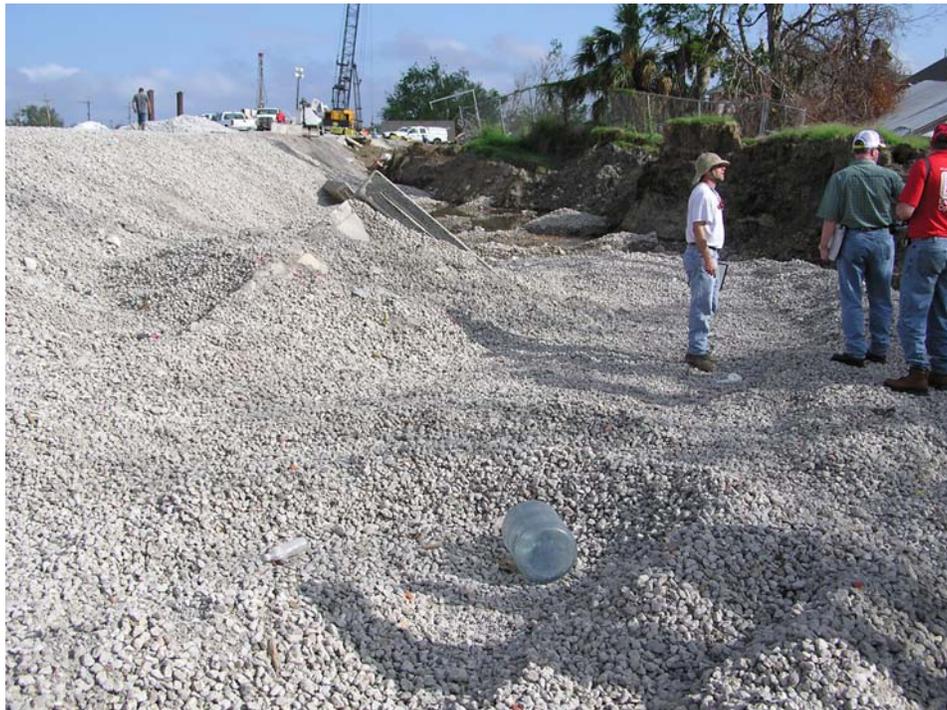
Figure 2.4: View of the 17<sup>th</sup> Street breach section from the south.

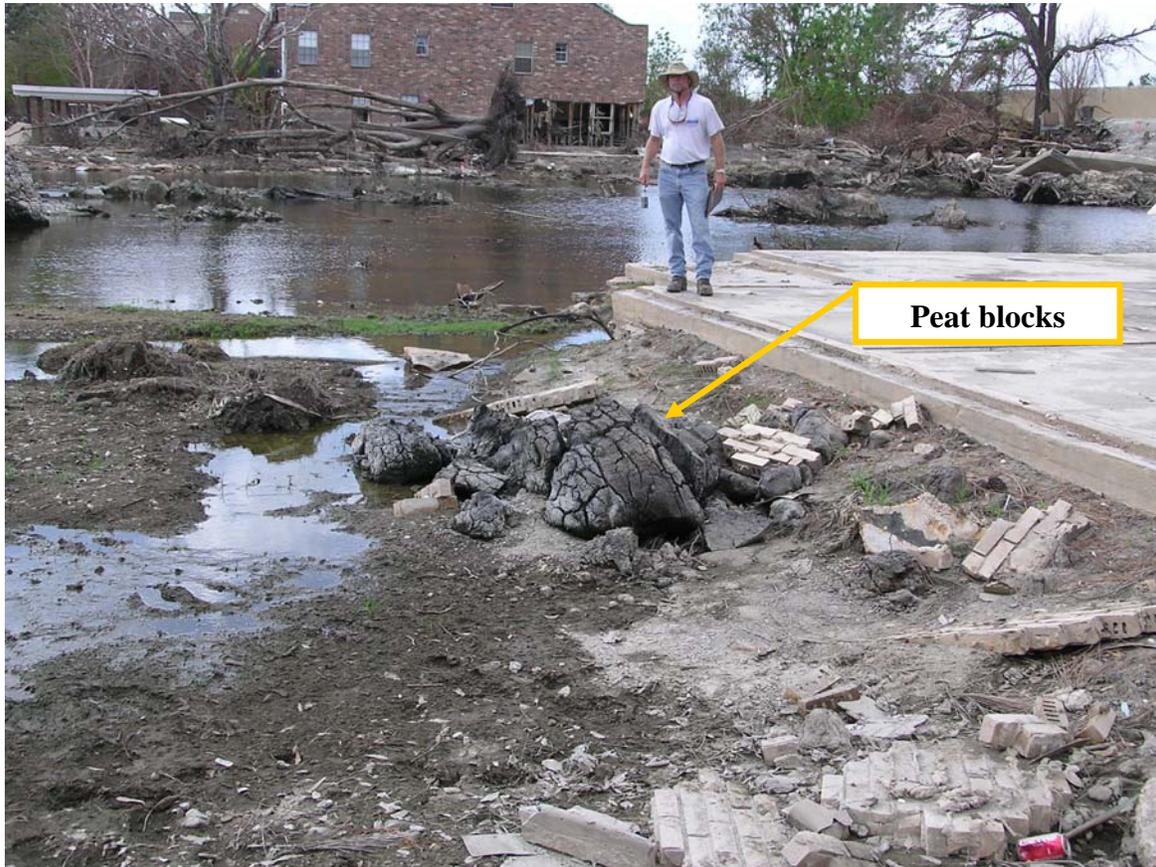
Figure 2.5 shows a view looking east across the zone through which the principal floodwaters flowed. Clearly evident in this photo are large blocks of peat scoured from the eroding foundation by the floodwaters.

Figure 2.5: View from crest of emergency embankment closure section at the 17<sup>th</sup> Street Canal breach, looking south across the floodwater scoured zone.

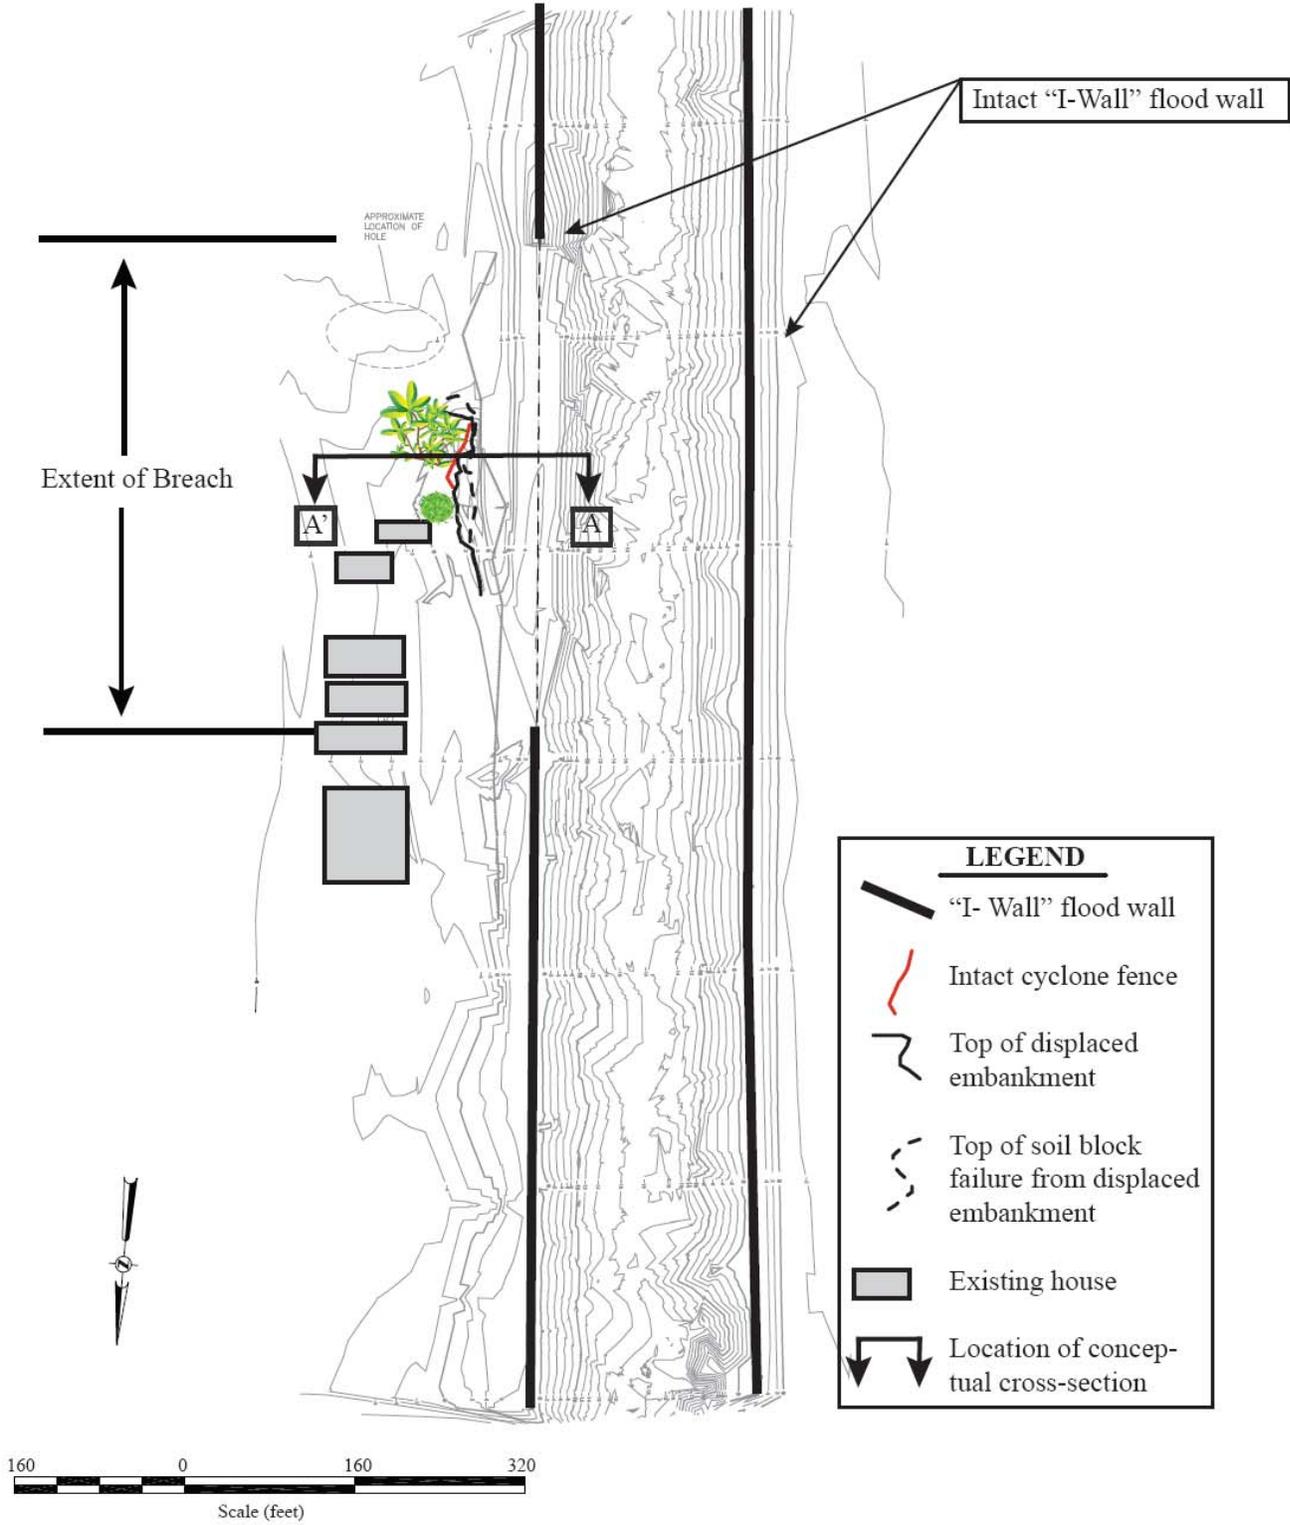
Figure 2.6: Schematic plan view of the 17<sup>th</sup> Street Canal breach site. Results of LIDAR scan superimposed on base survey.

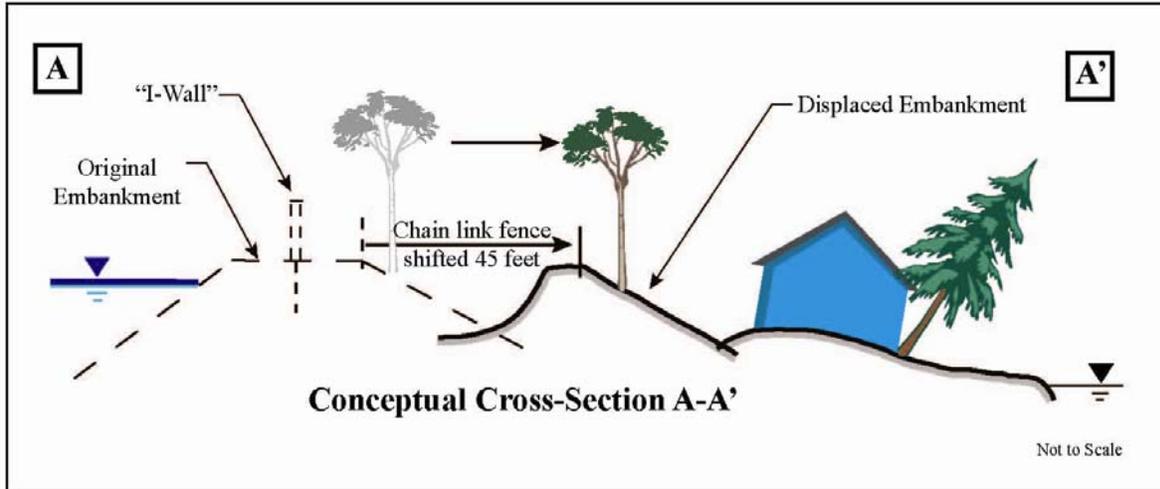
Figure 2.7: Schematic cross section at the 17<sup>th</sup> Street breach section.

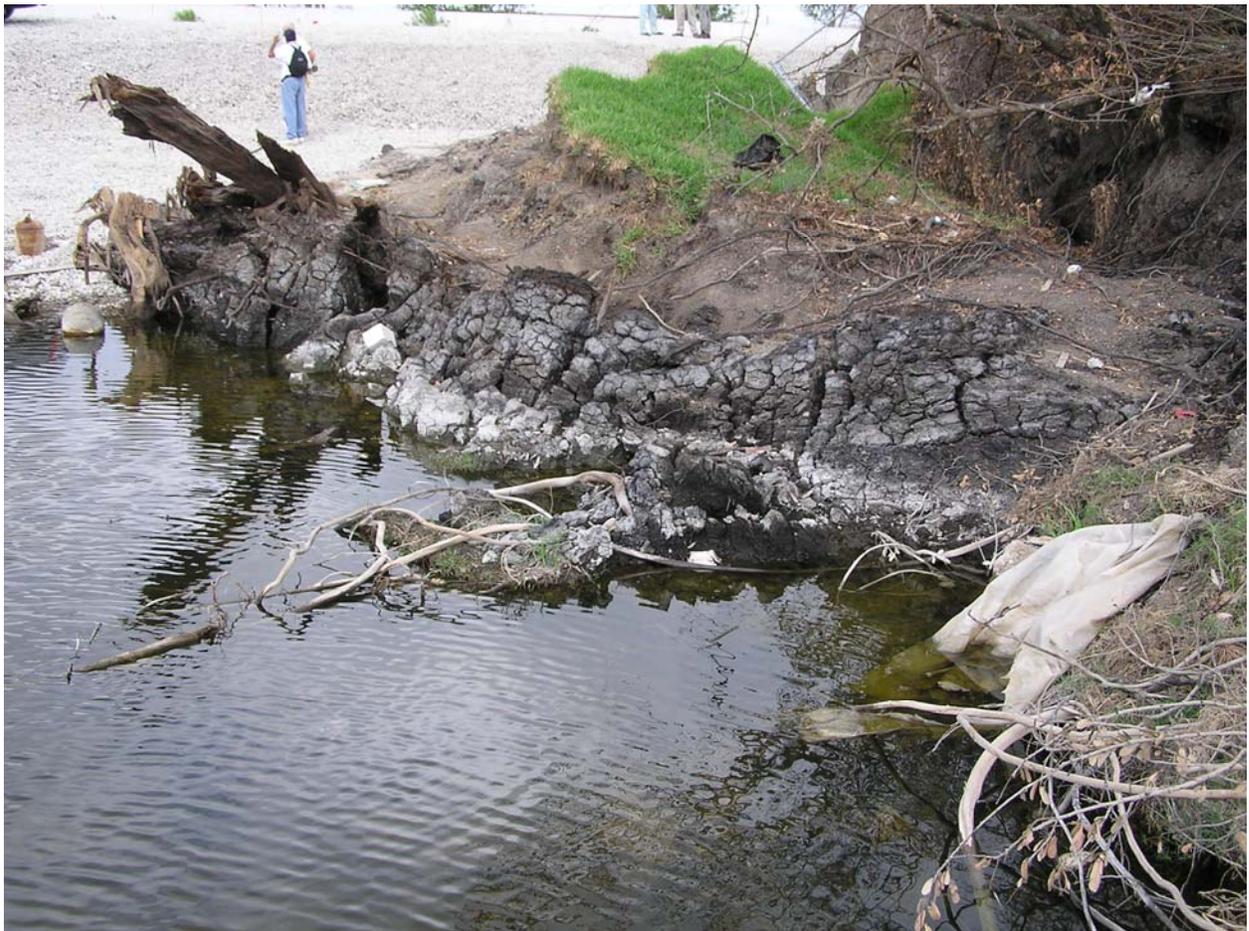
Figure 2.8: Location at which clay seam interbedded within the peat at the toe of the translated levee embankment was sampled.

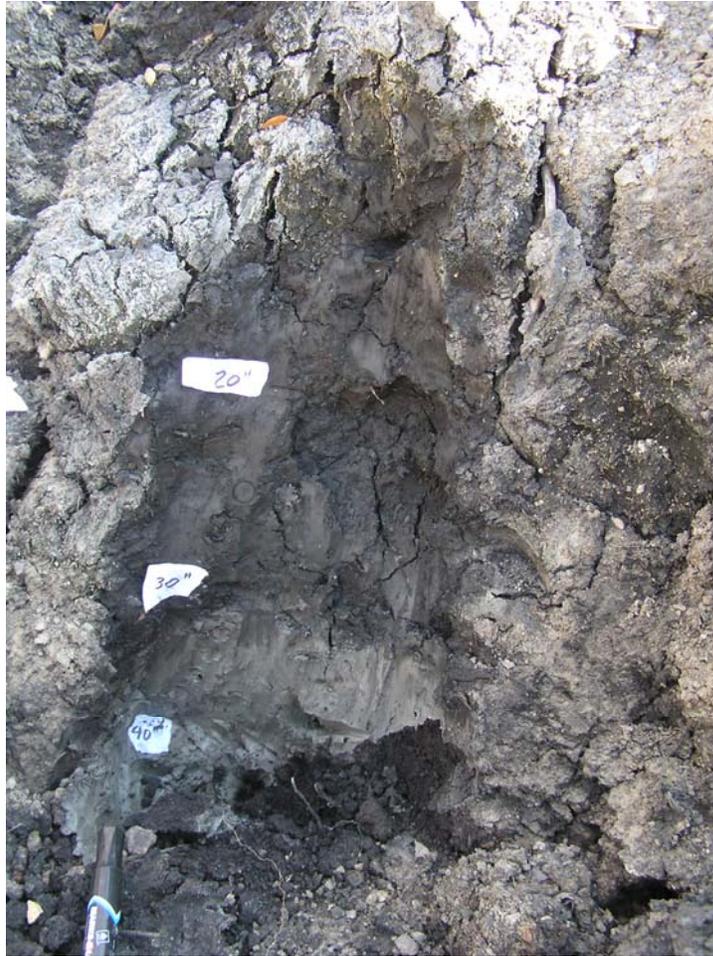
Figure 2.9: Clay seam (light gray layer) underlain by darker lean clay, and overlain by fibrous peat.

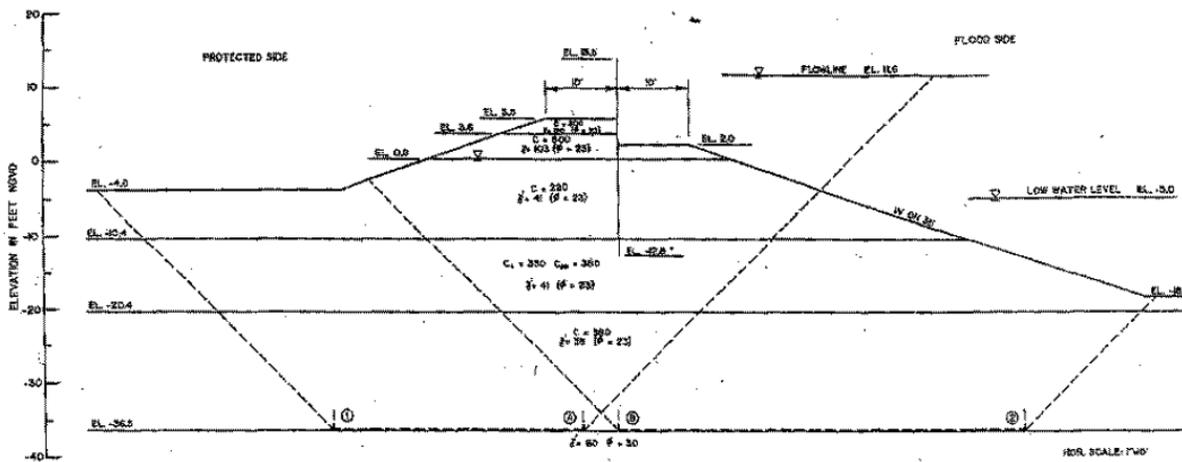
Figure 2.10: Design cross-section at the 17<sup>th</sup> Street breach.

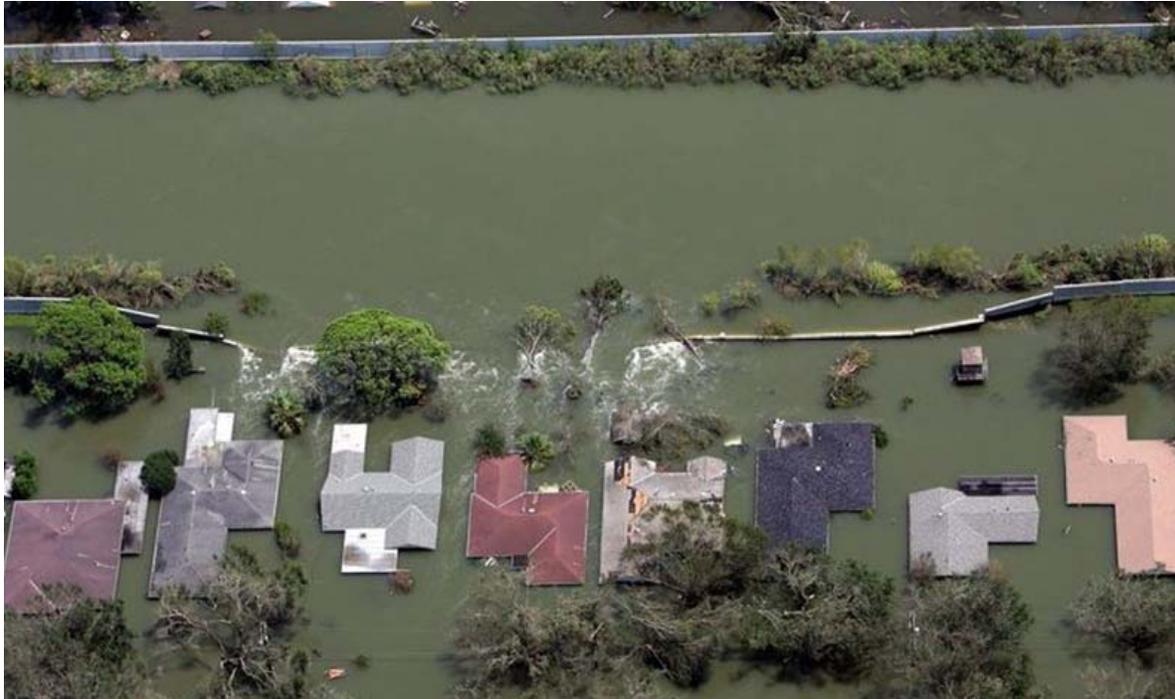
Figure 2.15: The breach section at the west side of the London Avenue Canal (North).

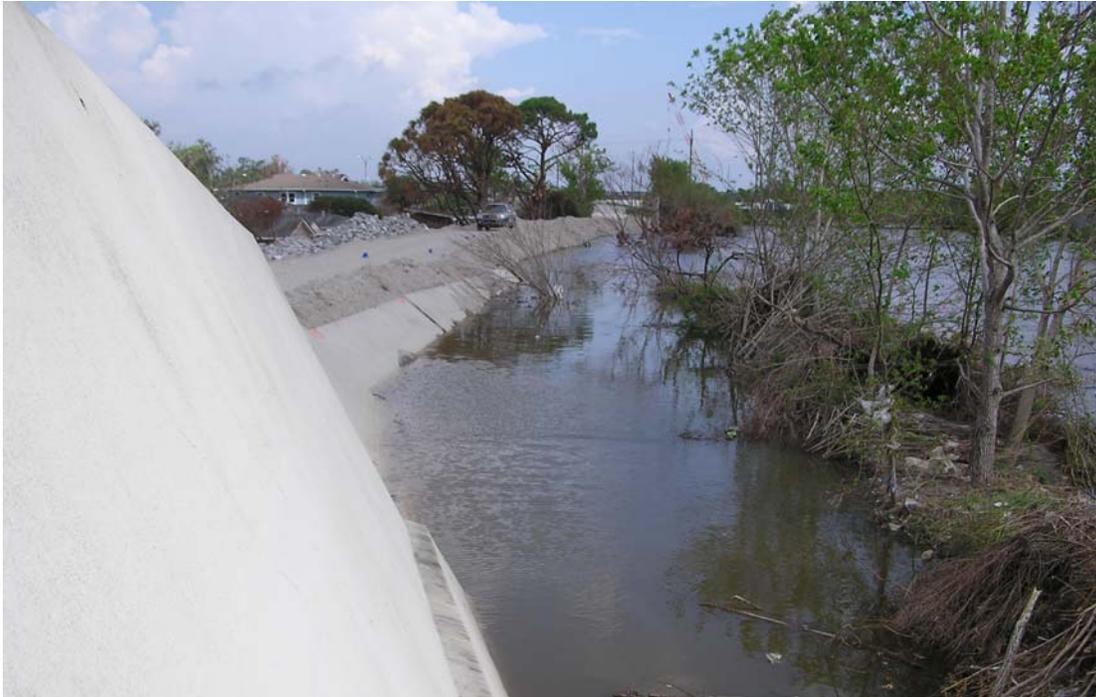
Figure 2.17: The toppled floodwall/sheetpile walls at the London Avenue Canal (North) breach site.

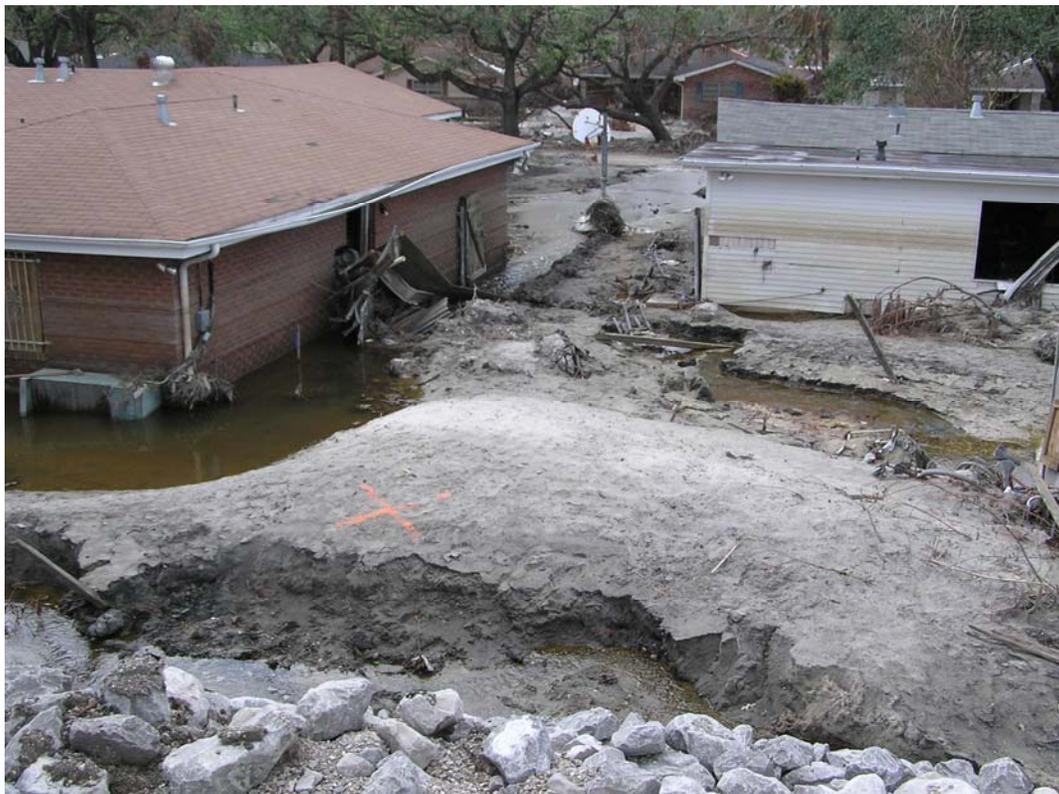
Figure 2.18: Sediment from the London Avenue Canal was deposited inboard of the levee break. High water marks (from long-term ponding) are visible on the exteriors of the residential homes.

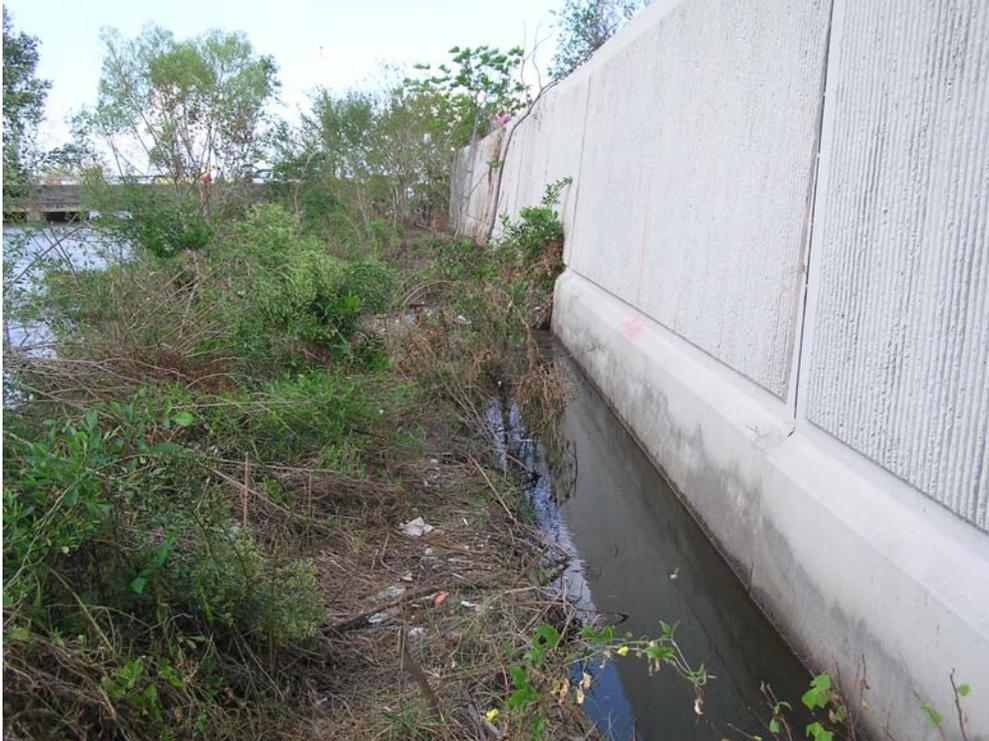
Figure 2.19: Gap at the base of the floodwall on the canal side of the East Bank “distressed” section.

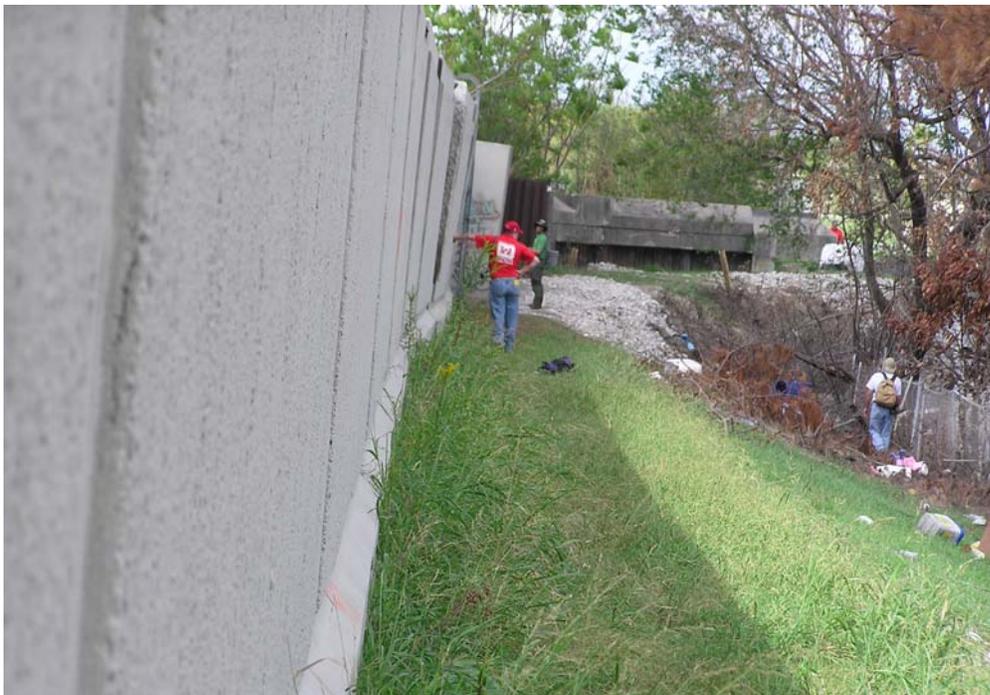
Figure 2.20: View of the inboard side of the floodwall and earthen levee embankment.

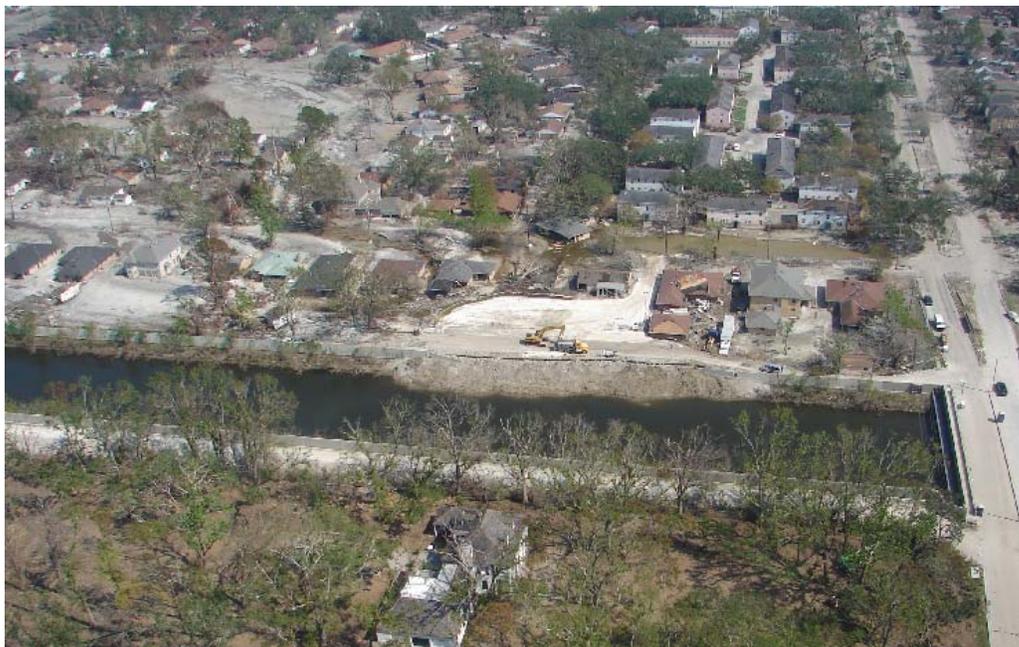
Figure 2.24: Aerial view of the breach section at London Avenue Canal (South).

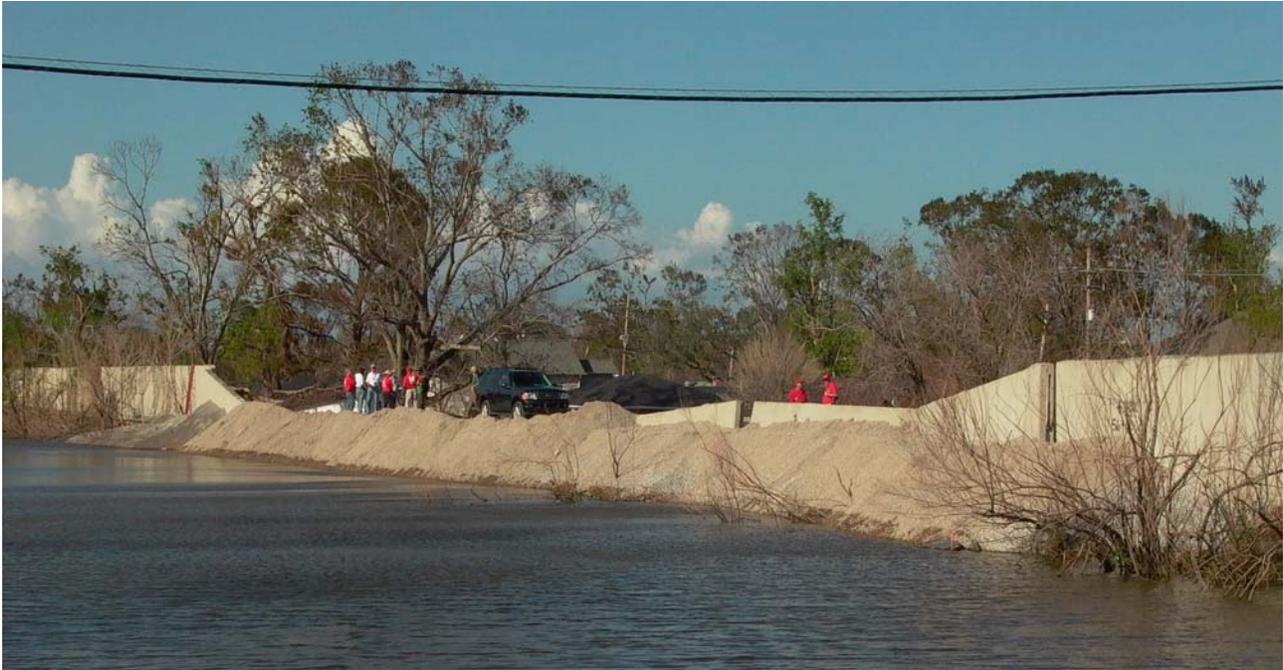
Figure 2.25: View of the crest of the temporary embankment closure section at the London Avenue Canal (South) breach.

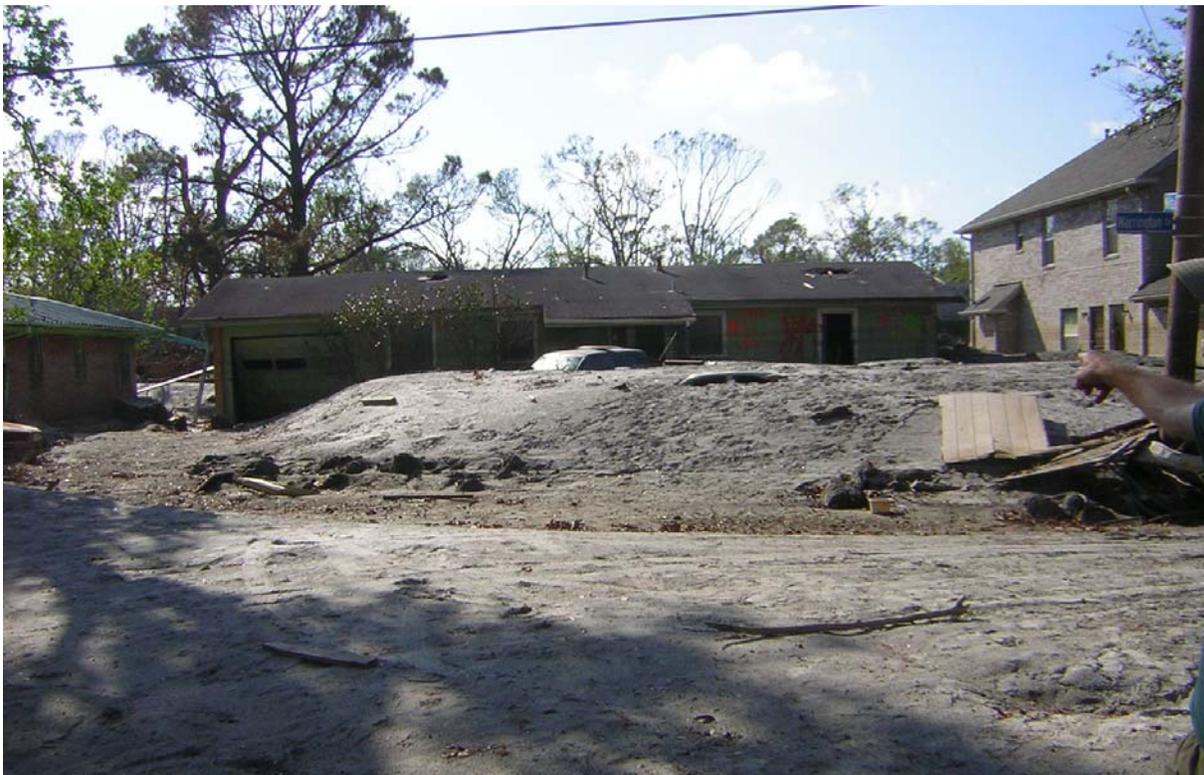
Figure 2.26: Significant quantities of sediment were deposited in the residential neighborhoods on the east side of the London Avenue Canal. More than five feet of sediment was deposited around this home.

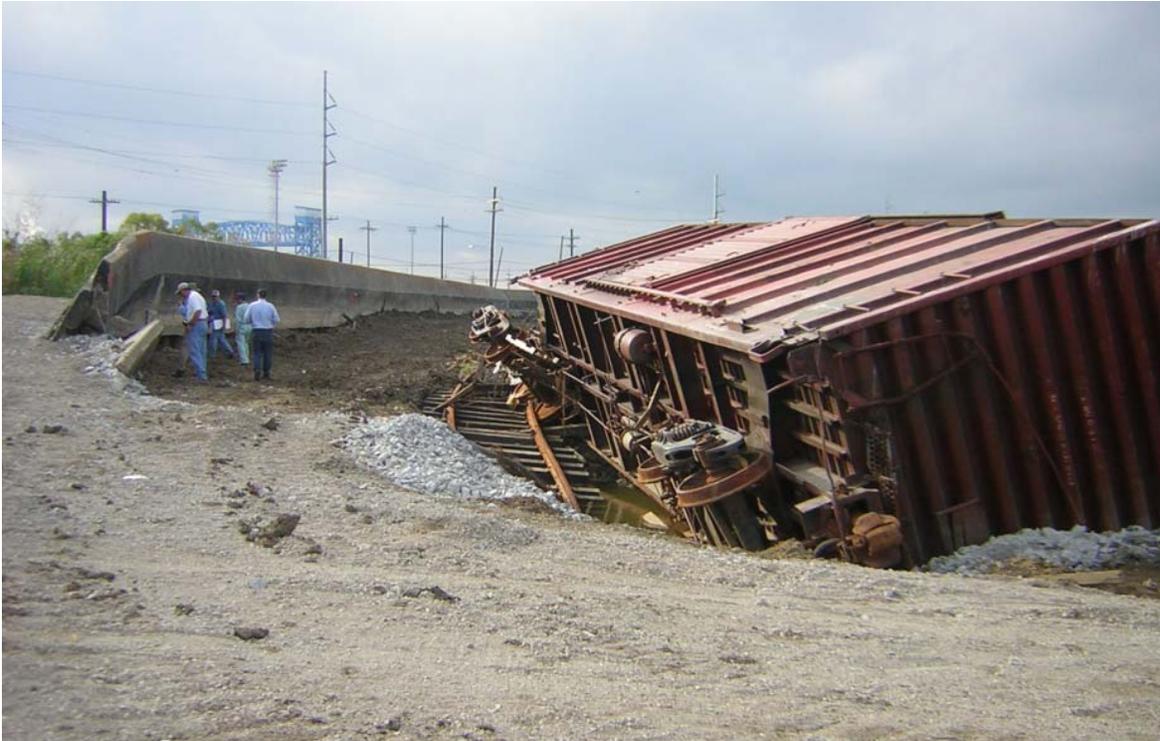
Figure 2.27: Breached levee floodwall section at Location “A” along the west side of the INHC.

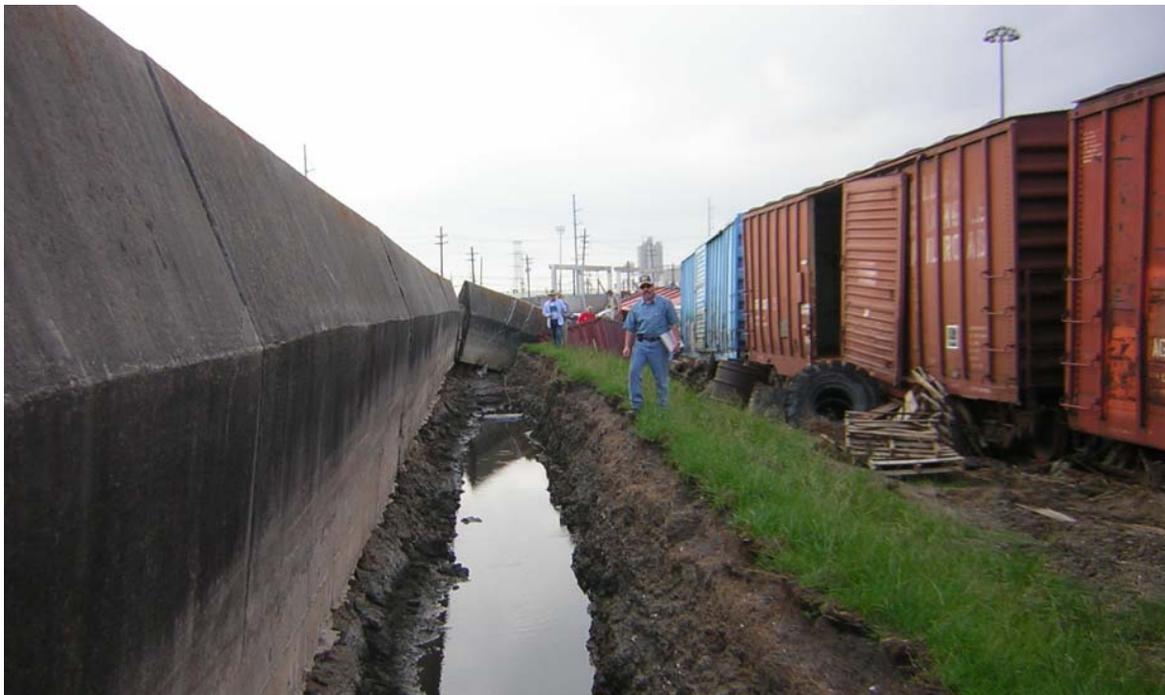
Figure 2.28: Erosion at the inboard toe of concrete floodwalls at Location “A” along the west side of the INHC, adjacent to the breached section shown previously in Figure 2.27.

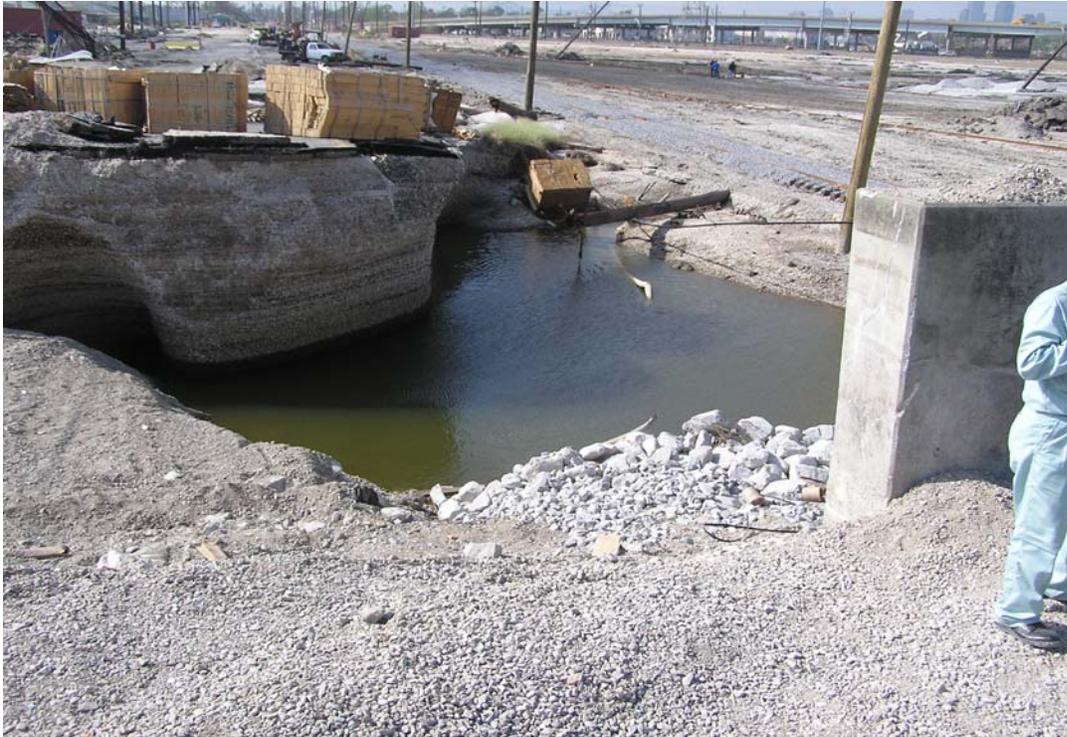
Figure 2.29: Erosion at a “transition” between a concrete floodgate wall and the adjacent earthen embankment section.

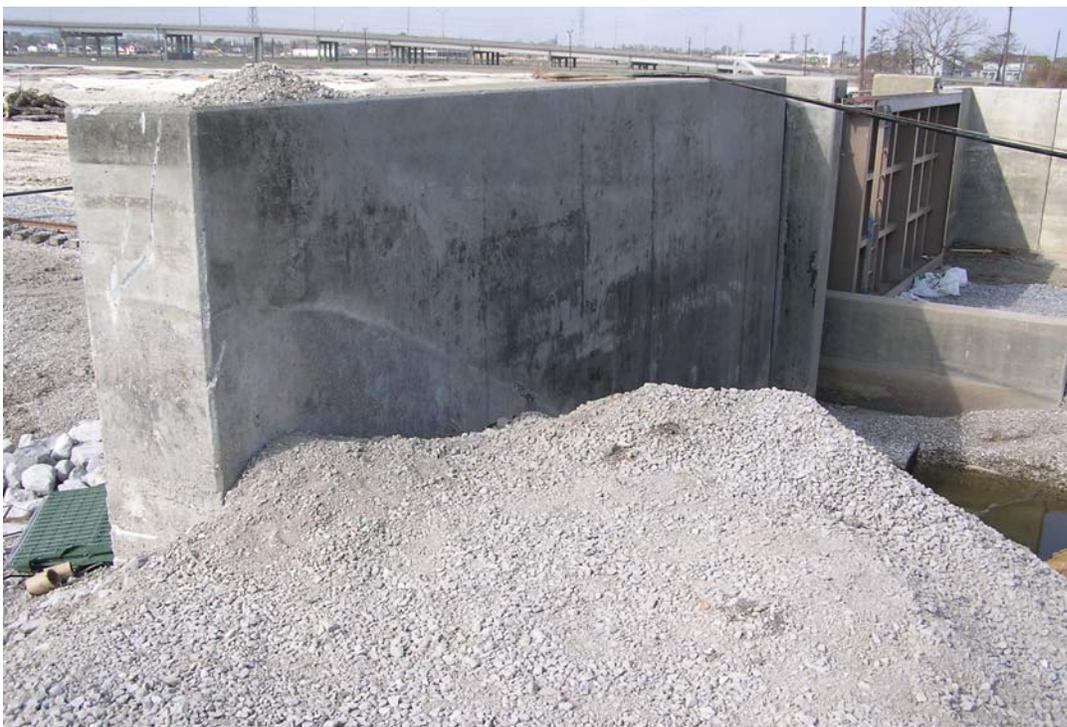
Figure 2.30: View of the structural wall and floodgate structure from Figure 2.29.

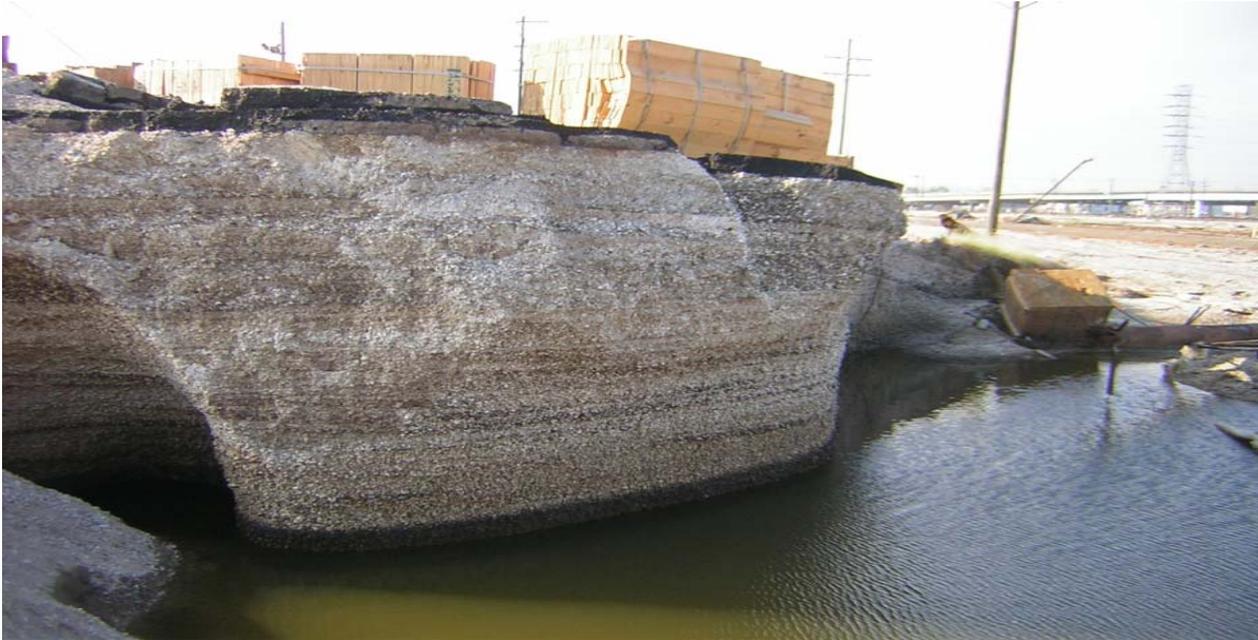
Figure 2.31: Close-up view of sandy “shell” fill at the scoured edge of the breach shown previously in Figure 2.29.
