# Preliminary Report on the Performance of the New Orleans Levee Systems in Hurricane Katrina on August 29, 2005

Preliminary findings from field investigations and associated studies performed by teams from the University of California at Berkeley and the American Society of Civil Engineers, as well as a number of cooperating engineers and scientists, shortly after the hurricane.

Report No. UCB/CITRIS – 05/01  
November 17, 2005

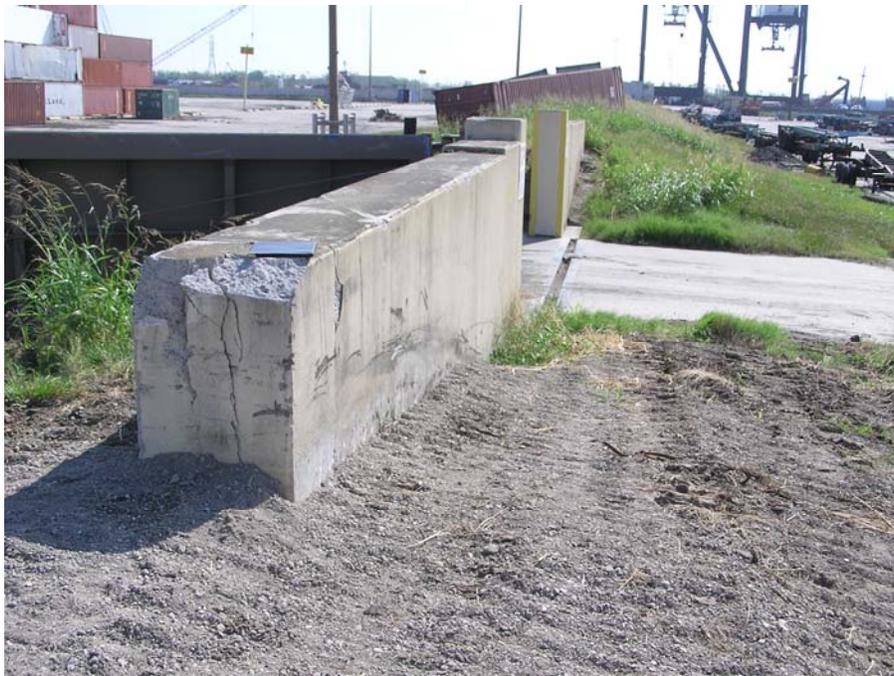
Figure 2.32: Common structural wall (with flood gate) and earthen levee transition problem with erosion at the contact between the earth and concrete sections.

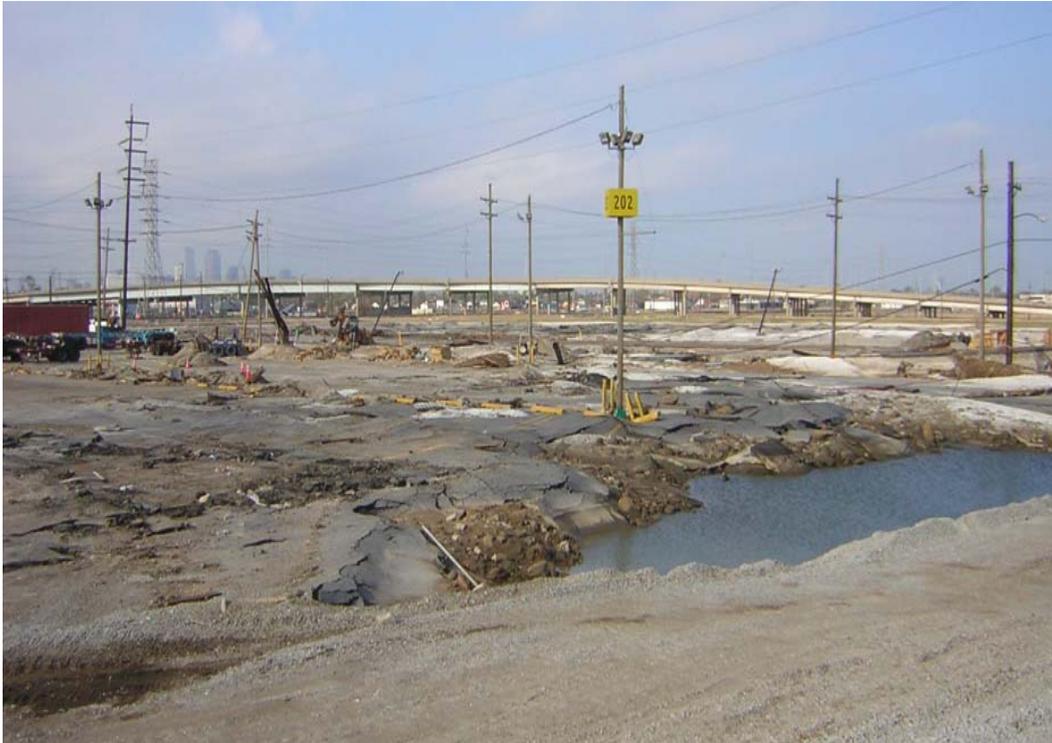
Figure 2.33: Scour hole and deposits of sediment and shells, inboard of the breach shown previously in Figure 2.32.

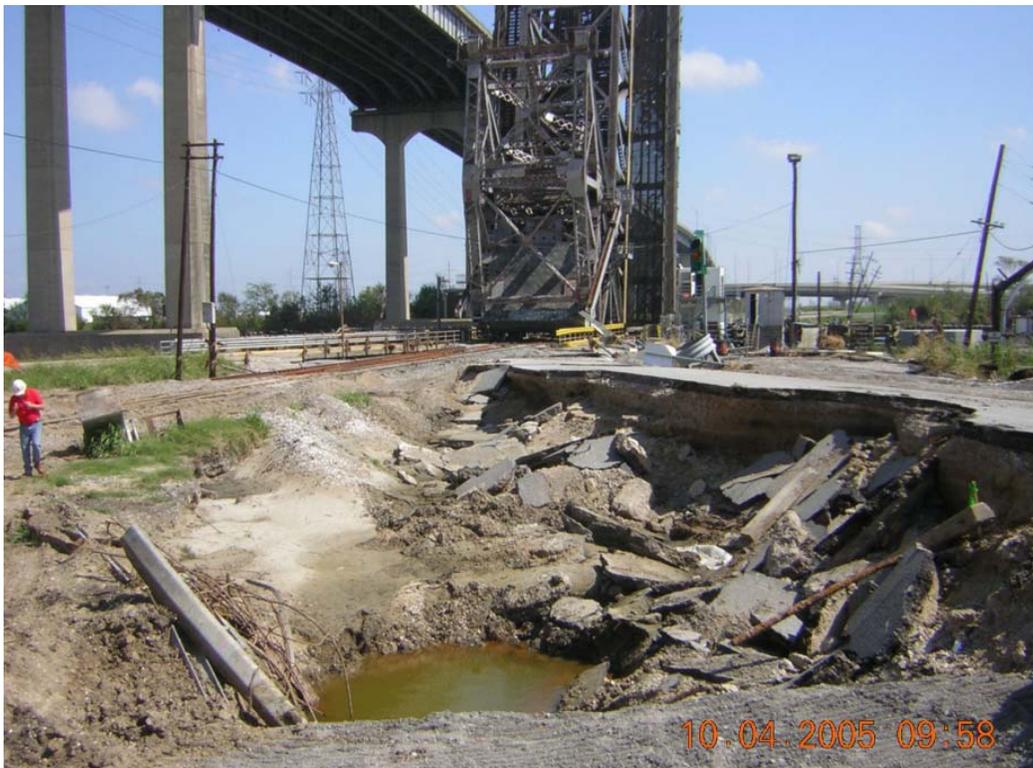
Figure 2.34 shows a complex “transition” at the northern end of the Port region along the west bank of the IHNC, immediately to the south of the Highway I-10 bridge, at Location “D” in Figure 2.1(a). At this location, outboard side levees and floodwalls associated with the Port and industrial operations conjoin with inboard side levees and floodwalls constructed by the USACE. In addition, a roadway embankment crosses through the levees, and a second gap in the “line of protection” for a railway line (crossing the adjacent IHNC) crosses through at this location. This represents a very complex “transition” section, with overlapping users and overlapping authorities and responsible entities. The gate of the railway’s floodgate wall had been knocked off by a train derailment several months prior to Hurricane Katrina, and the railway was to have closed the resultant opening with a sandbag levee section within the gated opening. Our understanding is that this sandbag closure was inspected by the Orleans Levee Board. This emergency closure appears to have been unsuccessful, as floodwaters appear to have passed through this opening, and then to have eroded and breached the earthen roadway embankment adjacent and behind this section. Our field investigation teams were unable to track the direct consequences of this, as additional breaches along this same frontage section, as well as the major breach at the east bank of the nearby London Avenue Canal, all apparently contributed to flooding of the neighborhoods immediately inboard of this site.

Figure 2.34: A complex “transition” involving several overlapping operations and penetrations through the flood protection levees immediately south of the I-10 bridge across the IHNC.

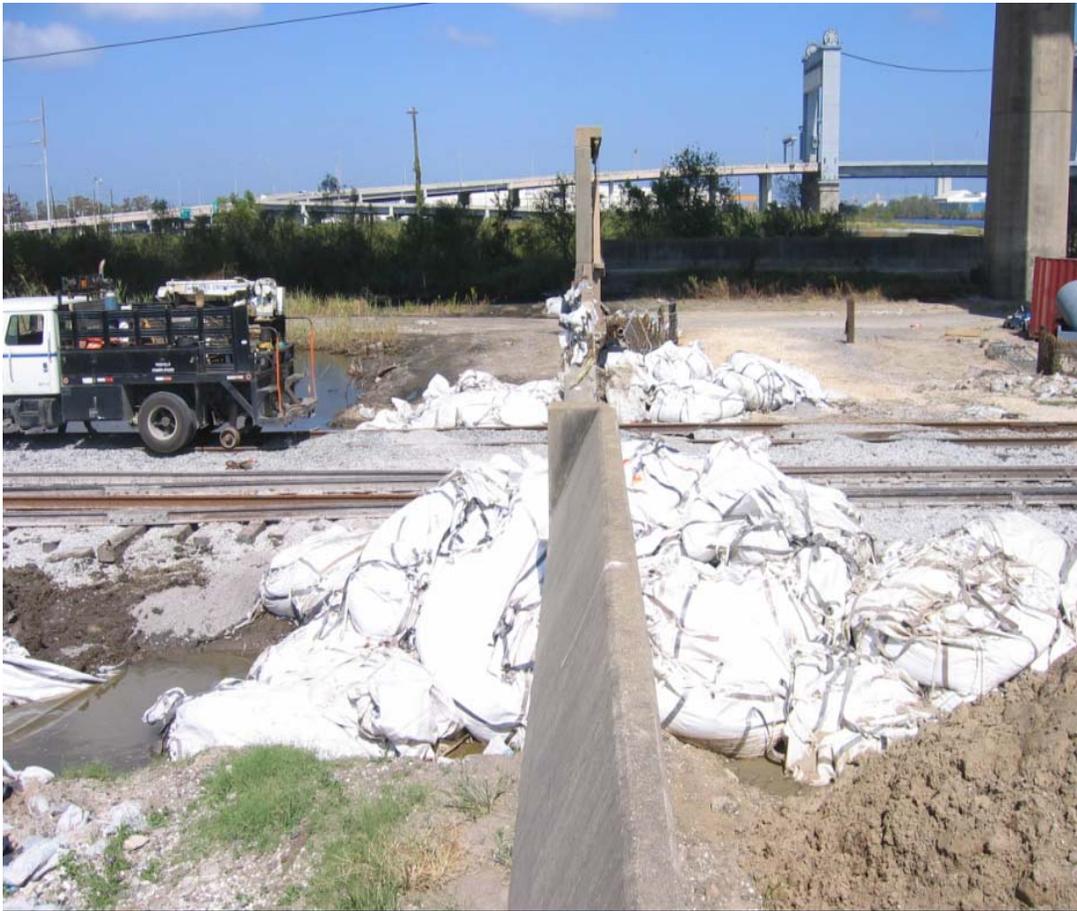
Figure 2.35: Rail line crossing through floodgate structure at the west side of the INHC at the complex transition shown in Figure 2.34.

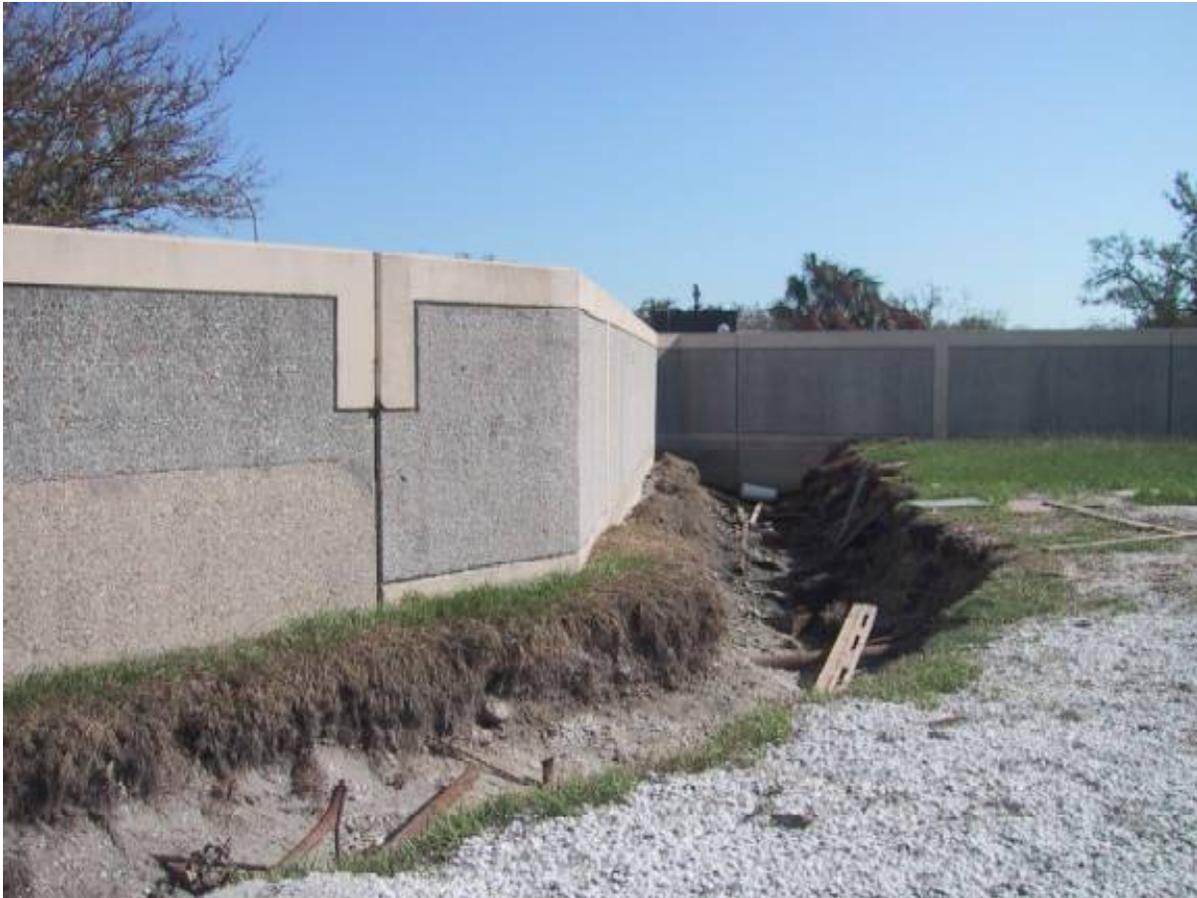
Figure 3.3: I-wall adjacent to the Lakefront Airport showing deep back-scour but no evidence of distress to the wall.

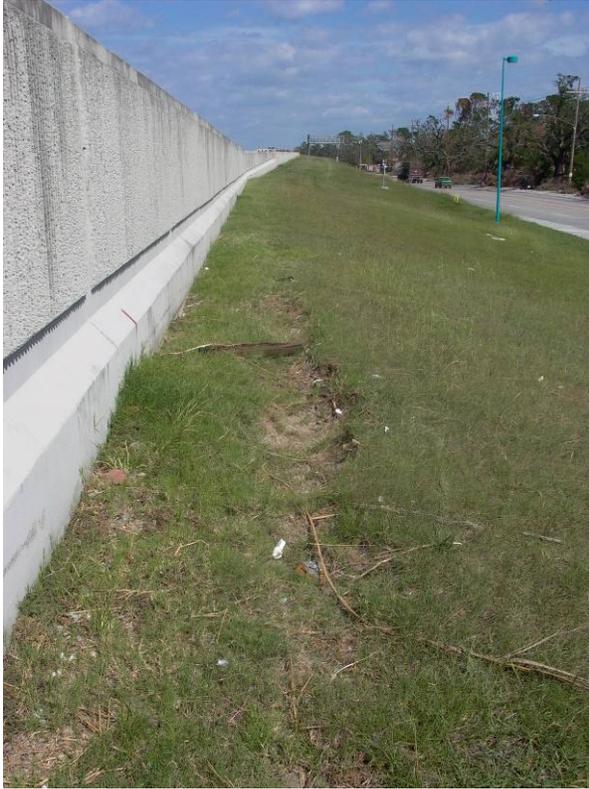
Figure 3.4: Beginning of overtopping scour along lakefront flood wall suggests moderate overtopping at this location.

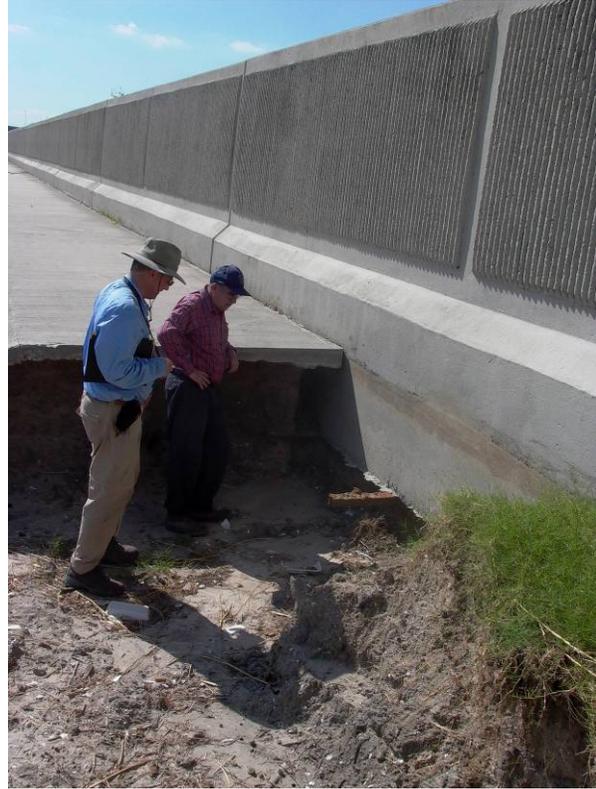
Figure 3.5: Concentrated scour due to presence of concrete apron. Area in the background is a good example of the benefits of armorng the base of the flood walls.

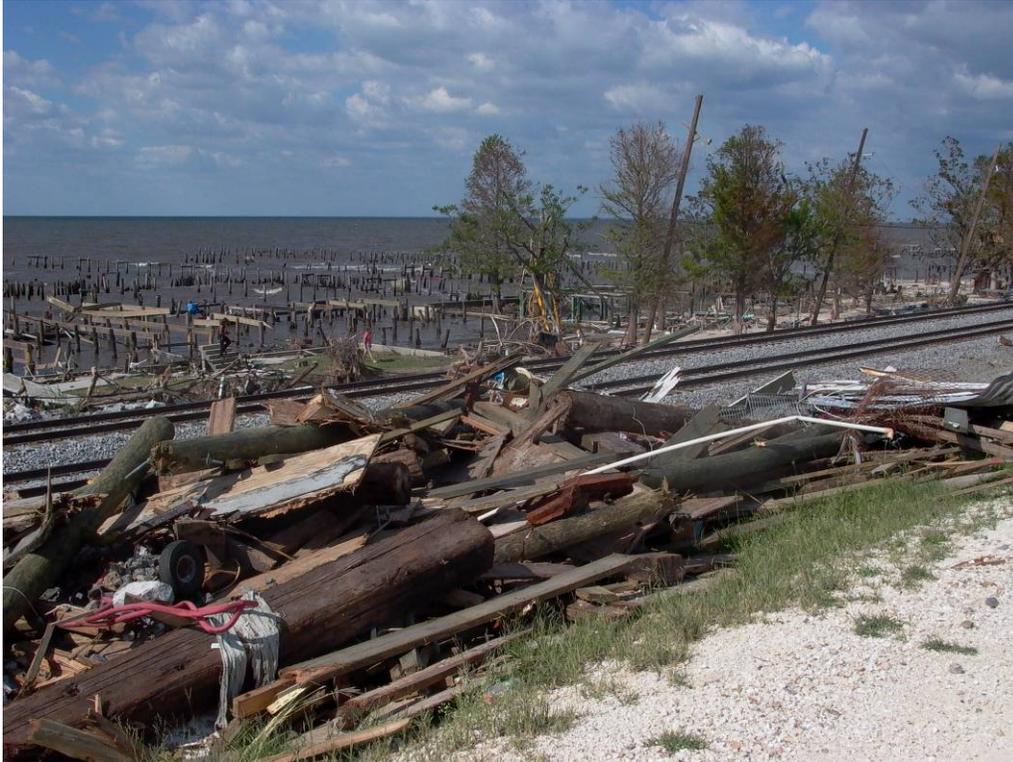
Figure 3.7: The lakefront community of Little Woods destroyed by wind and water (N 30° 04' 70.5", W 89° 56' 44.0")

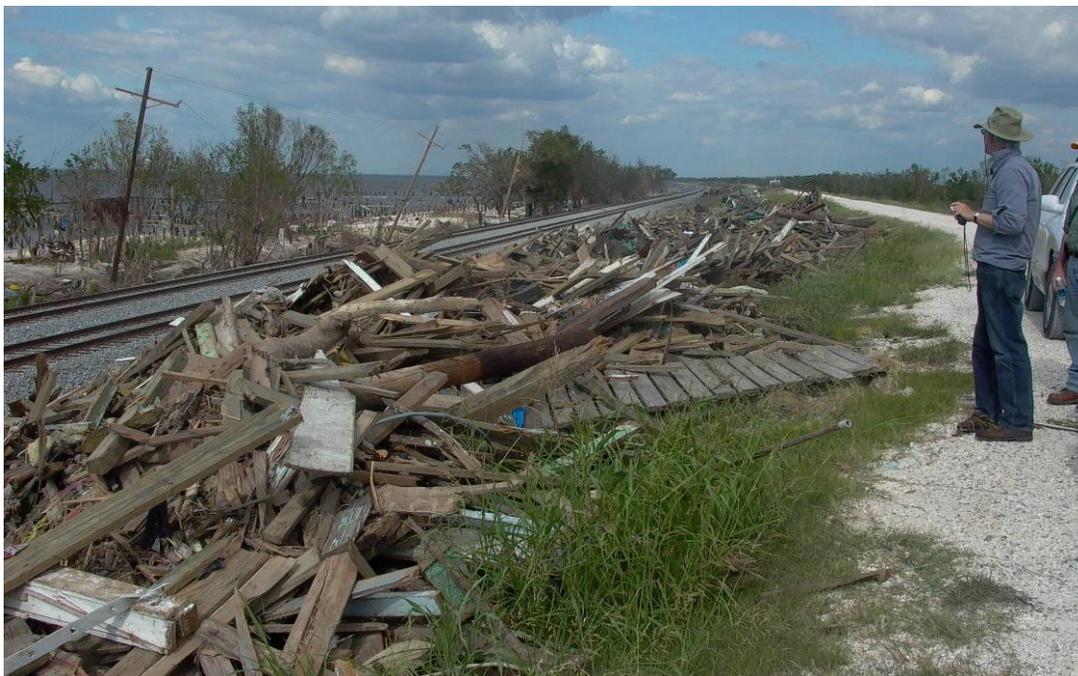
Figure 3.8: Debris from the Little Woods houses accumulated near the crest of the earth levee indicates the level of the lake waters during the storm. (N 30° 04' 70.5", W 89°, 56' 44.0")

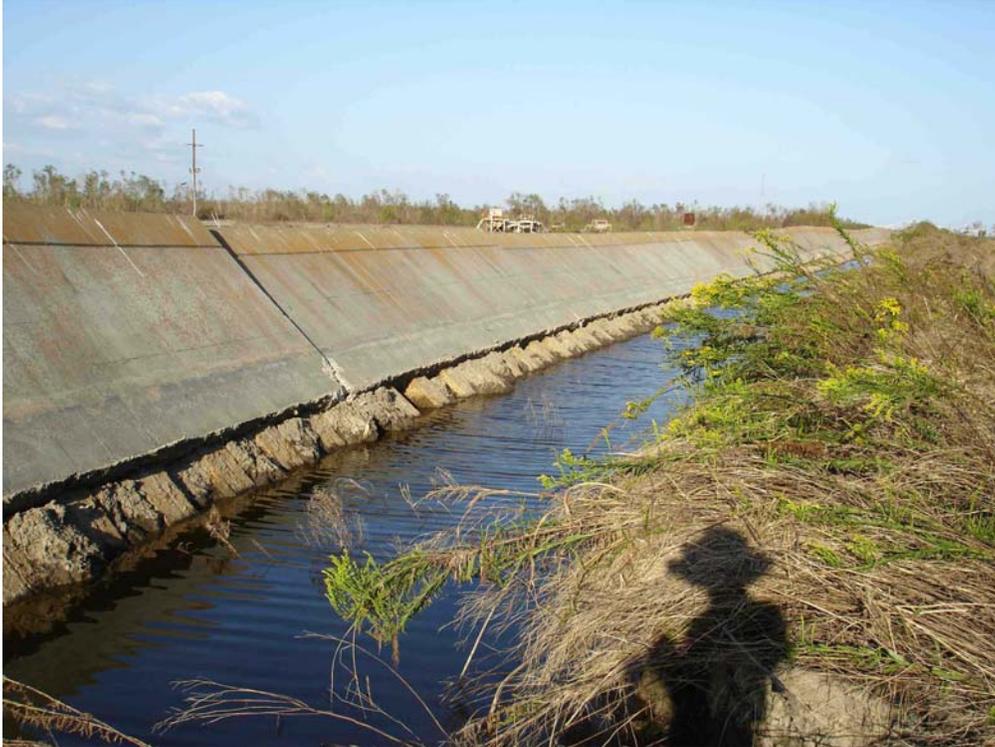
Figure 3.11: Severely distressed I-wall after overtopping from the water side along the IWW/MRGO.

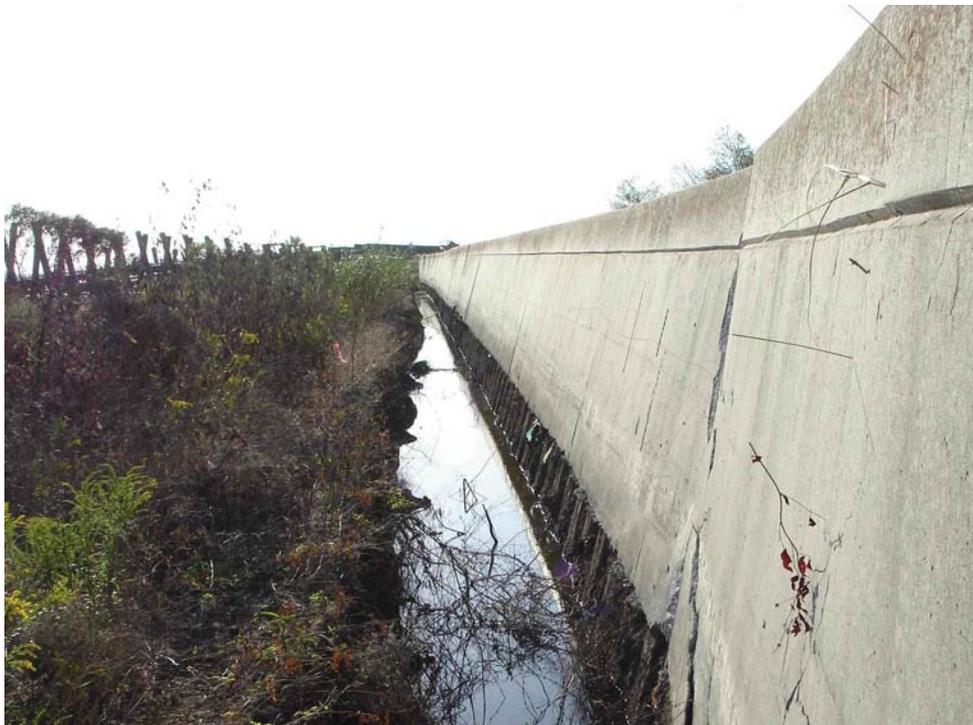
Figure 3.12: “Gapping” between soil and wall as distressed wall was displaced landward from the IWW/MRGO.

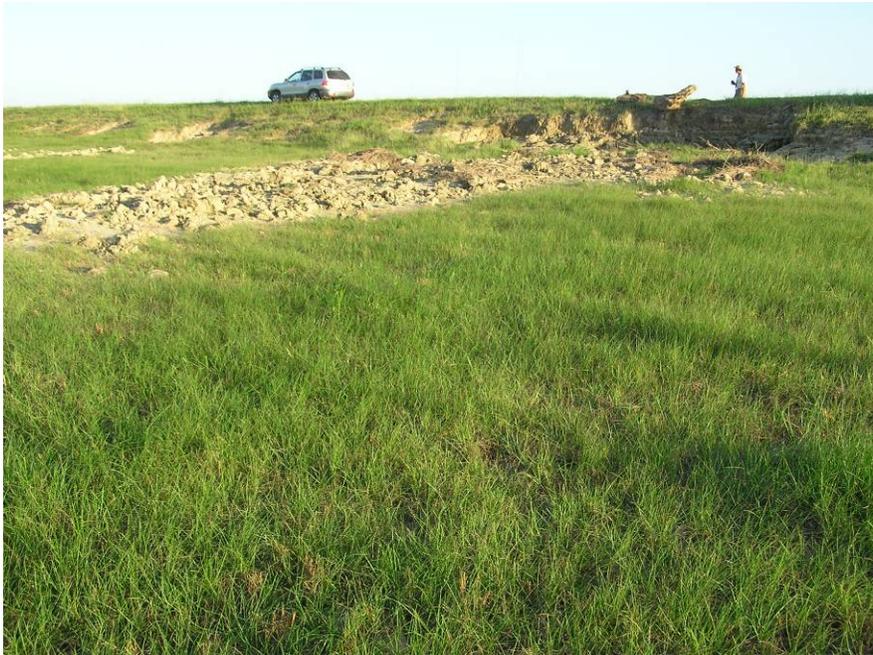
Figure 3.15: Embankment along the IWW/MRGO that survived although somewhat scoured.

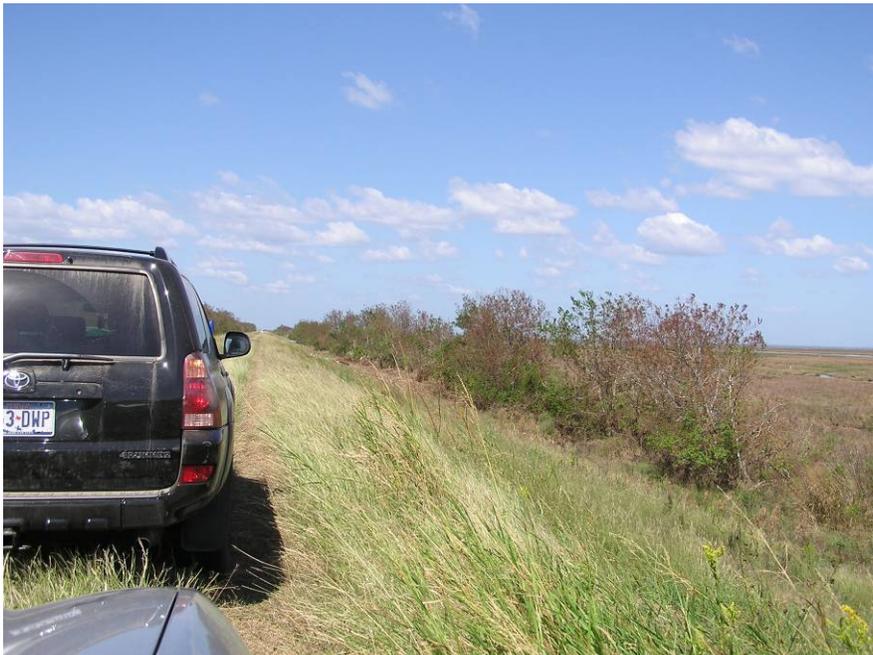
Figure 3.16: Virtually unscathed earth embankment levee on the eastern edge of the protected area of New Orleans East

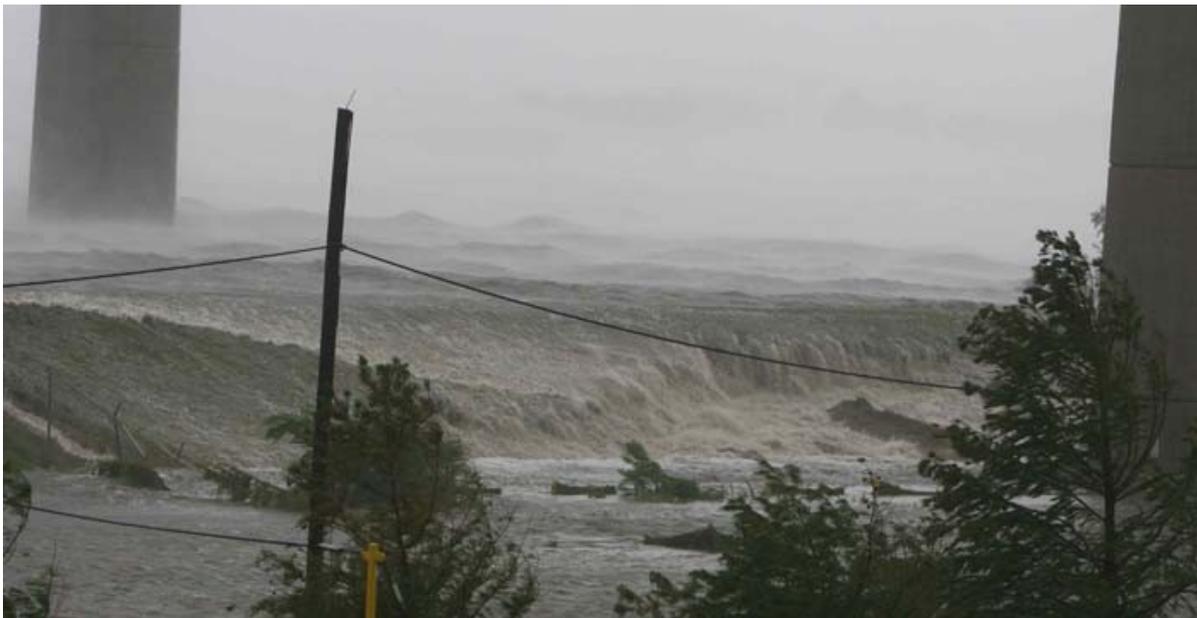
Figure 3.18: Same view of the overtopped earth embankment as seen in Figure 3.18 taken during the storm surge.

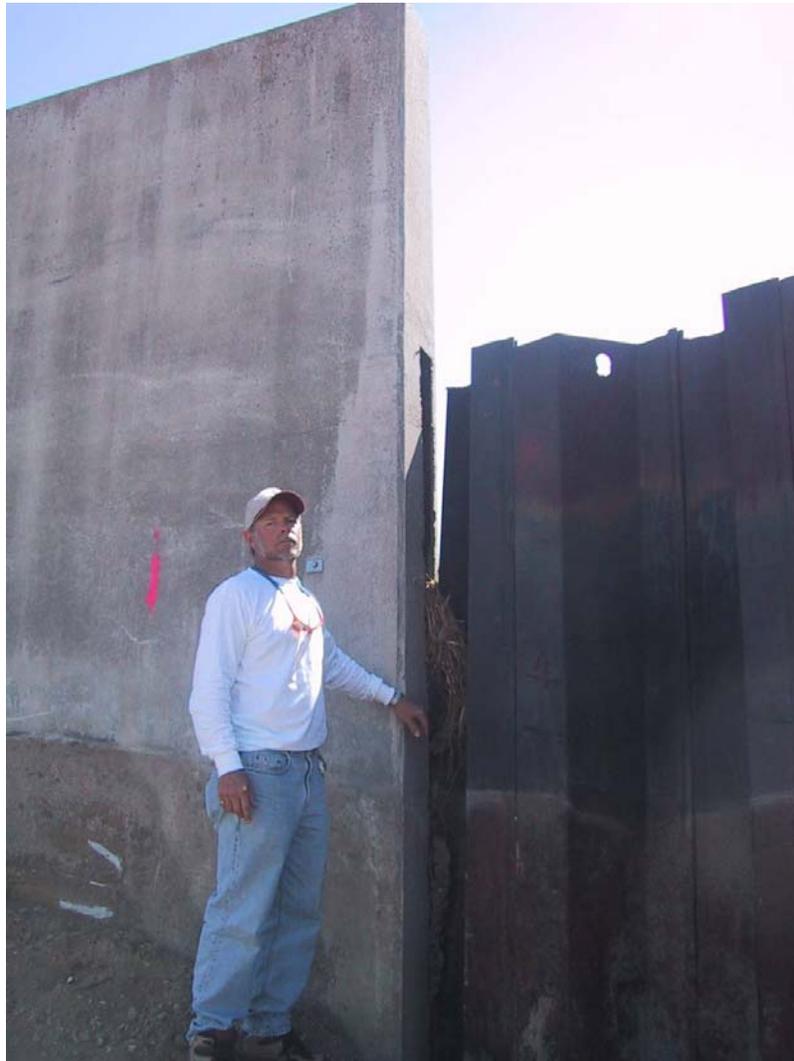
Figure 3.19: Transition between concrete and sheetpile walls at uneven wall height elevations

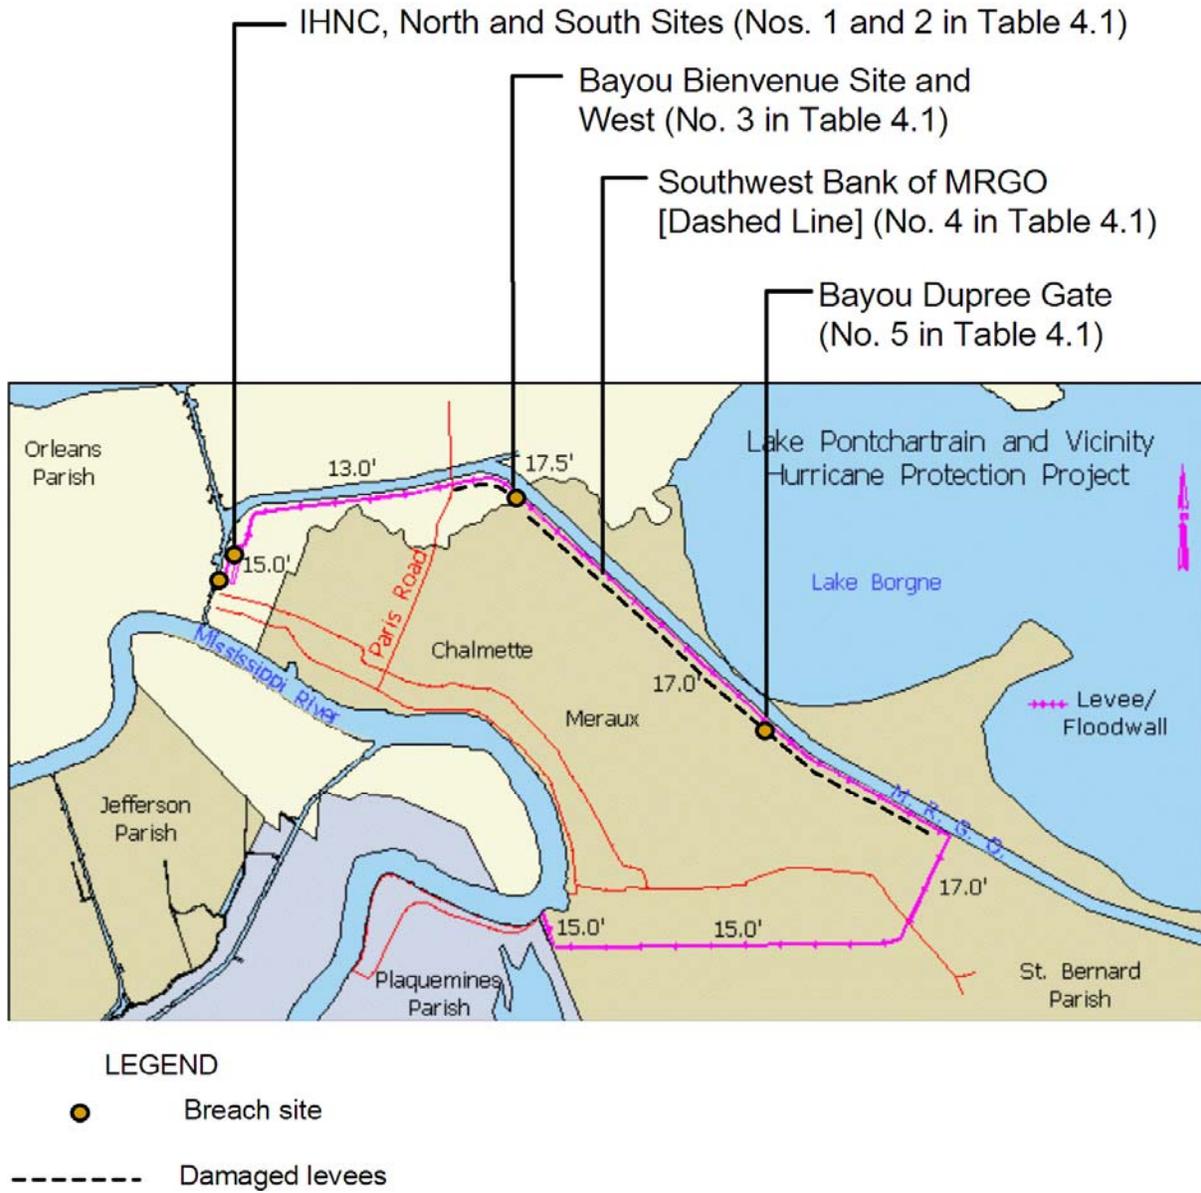
Figure 4.1: Overview map of the Lower Ninth Ward/St. Bernard Parish Polder showing the locations of damage to the primary levee system. Sites nos. 1 through 4 are summarized in Table 4.1. The elevations shown correspond to the top of the levee system at each location (after USACE).

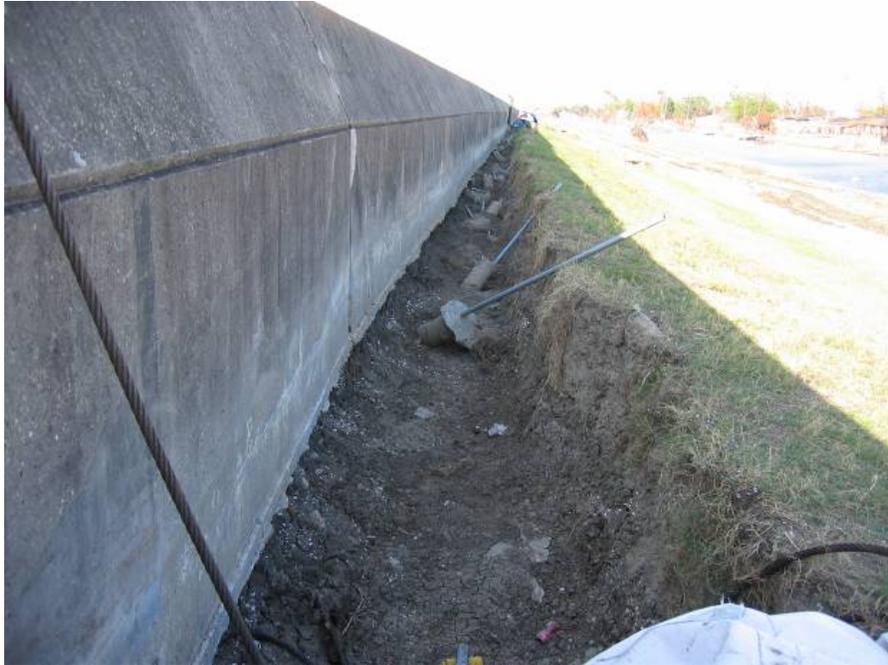
In this area, the earthen portion of the levee was almost completely destroyed and the I-wall was overturned toward the landside and dragged inland by as much as 190 feet. As shown in Figure 4.2, the displaced I-wall assumed a sinuous shape that reached its maximum distance along the northern extent of the breach. It is worth noting that the sheet pile remained interlocked, hence the displacement resulted from elongation of the sheet pile portion of the I-wall structure. The unbreached portions of the I-wall system located immediately north and south of the failure were tilted landward, reaching their maximum inclination of approximately 3 degrees near the breach and gradually tapered to close to vertical at further distances from the breach. Scour trenches at the landside toe of the floodwall (protected side) were found along the entire length of the intact I-wall section. The scour trenches were typically about 5 feet wide at the top and extended to depths of approximately 4 feet. The scour trenches were generally wide and U-shaped near the breach and gradually became narrower, V-shaped and incised with at further distances from the breach (Figure 4.4).

Figure 4.4: North view from the end of the south breach of Lower Ninth Ward. Note how the scour trench becomes progressively wider as it approaches the breach (J. Wartman, October 4, 2005).

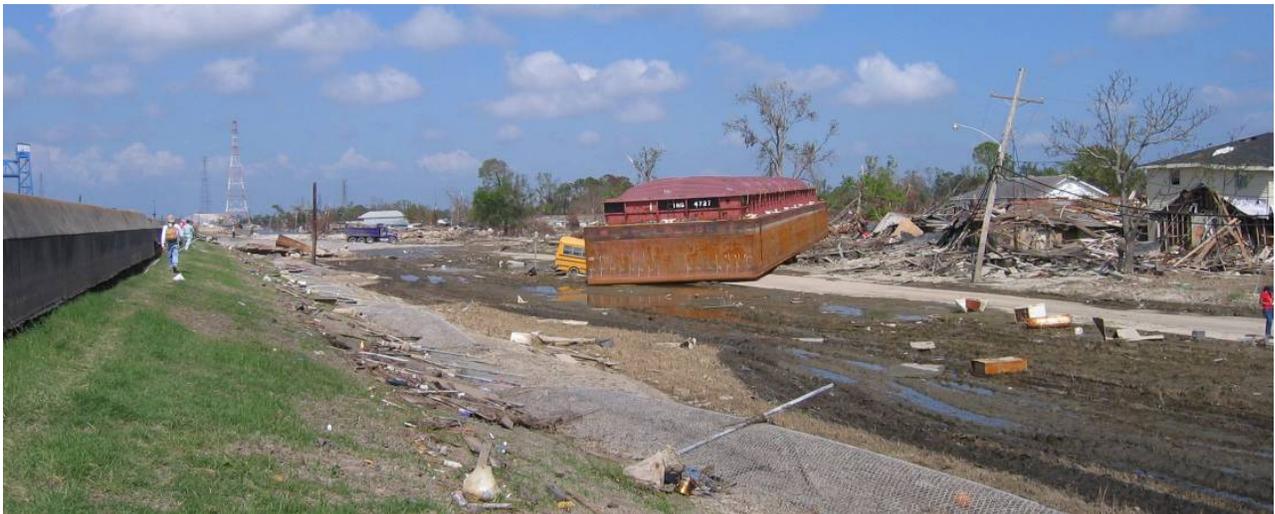
Figure 4.5 shows a unique feature of the failure site: a large barge that was drawn through the breach and came to rest on the landside of the levee as floodwaters receded. The barge was reportedly docked in the IHNC and became unmoored during Hurricane Katrina. Note the crushed school bus under the right side of the barge. Review of press photographs indicate that the barge initially came to rest further inland as floodwaters from Hurricane Katrina receded. The barge was later refloated as the Ninth Ward flooded a second time during Hurricane Rita. The barge drifted back toward the breach and came to rest upon the school bus as the Lower Ninth Ward was later unwatered.

Figure 4.5: A barge was drawn through the south breach of the Lower Ninth Ward (J. Wartman, October 4, 2005).

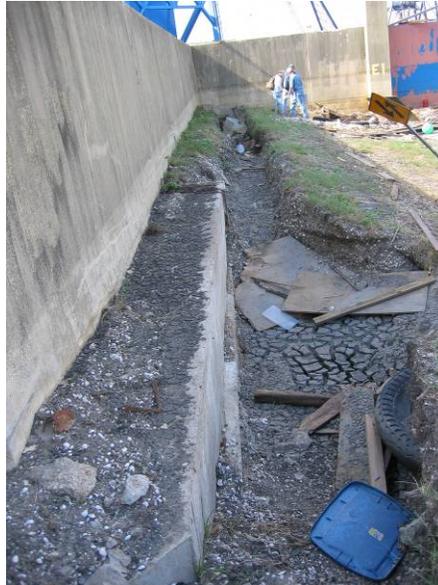
The unbreached portions of the I-wall system located immediately south of the failure were tilted inward (landward). The tilted I-walls reached their maximum inclination of approximately 3 degrees near the breach and gradually tapered to close to vertical at further distances to the south. Scour trenches at the landside toe of the floodwall (protected side) were found along the entire length of the intact I-wall section. The scour trenches were typically about 5 feet wide at the top and extended to depths of approximately 3 to 4 feet. As with the south breach, the scour trenches were wide and u-shaped near the breached area and gradually became narrower, v-shaped and incised at greater distances. Scour was also noted along the landside of the T-wall levee sections (Figure 4.8).

Figure 4.8: A scoured, but nevertheless well-performing "T-wall" levee section located near the north breach of the Lower Ninth Ward (J. Wartman, October 4, 2005).

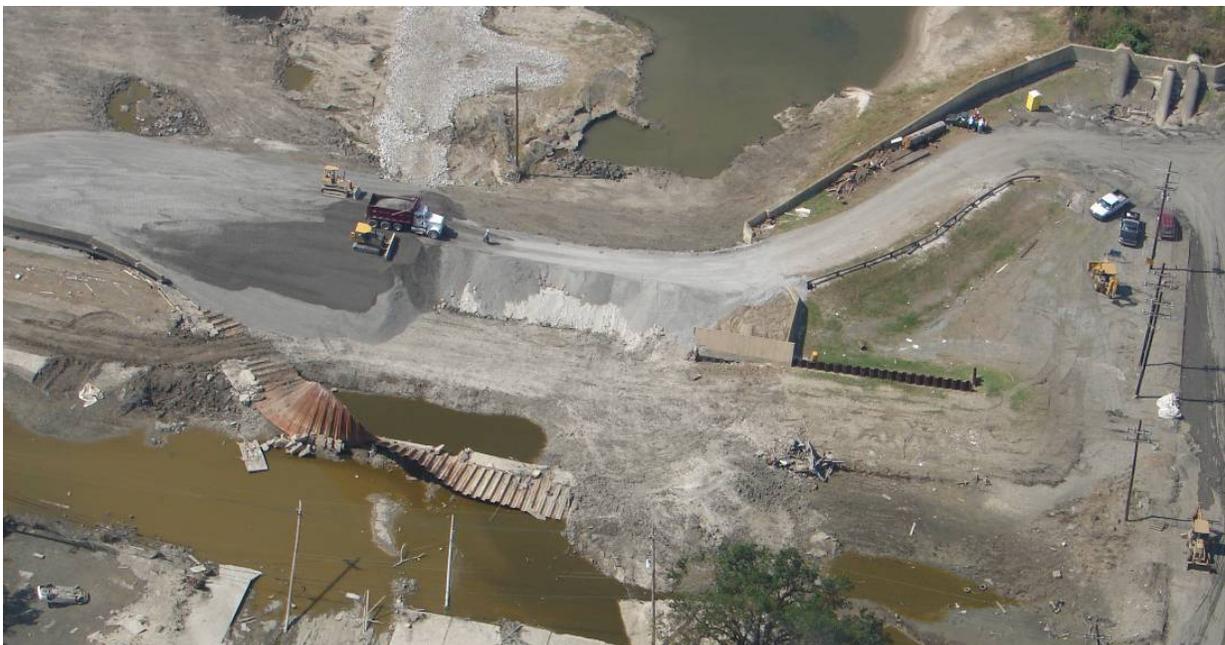
Figure 4.9 shows an aerial view of a 210 foot long levee breach located approximately 500 feet south of Florida Avenue. The breach initially resulted from the Hurricane Katrina storm surge in the IHNC. An emergency repair was made soon after. It is reported that unlike the south breach location, the north breach emergency repair was not overtopped in Hurricane Rita. The earthen portion of the I-wall levee system was almost completely destroyed and the I-wall was overturned and dragged inland by as much as 70 feet while remaining fully interlocked. In the most extreme case, the I-wall came to rest upside down, with the concrete portion at the bottom, and the toe of the sheeting pointing upward (Figure 4.10). The sheet pile separated from the concrete wall at the north end of the site by splitting the webbed section rather than tearing the interlock.

Figure 4.9: Aerial view of the north breach of the Lower Ninth Ward (L. Harder, October 14, 2005).

Figures 4.9 and 4.11 show the emergency repair, consisting of a core of large sandbags overlain by embankment fill. The sandbags were airlifted into place, while the stone was placed from land. Owing to the presence of standing water on the landside during a visit on October 4, it was not possible to determine if seepage was occurring through the repaired section.

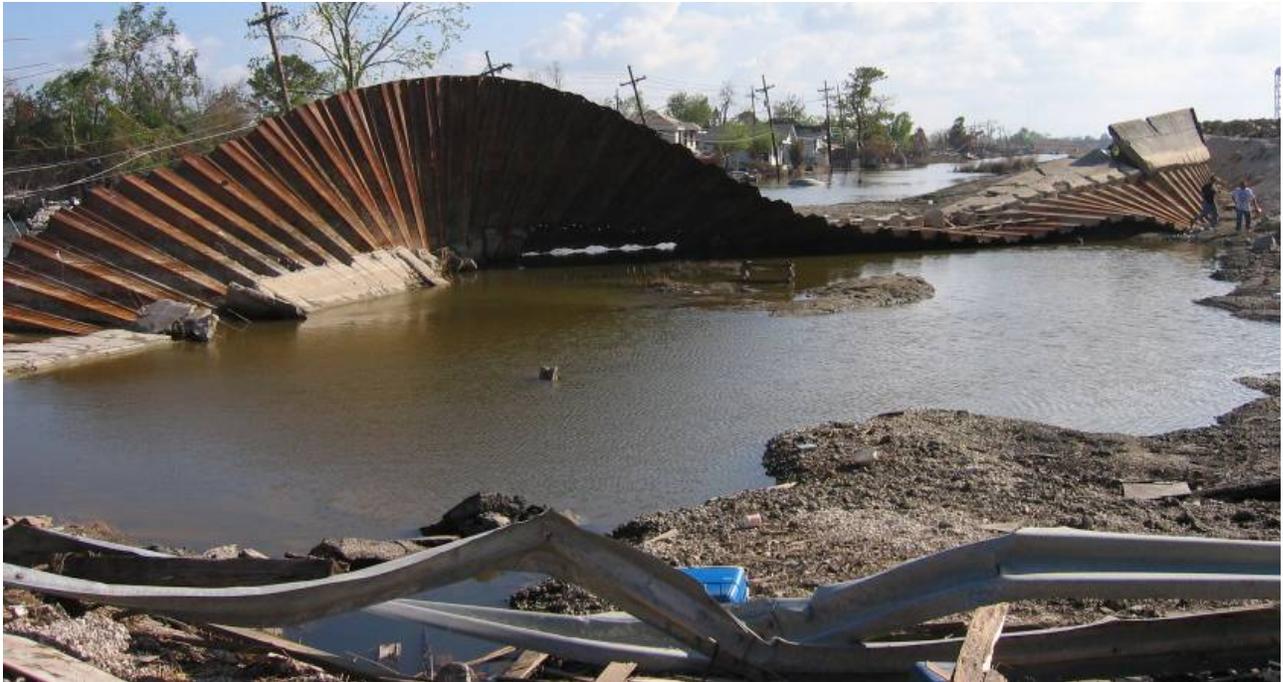
It is likely that the breach occurred in a manner similar to that described for the south breach location (i.e. overtopping of the levee, leading to scour and loss of passive resistance at the base of the wall, resulting in overturning). The scour-related failure hypothesis is again supported by extensive erosion found at the base of the protected side of the levee. While it is thought that overtopping may be the principal cause of the levee failure, it is not yet known why the failure occurred at this location along the IHNC levee system.

Figure 4.10: Overturned I-wall system at north breach of Lower Ninth Ward (J. Wartman, October 4, 2005).

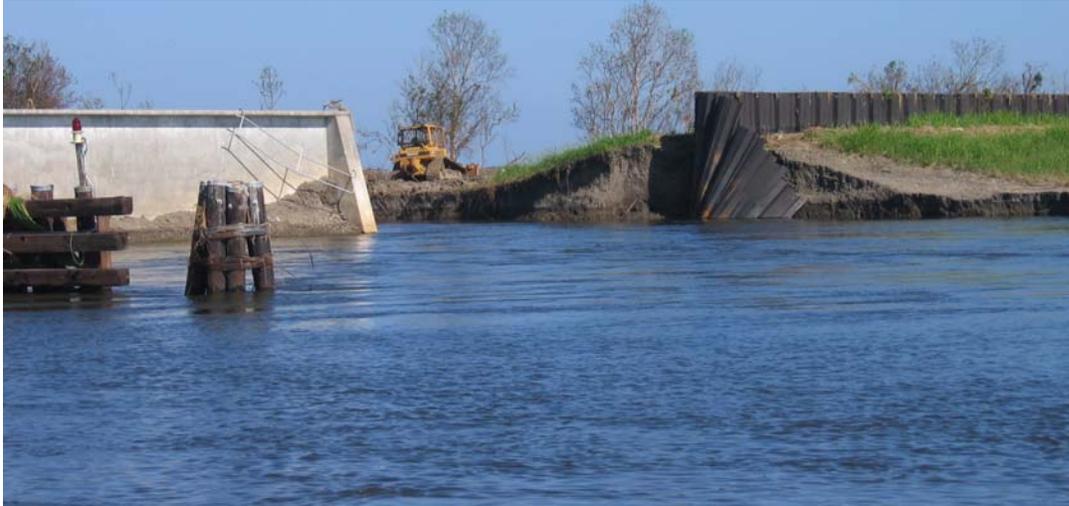
Figure 4.13: Sheet pile breach at the Bayou Bienvenue Gate (J. Wartman, October 5, 2005).

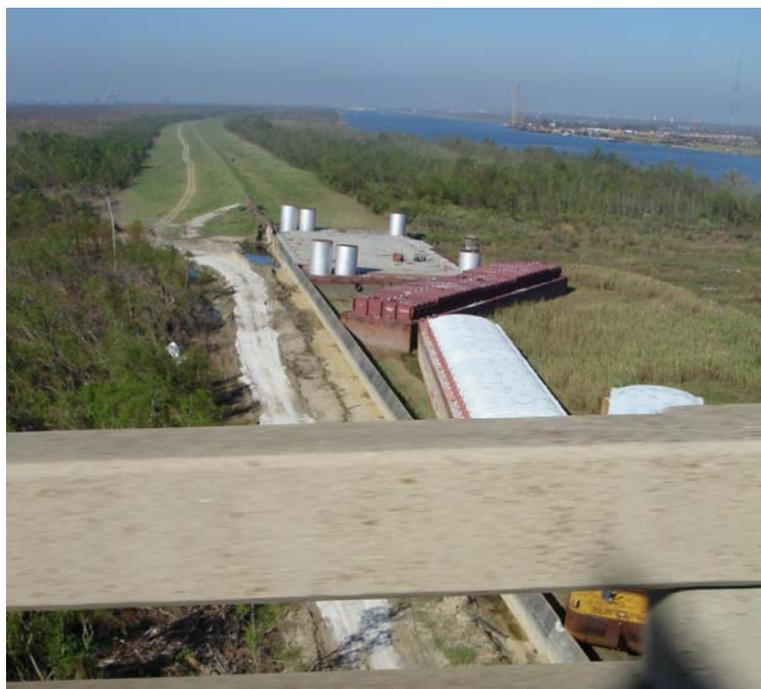
Figure 4.16 shows the levee and floodwall along the south bank of the IWW, looking west from the Highway 47 Bridge. The concrete floodwall survived with only minor damage despite the impact of several barges shown in the photograph grounded against the levee. Also evident in Figure 4.16 is the characteristic scouring from floodwall overtopping. The levee did experience a breach at the transition between the concrete gate structure and the earth embankment. Flood-transported debris partially plugged the breach.

Figure 4.16: View of levee along the south bank of the Intracoastal Waterway from the Rt. 47 Bridge (Lee Wooten, October 6, 2005).

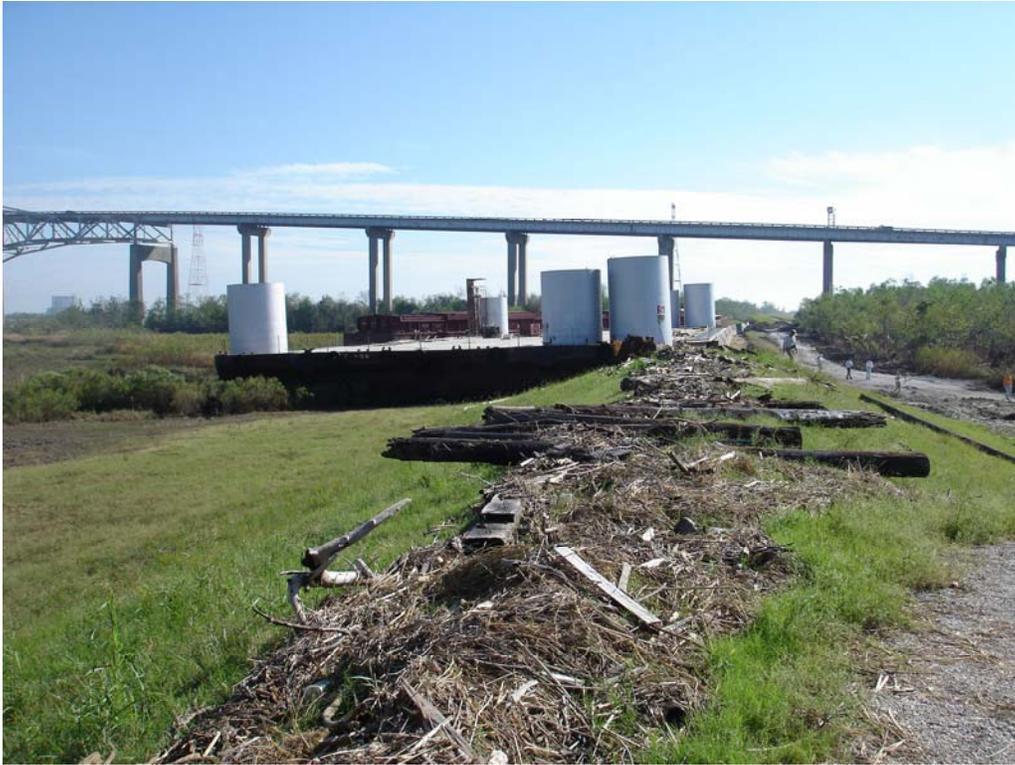
Crest road erosion damage was also noted at several locations along the earthen levee between the Bayou Bienvenue Gate and the northwest corner of the Lower Ninth Ward. This suggests that the earthen levees were overtopped at these locations; nevertheless, no breaches were found and the overall performance of the levee system was very good at these locations. These earth levees (west of Bayou Bienvenue) show a clear debris line at the crest level as

Figure 4.17: Debris line near levee crest just west of the Rt. 47 Bridge south abutment (L. Wooten, October 5, 2005).

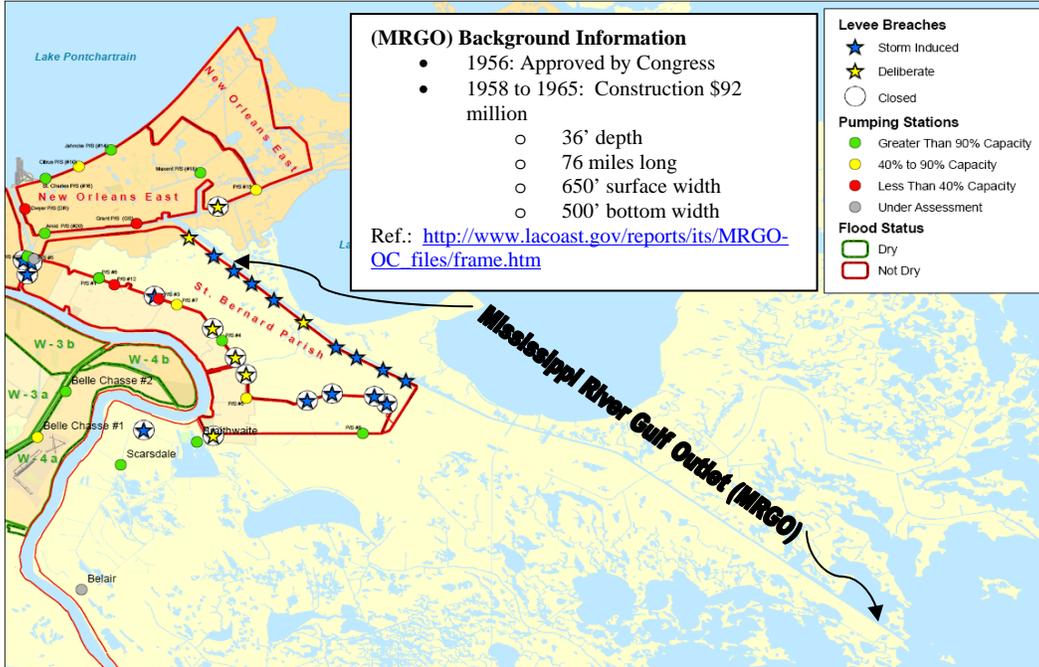
Figure 4.19 presents a plan view of MRGO and indicates the numerous breaches caused by Hurricane Katrina along the southwest bank of the waterway. This section covers the levee sections located southeast of Bayou Bienvenue. The field evidence, including numerous sections of earth levees obliterated by the storm waters, indicates that the flood protection barriers were overtopped along the MRGO.

The map in Figure 4.19 shows that the storm barriers along the MRGO suffered damage at many locations. Figures 4.20 and 4.21 capture the failure of earth levees with steel pile sheeting between Bayou Bienvenue and Bayou Dupree. At some locations, the canal side of the earth embankment was completely eroded away and the erosion from overtopping left only remnants of the landside portion of the levee. The section where pipelines cross the steel sheeting (Figure 4.21) show scour on both sides of the sheets and deflections in both directions possibly as result of wave action and outflows.

Figure 4.19: Mississippi River Gulf Outlet [MRGO] (USACE). The two yellow stars (i.e., deliberate breaches) along MRGO seem to correspond to locations of gate structures where storm-induced breaches occurred. These yellow star markers are likely errors in the original map that should have been designated using blue star markers.

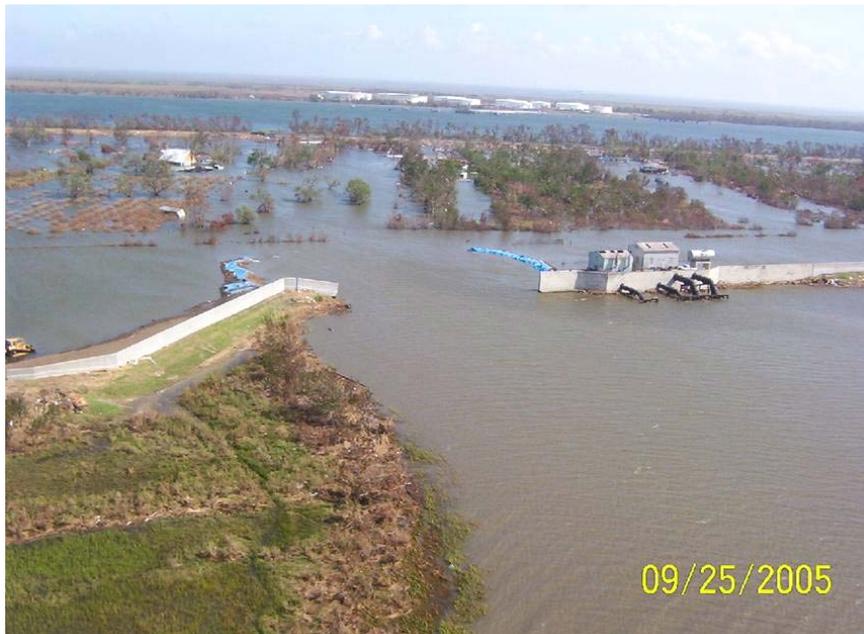
Figure 5.2: Aerial photograph of levee breach of hurricane (back) levee along western side of the Mississippi River near the community of Sunrise (September 25, 2005)

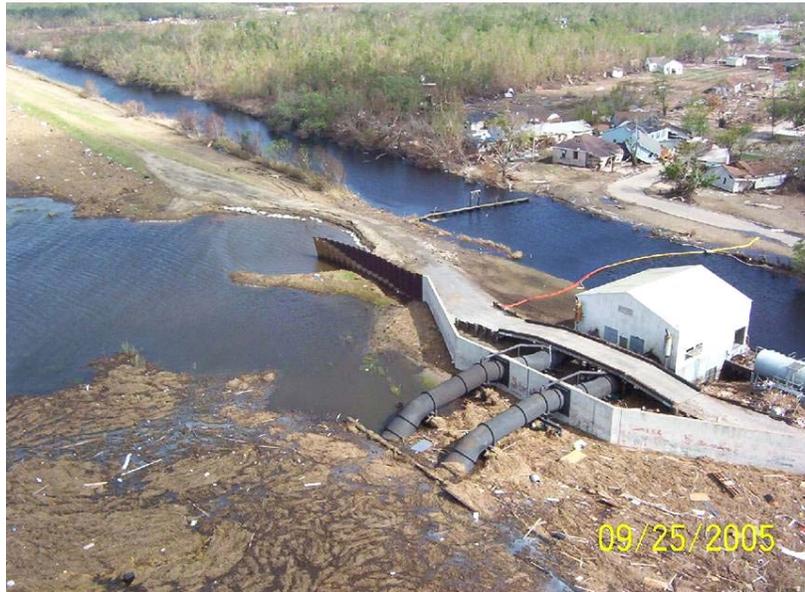
Figure 5.3: Aerial photograph of levee breach of hurricane (back) levee at levee transition near Hayes Pump Station (September 25, 2005)

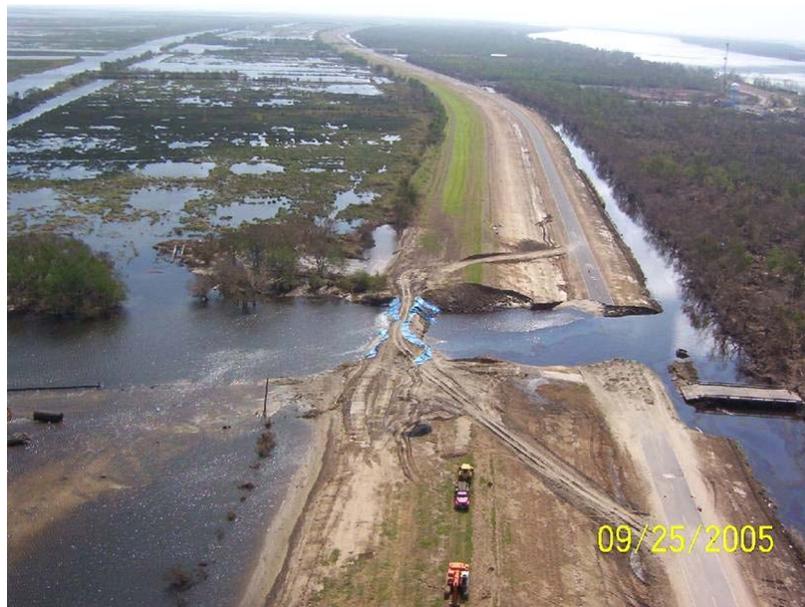
Figure 5.4: Aerial photograph of levee breach of hurricane (back) levee east of Pointe a la Hache (September 25, 2005)
