# Preliminary Report on the Performance of the New Orleans Levee Systems in Hurricane Katrina on August 29, 2005

Preliminary findings from field investigations and associated studies performed by teams from the University of California at Berkeley and the American Society of Civil Engineers, as well as a number of cooperating engineers and scientists, shortly after the hurricane.

Report No. UCB/CITRIS – 05/01  
November 17, 2005

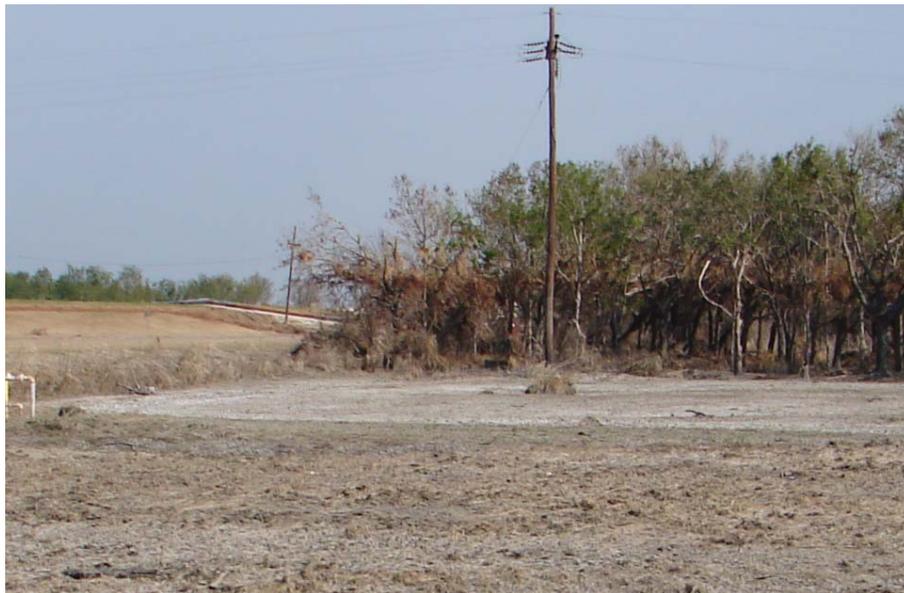
Residences in Pointe a la Hache were commonly inundated to depths of 12 to 15 feet (see Figure 5.6). Flooding was so great that water flowed across the community from the east

Figure 5.6: Photograph of flood elevation on trees landward of hurricane levee east of Pointe a la Hache – illustrating that flood water remained to large depths for extended periods (October 12, 2005)

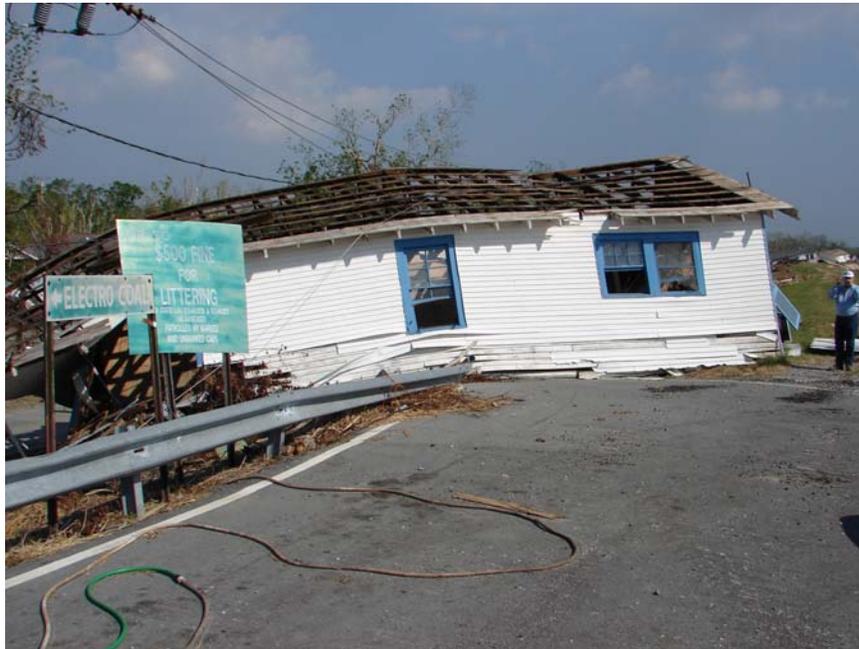
Like many New Orleans residences, the small wooden homes in Pointe a la Hache were commonly founded on cinderblock piers. As a result of the deep flooding and the flow towards the Mississippi River, homes in Pointe a la Hache were commonly picked up and floated away from their foundations. Many ended up being deposited on or across the Mississippi River Levee as a result of flood waters flowing into the Mississippi River (see Figures 5.7 through 5.9).

Figure 5.7: Photograph of Pointe a la Hache home deposited on Mississippi River levee crown after storm surges overtopped this levee from the east (left) towards the river – which is to the right in this photograph (October 12, 2005)

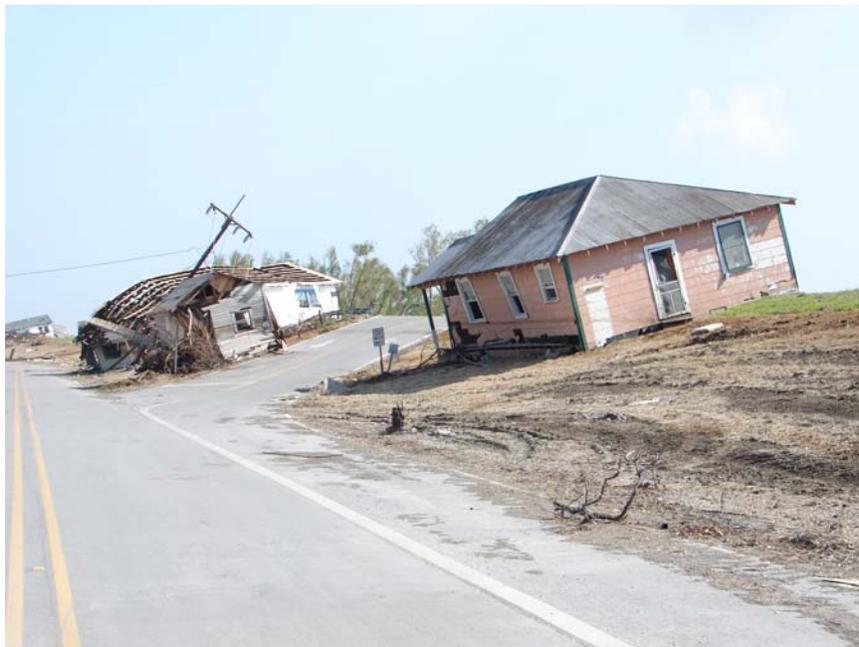
Figure 5.8: Photograph of Pointe a la Hache homes deposited on Mississippi River levee after storm surges overtopped the levee from the east (left) towards the river (right) (October 12, 2005)

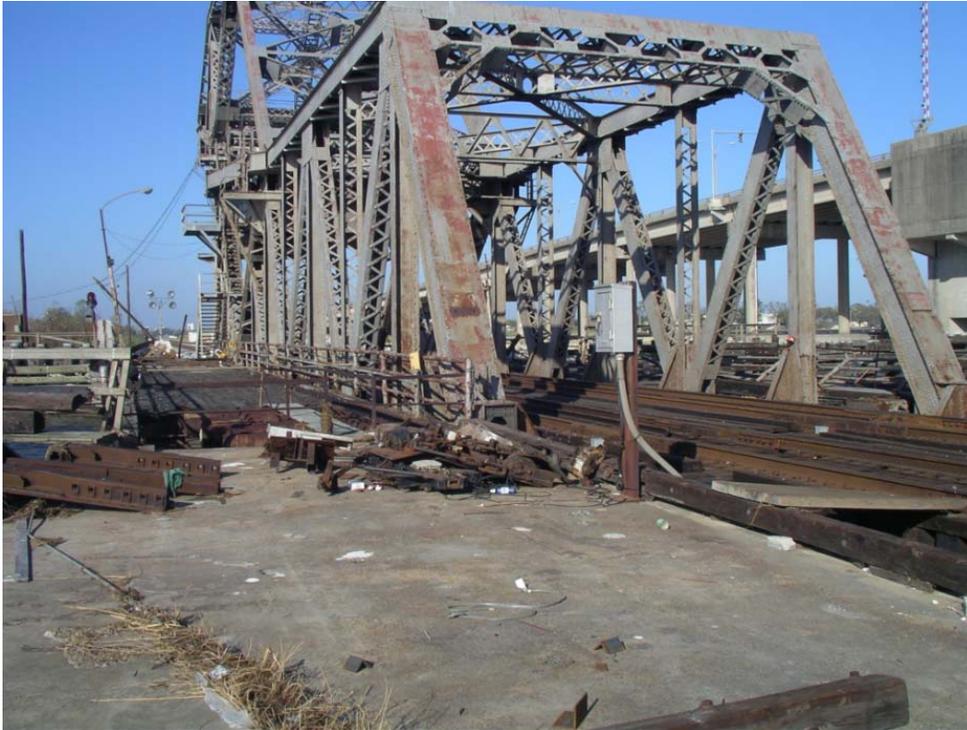
An example of system vulnerabilities associated with the multiplicity of organizations was found on the east side of the IHNC at the lake front adjacent to the railroad bridge that crosses this canal near the Lakefront Airport (Figure 6.1). Inspections of this area clearly indicated that large amounts of water had entered through a railway opening in the adjacent concrete flood wall and soil levee (Figure 6.2). The inspection did not disclose the presence of a flood gate that had closed the railway opening, even though immediately adjacent to this opening was a securely closed flood gate and concrete flood control structure maintained by the USACE (this gate and the adjacent flood control structure had not been breached and showed no signs of overtopping). The low spot in this complex interchange was the base of the railroad ballast, and it was here that the water had flowed through. Attempts had been made to place sandbags prior to the arrival of hurricane Katrina; the attempts had not been successful and water had poured through the opening flooding the areas immediately south and west of the opening.

Figure 6.1: A railroad bridge adjacent to the Lake Pontchartrain frontage road.

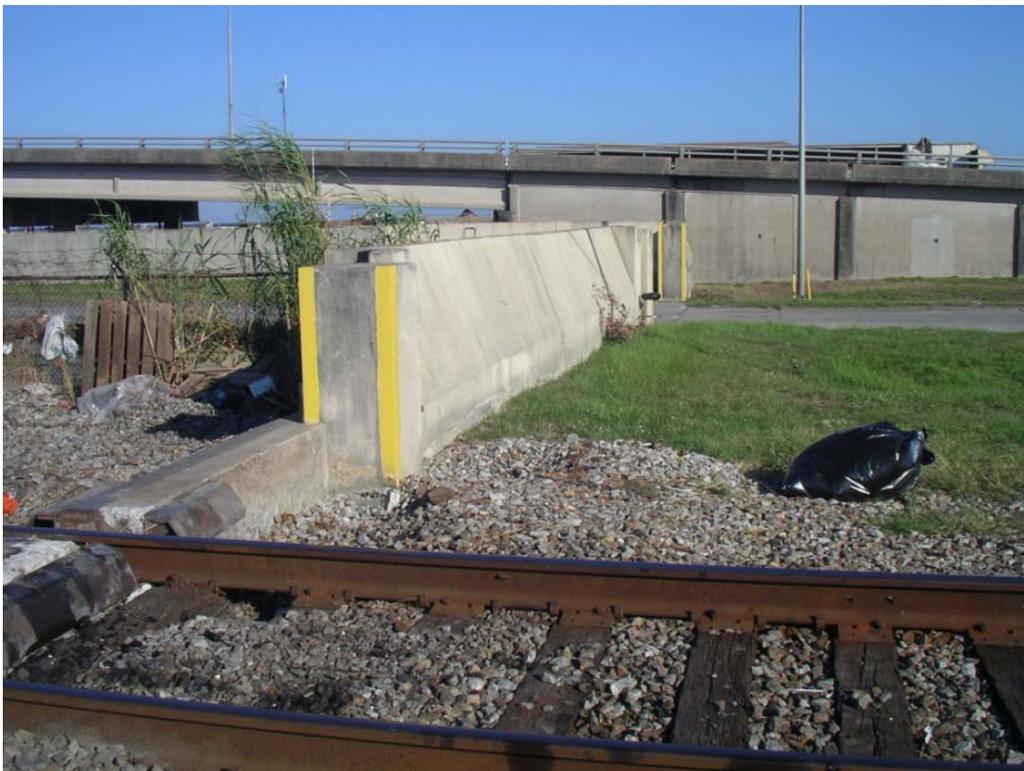
Figure 6.2: Lack of a floodgate at the railroad line crossing resulted in scour around the railroad tracks. No overtopping was observed the floodgate across the adjacent roadway.

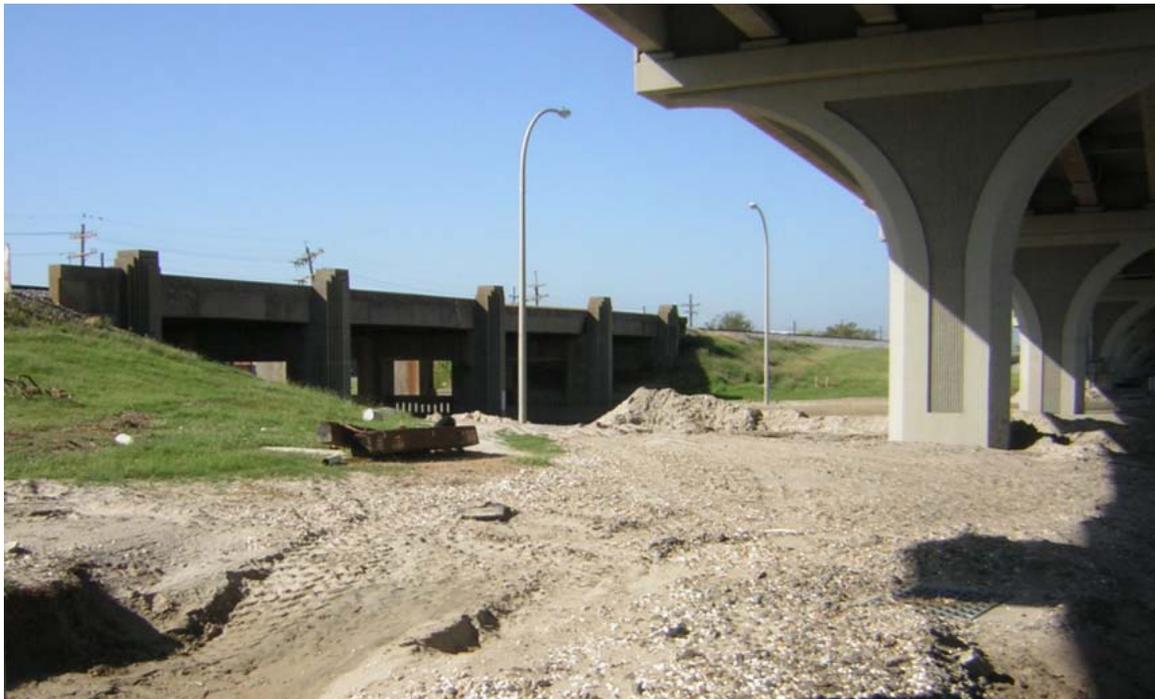
Another example of system vulnerabilities associated with the multiplicity of organizations occurred in the same area, near the lake front airport (Figure 6.3). The earth levee that paralleled the lake front defending the neighborhood to the south of the Lakefront airport had experienced some overtopping, but water had breached a section between the adjacent flood control structure (concrete, flood gate closed) and the earth levee (Figure 6.4). The earth levee was at an elevation that was lower than the flood control structure. Massive

Figure 6.3: Lack of a flood gate beneath the railroad over-crossing facilitated the flooding of residential neighborhoods.

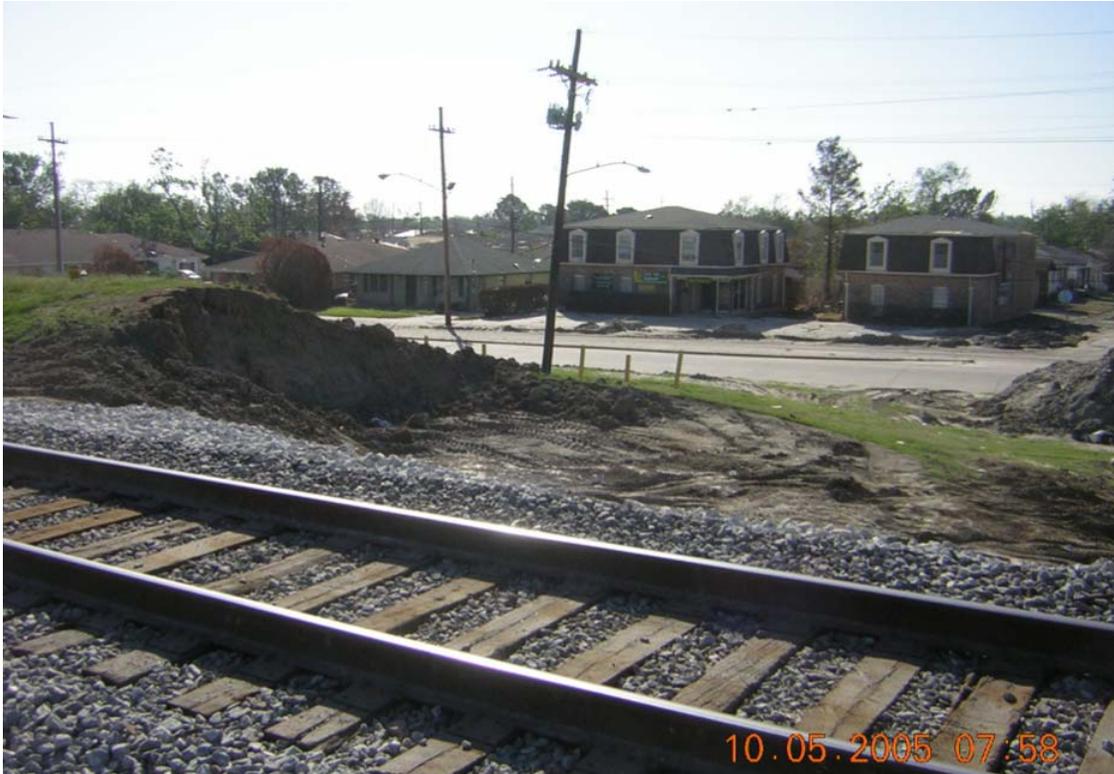
Figure 6.4: This flood protection levee was overtopped and scoured, resulting in flooding of this lakefront residential area.

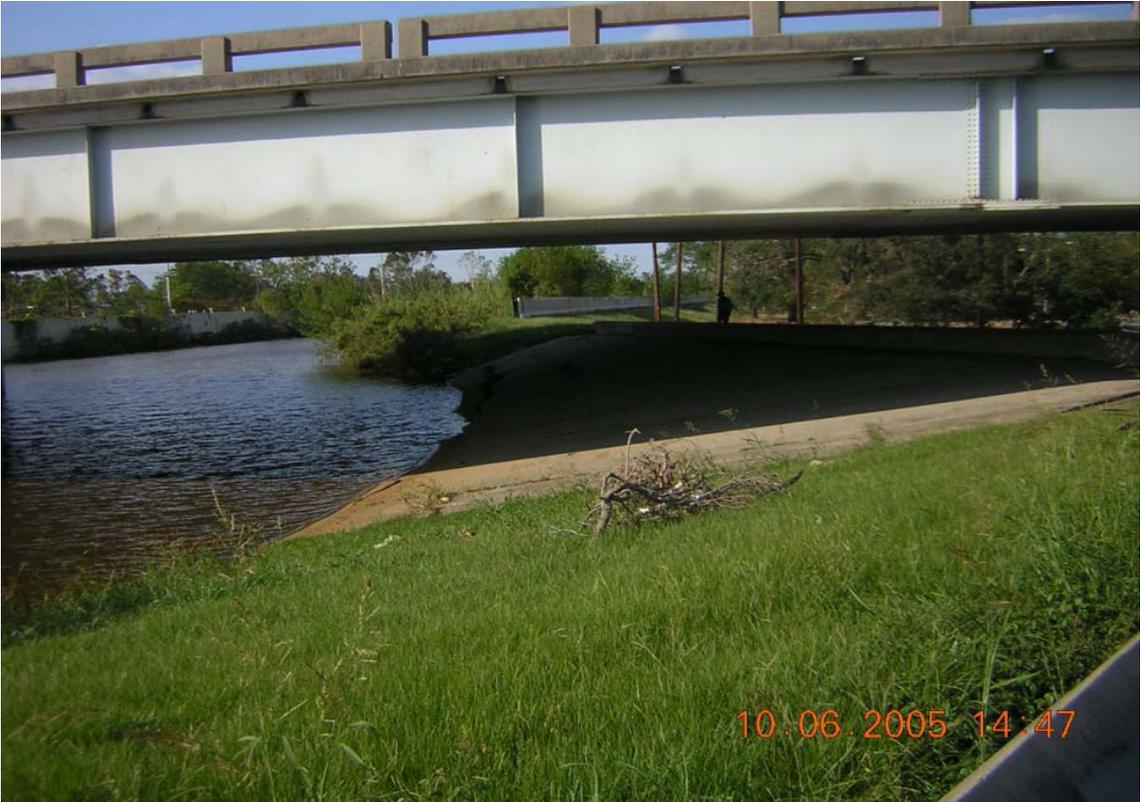
After touring the pump station, we surveyed the area immediately outside of the pump station to determine how the flood walls and other parts of the levee system had performed. We found that it had performed very well, with little signs of overtopping. However, as we toured the area we found that there were 5 different elevations of different parts of the levee system in a small area (Figure 6.8). A significant example of this occurs on the east bank where the floodwall on the earthen levee abruptly ends at a considerable distance (some 300 feet) before the levee reaches the pumping station, leaving a long, low gap where there should have been a contiguous, closed perimeter flood defense. A similar situation occurs on the west side where the floodwall transitions into a short stretch of sheet pile with a considerably lower elevation. Note that these gaps provide access of floodwater into the surrounding residential areas at a water level well below the flood protection system design level. Some overtopping had in fact occurred in both places, as reported by the pump station operator, who was onsite during Hurricane Katrina. Other variations in the elevations of the flood defense elements were correlated with the agencies that had responsibilities for various parts of this part of the system, (e.g. highway department determining the heights under the road overpass immediately adjacent and upstream of the pump station, Figure 6.9)).

Figure 6.8: Area outside (to the north of) the Orleans pump station.

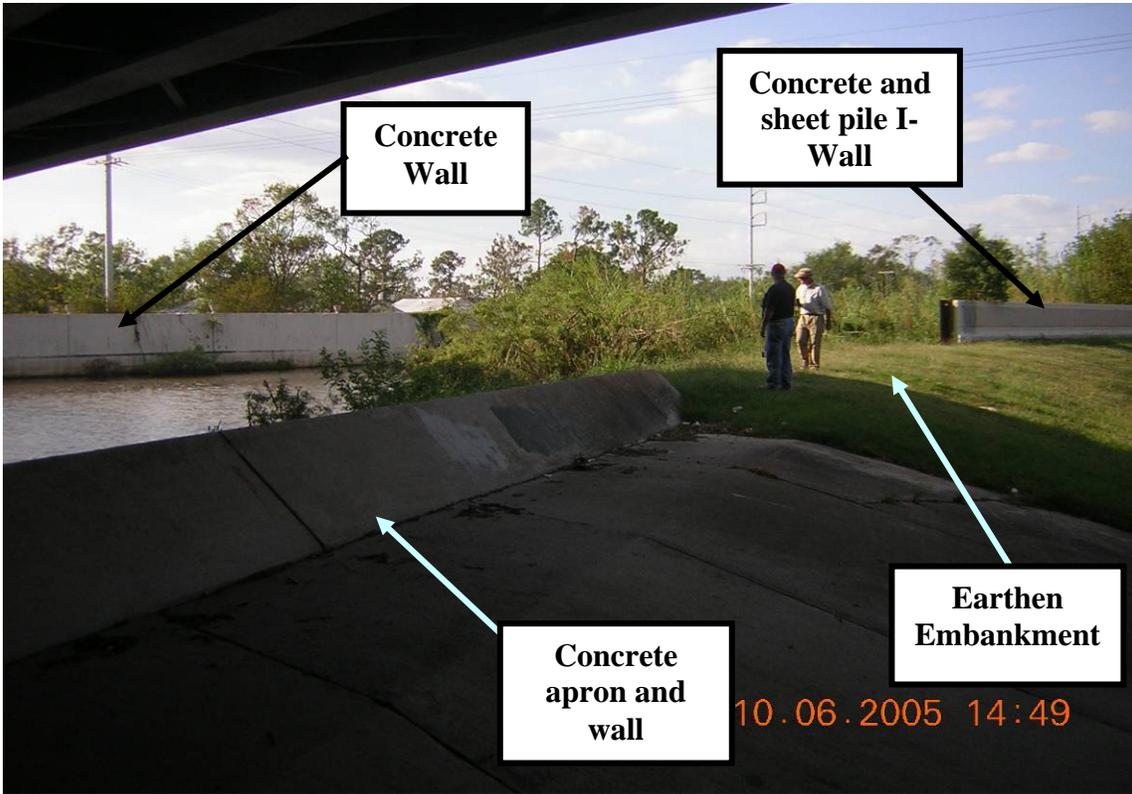
Figure 6.9: At the Orleans Canal pump station, the flood protection system consisted of different components, each with a different “top of wall” elevation.

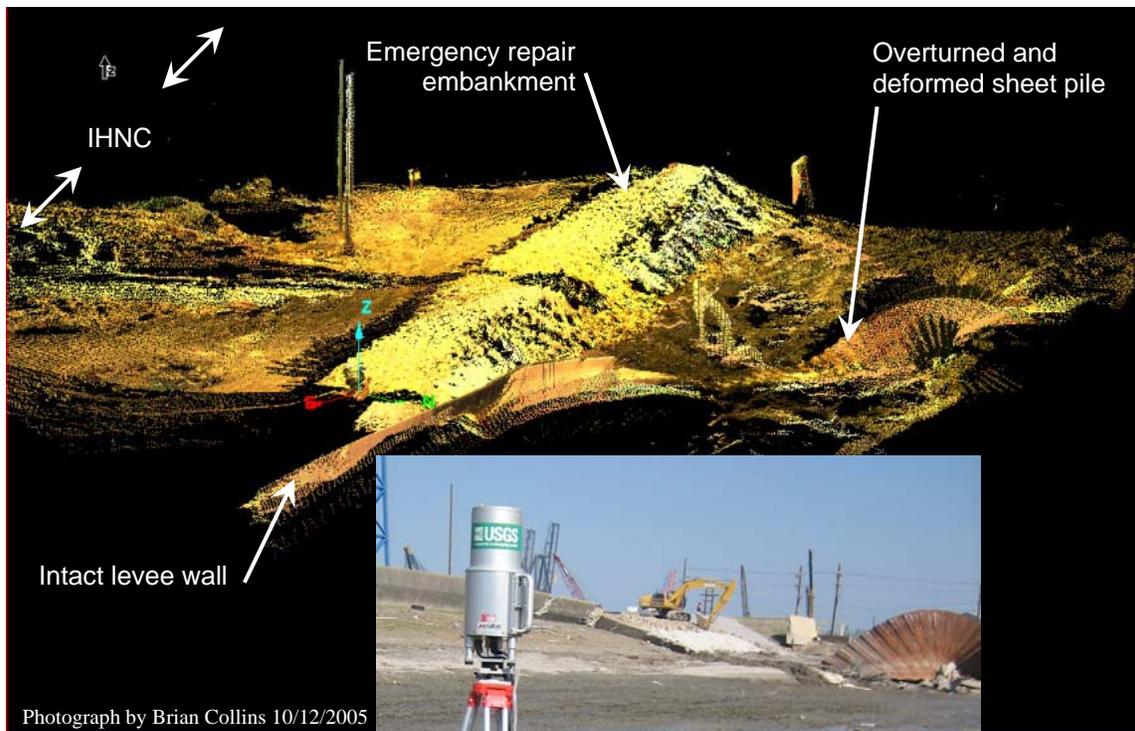
in a scan of the levee at the east side, north breach of the Inner Harbor Navigational Canal (IHNC), locally referred to as the Industrial Canal (Figure 7.4) that shadows are cast by near-field objects like the exhumed sheet pile foundation over the debris behind it. As the incident-angle of the laser point decreases, proportionally larger shadows are cast on the ground behind the target. Therefore, to minimize shadow zones and get full coverage of the target surface using terrestrial LIDAR, the scanner is moved to a number of locations surrounding the target zone (Figure 7.5). The levee scans involved 13 to 29 scanner set-ups to cover the entire feature and surrounding area and to minimize the number of shadow areas. Using multiple setups provided both a convenient way to limit the number of shadow zones while also increasing the resolution of the data collected and the boundaries of the scanned area.

Figure 7.4. For complete coverage of the IHNC-North levee breach the laser was moved around objects that cast shadows. The sheet pile foundation and levee were imaged from both sides to complete the 3-D model.

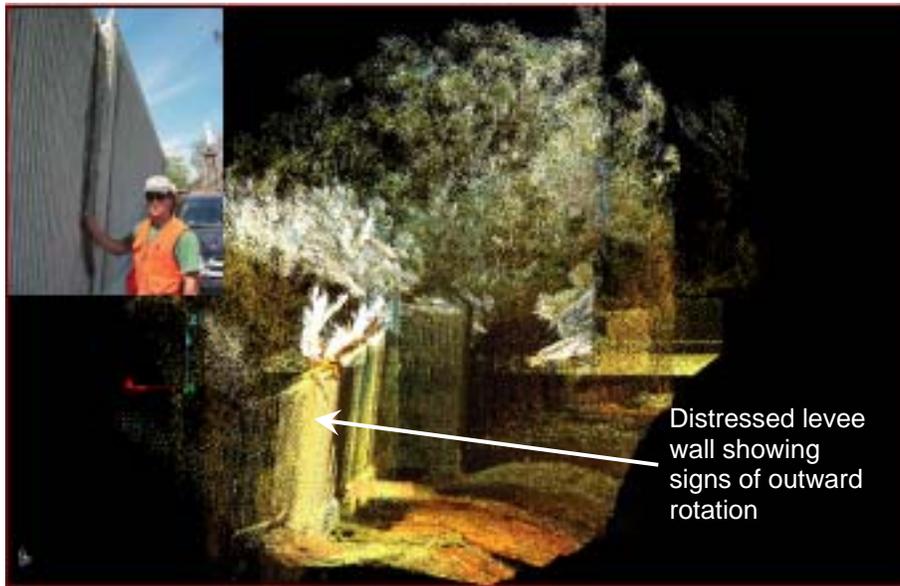
distress and lateral deformation associated with incipient failure of the levee. This movement is along a section of wall diagonally northeast of the west side breach across the canal. In Figure 7.13, an oblique image of the distressed wall can be seen from the south. The wall, preserved in incipient failure, leans toward the levee maintenance road and landside portion of the levee. In the right-hand background, is the bridge abutment on Robert E. Lee Blvd for reference.

Figure 7.13: Leaning I-wall of a distressed portion of the London Avenue Canal. The wall leans toward the levee maintenance road and landside portion of the levee. In the right-most background is the abutment of the bridge on Robert E. Lee Blvd. along with vegetation on the canal side of the levee.

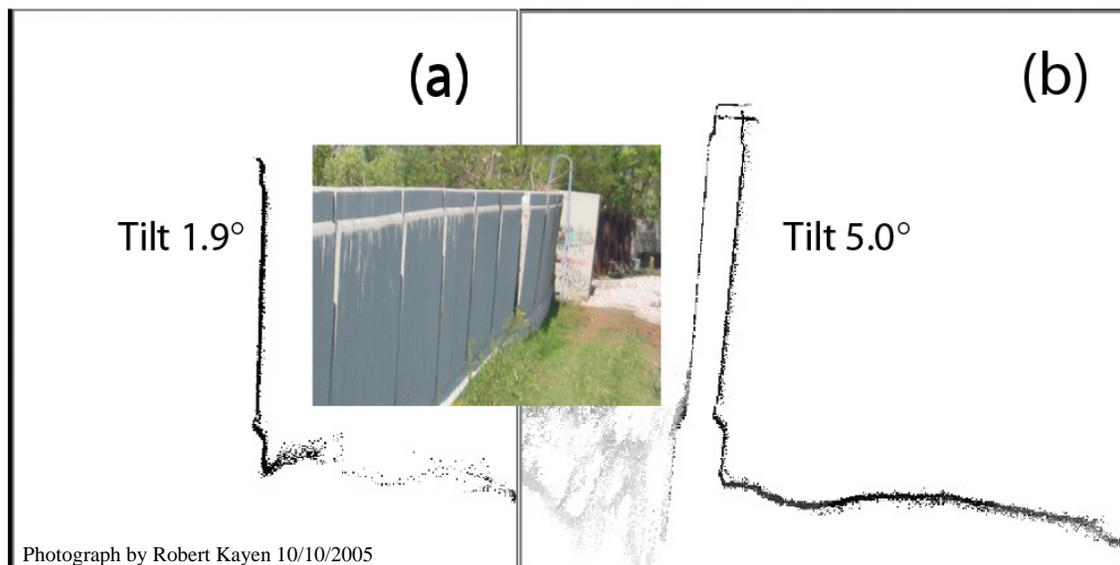
Considerable vegetation grows along the banks of the canal side of the levee that are less maintained for growth than the landside neighborhood-side of the levee wall. Thin slices of the point-cloud data orthogonal to the alignment of the levee wall (Figure 7.14) display highly accurate cross sections of the distressed I-wall at London Canal. Segment (a) is toward the south (left) of Figure 7.13 and has a modest 1.9 degree rotational deformation. Near a position of maximum distress, the I-wall has 5.0 degrees of rotational deformation toward the landside of the levee.

Figure 7.14: Cross sections through two segments of distressed I-wall at London Avenue Canal. Segment (a) is toward the south (left) of Figure 7.13 and has a modest 1.9 degree rotational deformation toward the landside of the levee. Near a position of maximum distress, the I-wall has 5.0 degrees of rotational deformation.

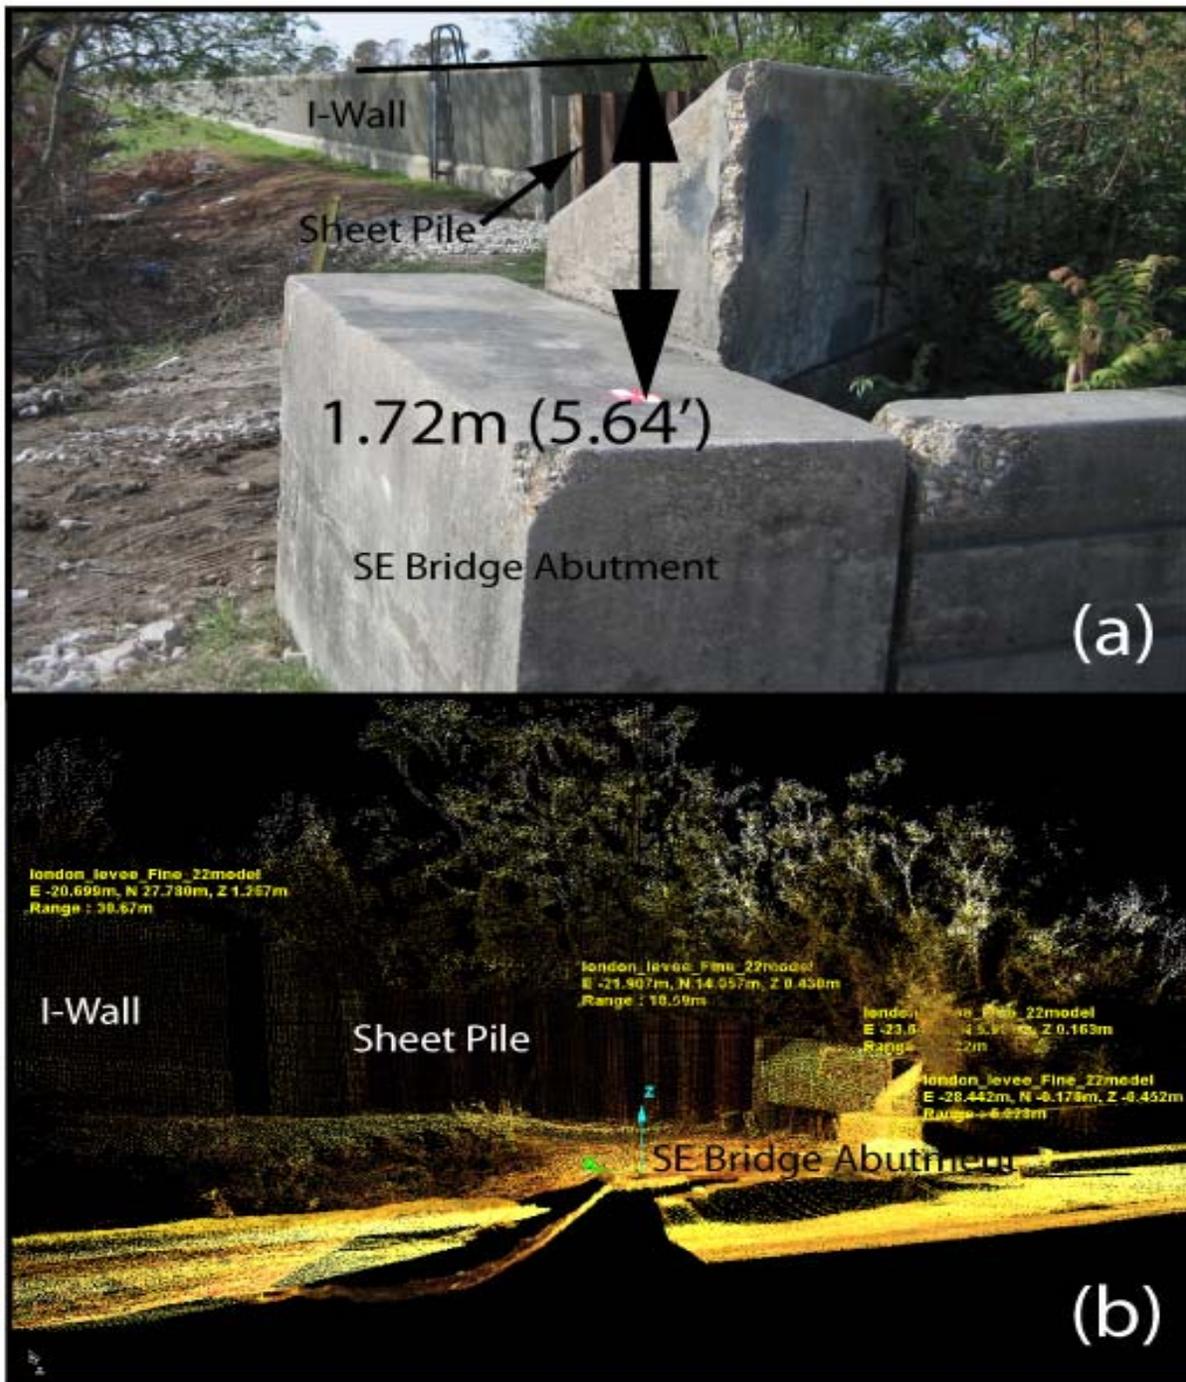
The London Canal levee failure (west side) and distressed wall (east side) are both immediately south of the bridge crossing at Robert E. Lee Boulevard. A significant gap in height between the lower un-walled bridge abutment and I-wall prevents water from overtopping these levees. The height gap differs slightly between the walls located north and south of the bridge, due either to differing design heights or differential settlement following construction. At the distressed I-wall section on the southeast corner of the bridge, LIDAR surveys and visual inspection indicated the gap at this location was approximately 1.7 meters (5.6 feet). Therefore, water rising in the canal would overtop the bridge abutment and begin to flood the surrounding community when the water level was 1.7 meters (5.6 feet) below the top of the I-wall. Figure 7.15 shows this considerable wall gap, as well as moderate scour at the southeast edge of the bridge abutment (Figure 7.15a). On the northeast corner of the bridge abutment near the north levee wall, LIDAR surveys indicate the gap at this location to be approximately 1.51 meters (5.0 feet). Figure 7.16 and 7.17 show this gap, as well as a scour trench at the base of the northeast abutment (Figure 7.17a).

Figure 7.15: Photograph of the southeast abutment of the London Avenue Canal bridge at Robert E. Lee Blvd (a), and LIDAR scan of the same location (b). New soil and rock apparently fills scour and sink hole erosion beneath the abutment. The relative height gap between the bridge abutment and the flood wall is 1.72 meters (5.6 feet).

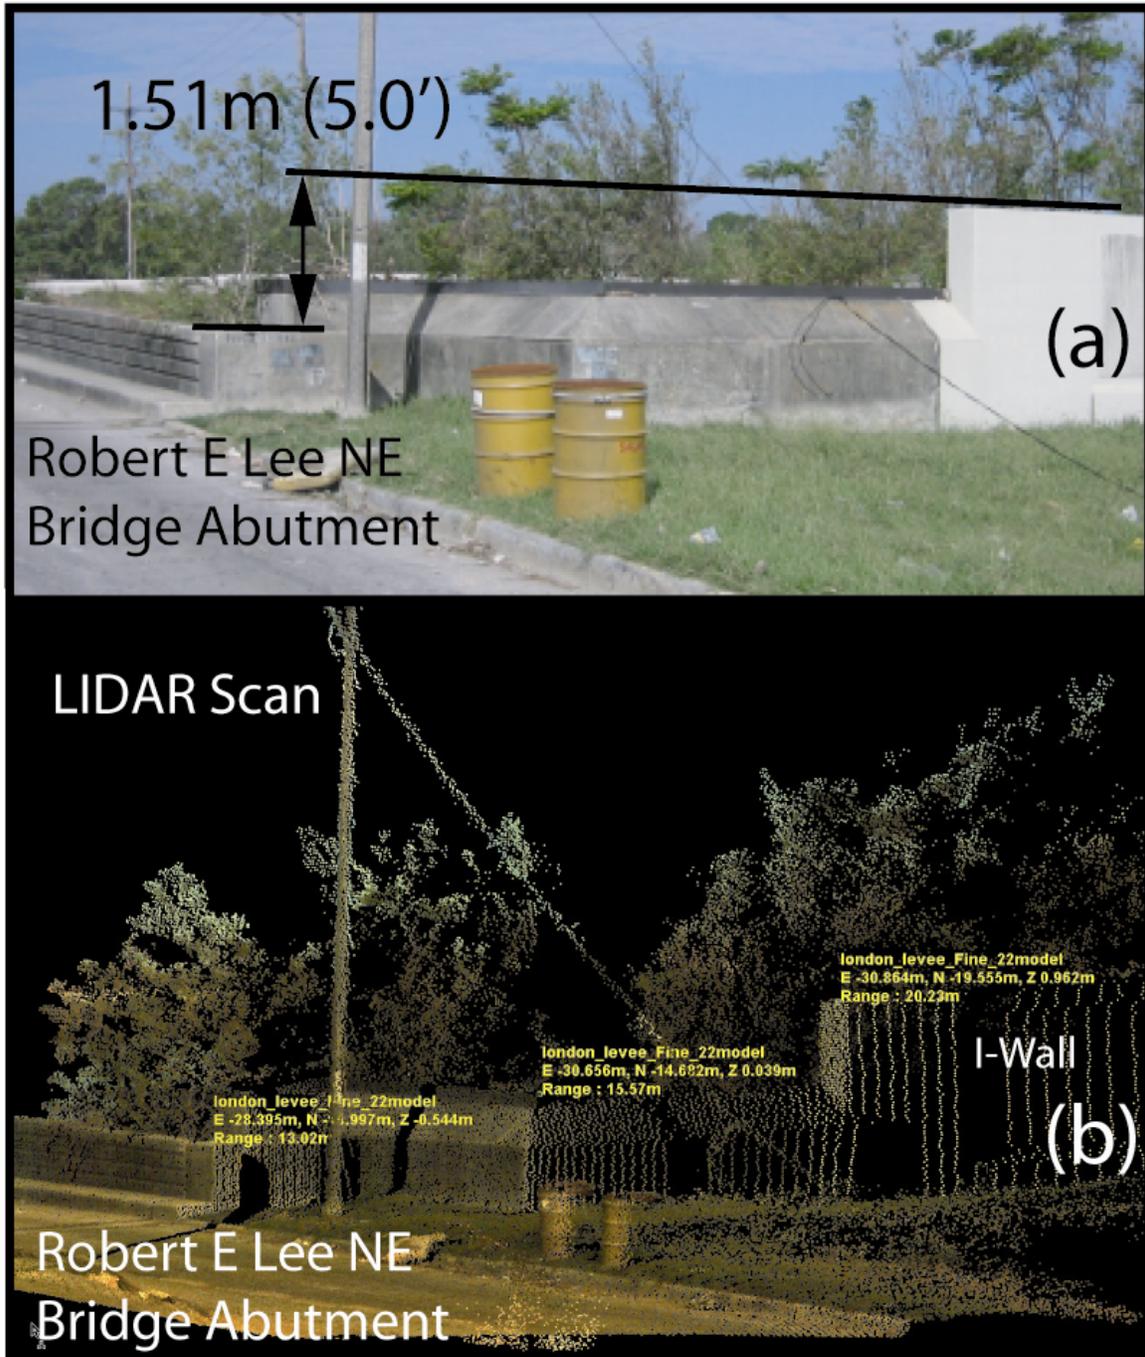
Figure 7.16: The northeast abutment of the London Avenue Canal bridge on Robert E. Lee Blvd. in photograph taken from the lower portion of the bridge approach-fill embankment (a), and corresponding LIDAR scan (b). The wall gap here is 1.51 meters (5.0 feet).

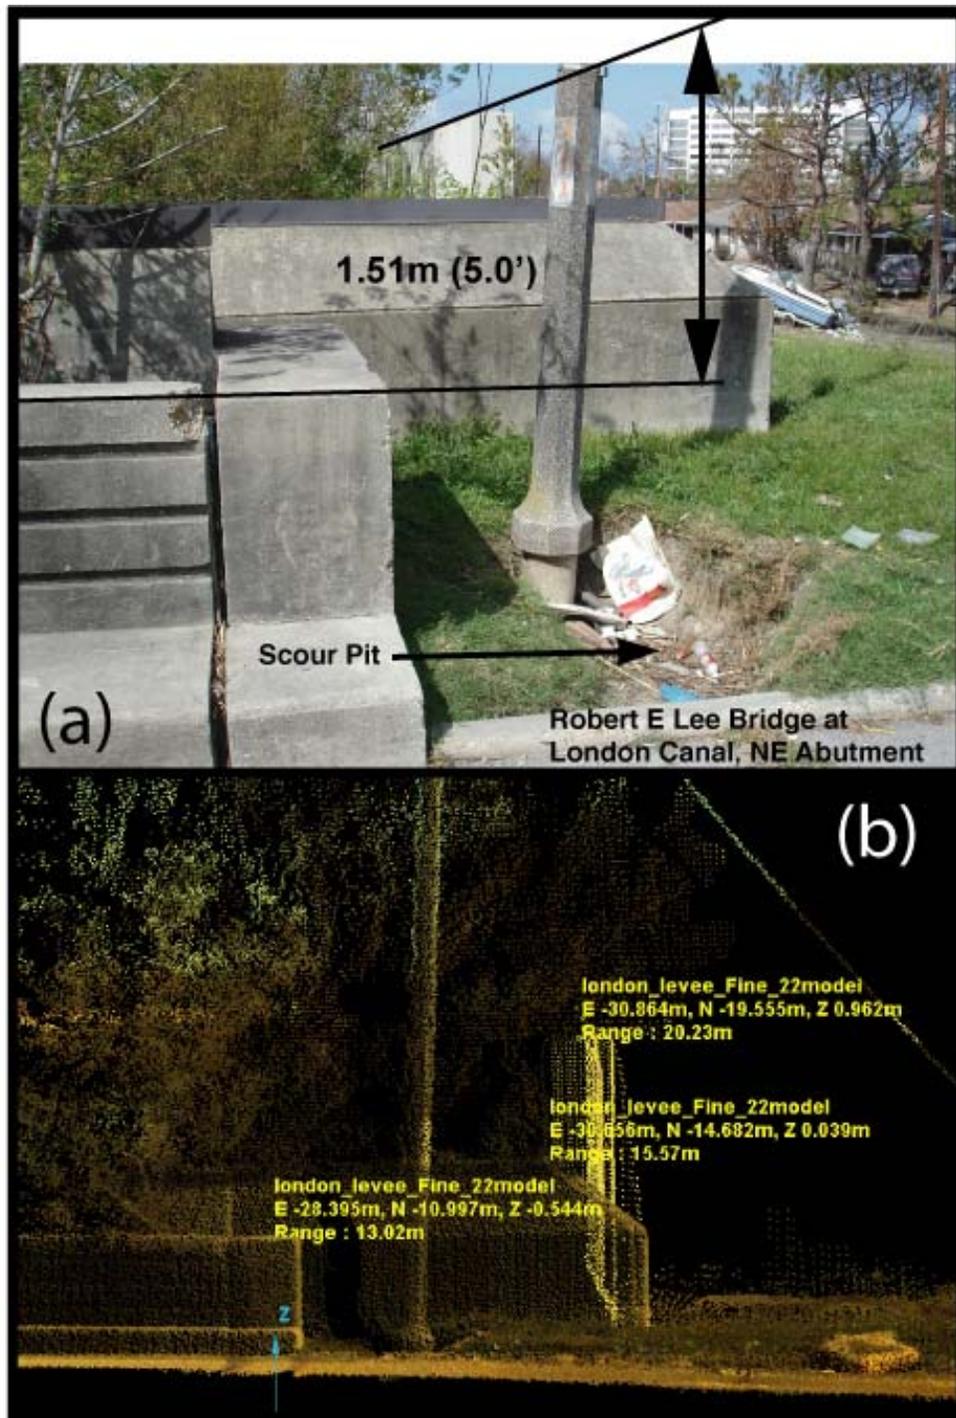
There was no evidence of overtopping of the levee walls or erosion scour anywhere along this section of the canal except at the gap at the bridge. The LIDAR and scour evidence therefore indicate that the floodwalls along the London Canal section, south of the Robert E. Lee Boulevard Bridge were not overtopped prior to failure of the levee wall.

Figure 7.17: Photograph taken directly south and adjacent to the northeast abutment of the Robert E. Lee Bridge (a), and corresponding LIDAR scan of the same location (b). A scour trench is clearly visible beneath the abutment. The wall gap here is 1.51 meters (5.0 feet).

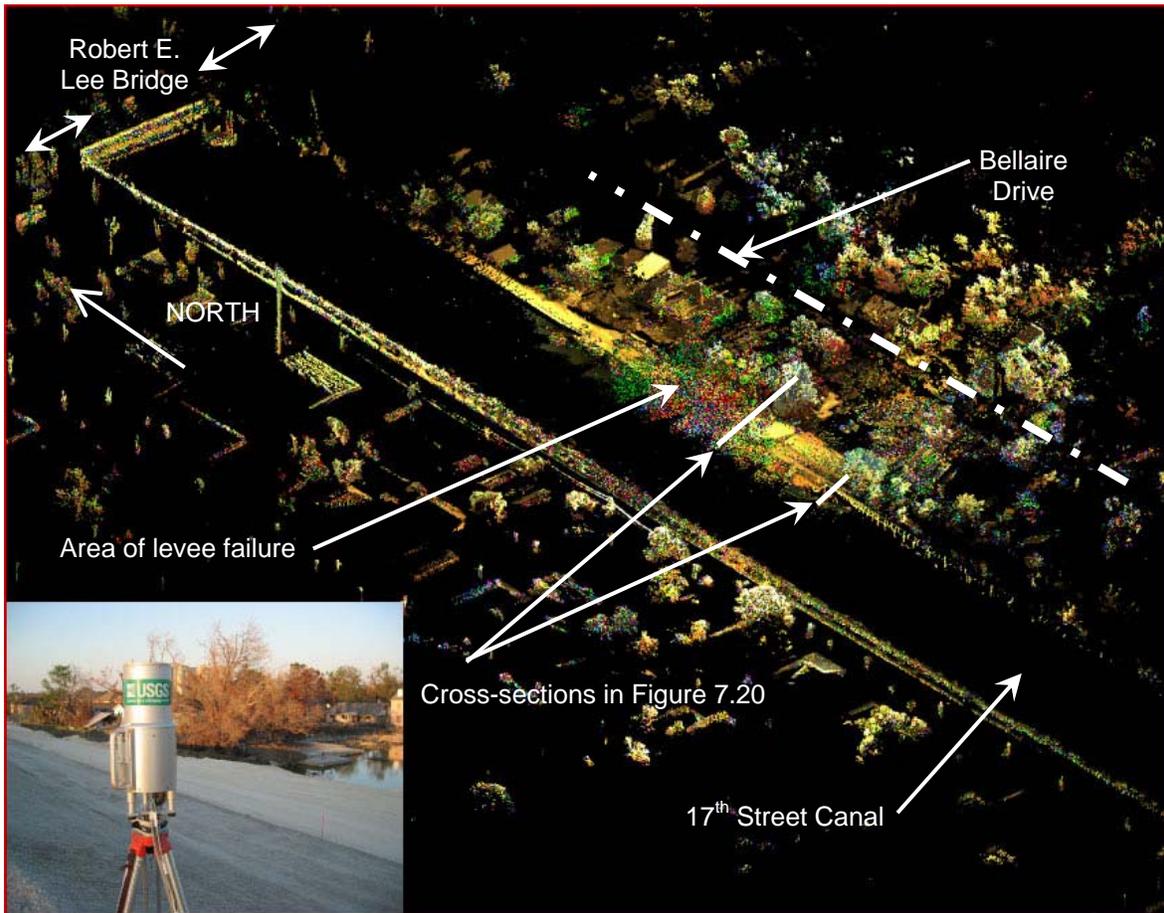
Measurement of displacement along the 17<sup>th</sup> Street Canal breach can be made by identifying the blocks of ground formerly within the intact levee that slid eastward toward the landside of the levee. Figure 7.18 is an overview image of a portion of the 17<sup>th</sup> Street point cloud data set consisting of 11 individual scans. In this image, the bridge crossing over the canal at Robert E. Lee Blvd. (also called the Hammond Highway.) is toward the upper left (north). A dense cluster of points is visible at the levee breach in the center of the image as are the houses in the affected area. Close in to the levee breach in Figure 7.19, the remaining I-wall can be seen in alignment with the crest of the replacement structure. Here, a total breach repair width of 142 meters (466 feet) as measured between intact I-wall sections has been calculated directly from the LIDAR data set. A cross section taken through this area is shown in Figure 7.20. A multi-section view is shown, consisting of a section of the intact southern I-wall overlain over the failed section of the levee. The geometry of the emergency repair embankment is clearly visible. The sections also show the magnitude of the

Figure 7.18: Overview oblique image of the 17<sup>th</sup> Street Canal area in the vicinity of the breach. The Robert E. Lee Blvd. Bridge is to the north (upper left) and the breach area is to the upper right (east). Houses within the neighborhood breach area and the scour pond were imaged from the new levee and Bellaire Drive.

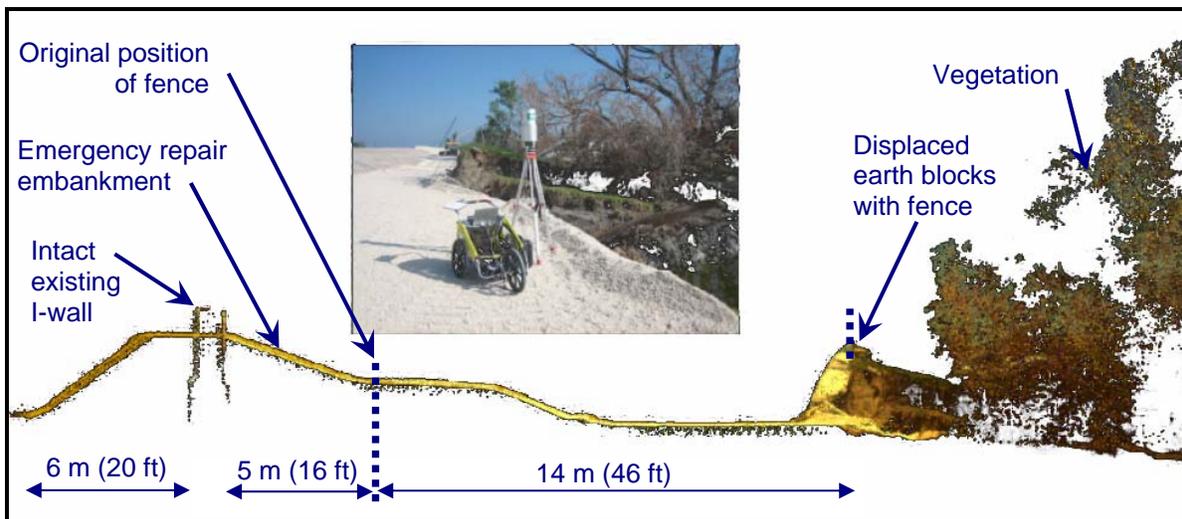
displacement of several earth blocks that moved away from the levee break during failure. While forensic work on the original positions of the earth blocks is still ongoing, the LIDAR data shows that blocks translated approximately 14 meters (46 feet) as measured from the existing alignment of the cyclone fence line to its new position within the displaced blocks. From the perspective shown in Figure 7.20, it can also be seen that the width of the 17<sup>th</sup> St. Canal has been reduced about 6 meters (20 feet) by the placement of the earthen embankment.

Figure 7.20 Cross-section of the 17<sup>th</sup> Street Canal breach looking northward. Measurement of the lateral translation of the landside soil levee from its original position is approximately 14 meters (46 ft). The I-wall in this image is offset (out of the page) from the slide block.

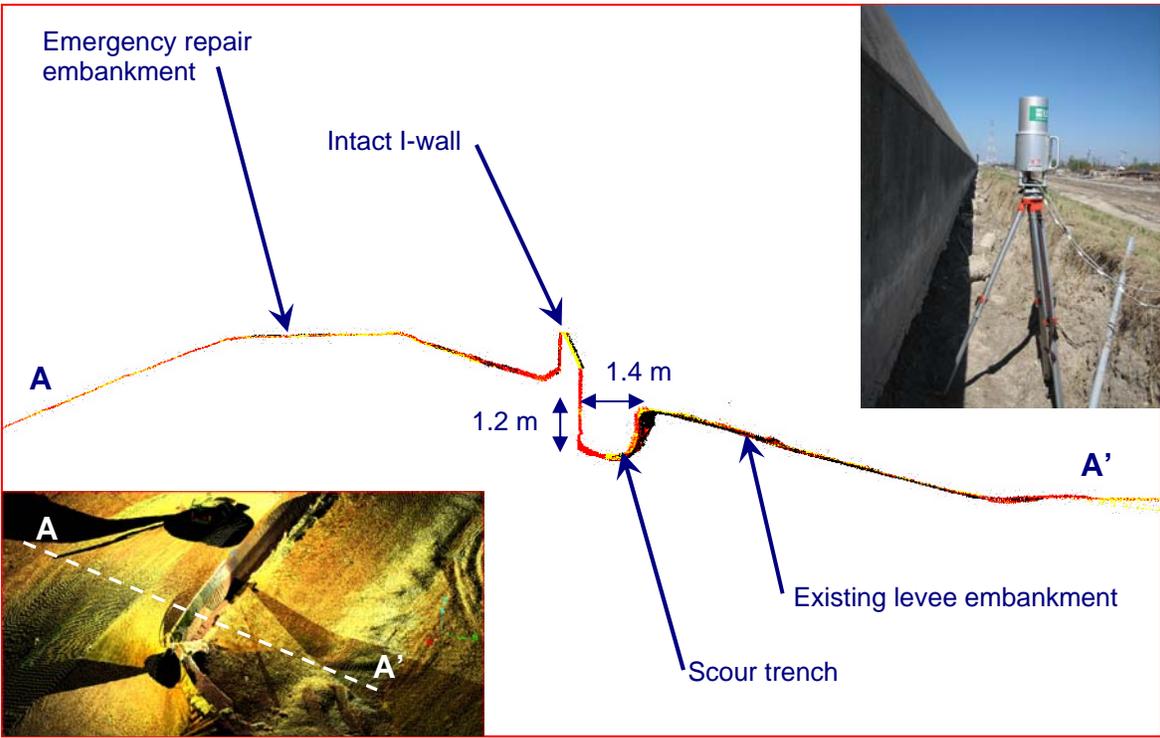
Figure 7.21: Measurement of scour trench dimensions at the IHNC – South site.
